# MTR Works Contract 1117-Pat Heung Depot Modification Works

# Monthly Noise Monitoring Report for December 2013

# Pat Heung Modification Works Monthly Noise Monitoring Report No. 10

[Period from 1 to 31 December 2013]

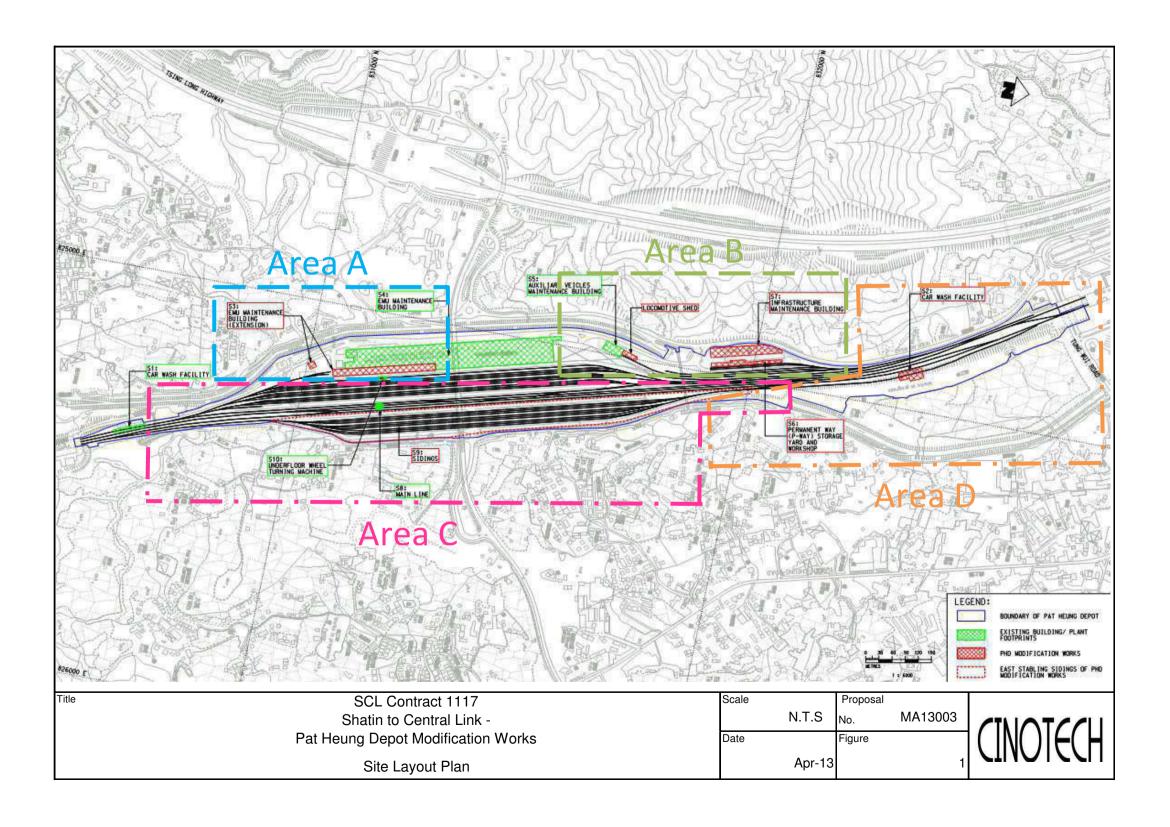
2.5 The site layout and proposed modification works are illustrated in **Figure 1**.

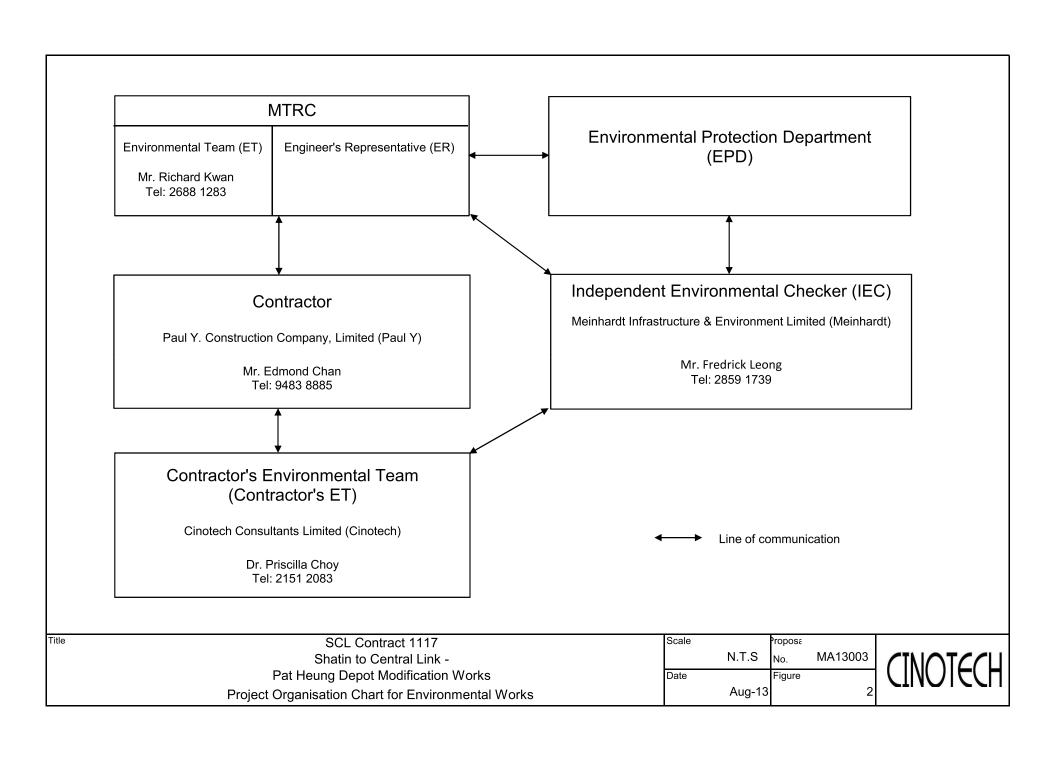
- 2.7 Different parties with different levels of involvement in the project organization include:
  - Engineer or Engineer's Representative (ER)– MTR Corporation (MTRC)
  - Contractor's Environmental Team (Contractor's ET) Cinotech Consultants Ltd. (Cinotech)
  - Independent Environmental Checker (IEC) Meinhardt Infrastructure and Environment Limited (MIEL)
  - Contractor Paul Y. Construction Company, Limited(Paul Y)
- 2.8 The responsibilities of respective parties are detailed in Section 2 of the approved EM&A Programme for PHD Modification Works.
- 2.9 The project organisation including key personnel contact names and telephone numbers is presented in **Figure 2**.
