# Wan Chai Development Phase II – Central – Wan Chai Bypass at Wan Chai West Contract No. HK/2012/08

# Landscape Plan

#### for FEP-09/364/2009/B

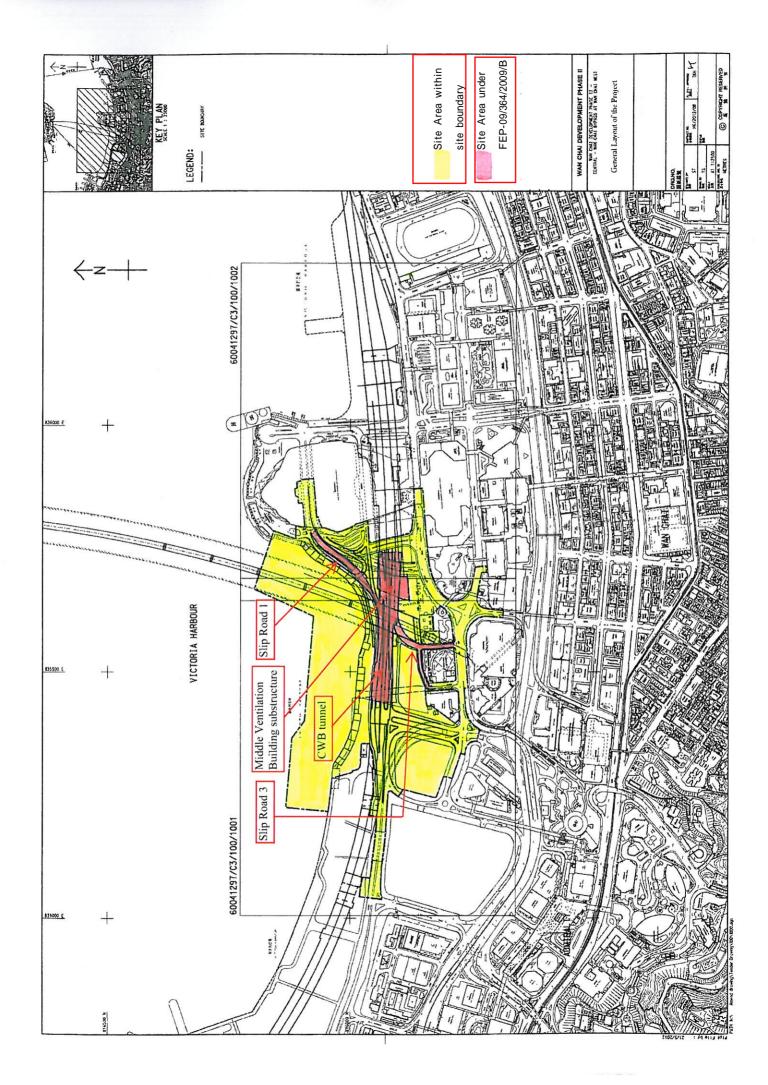
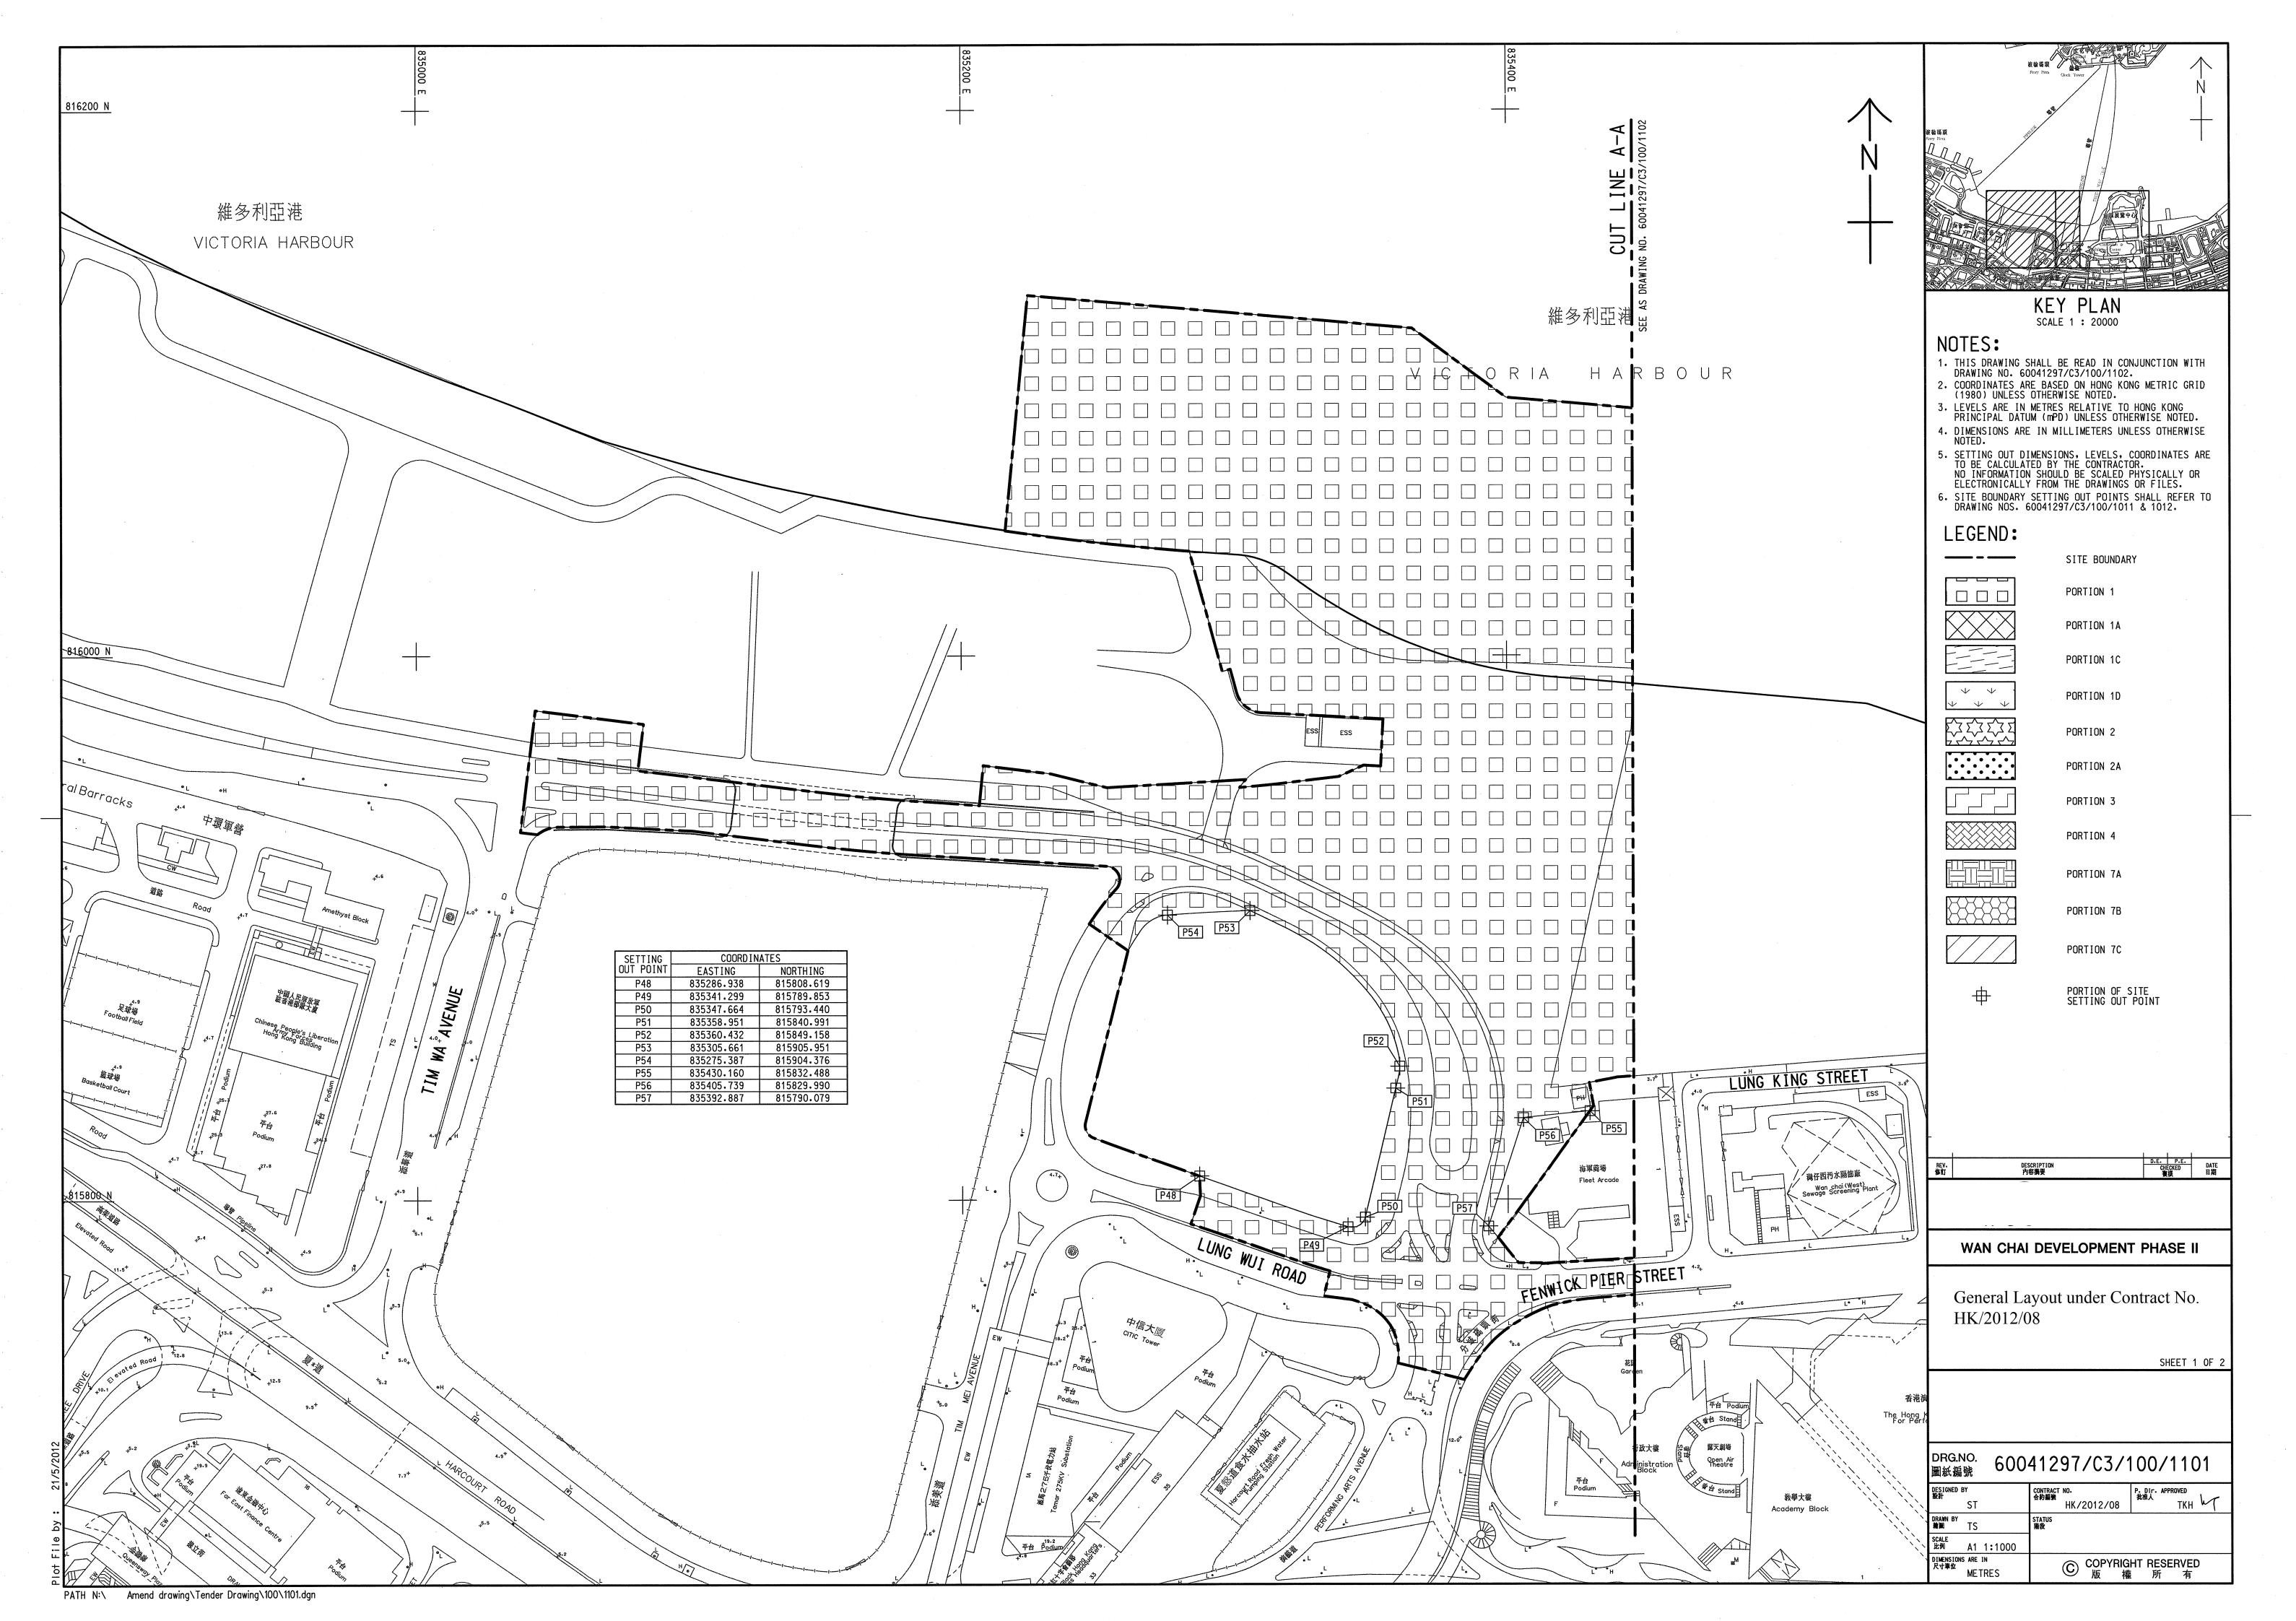
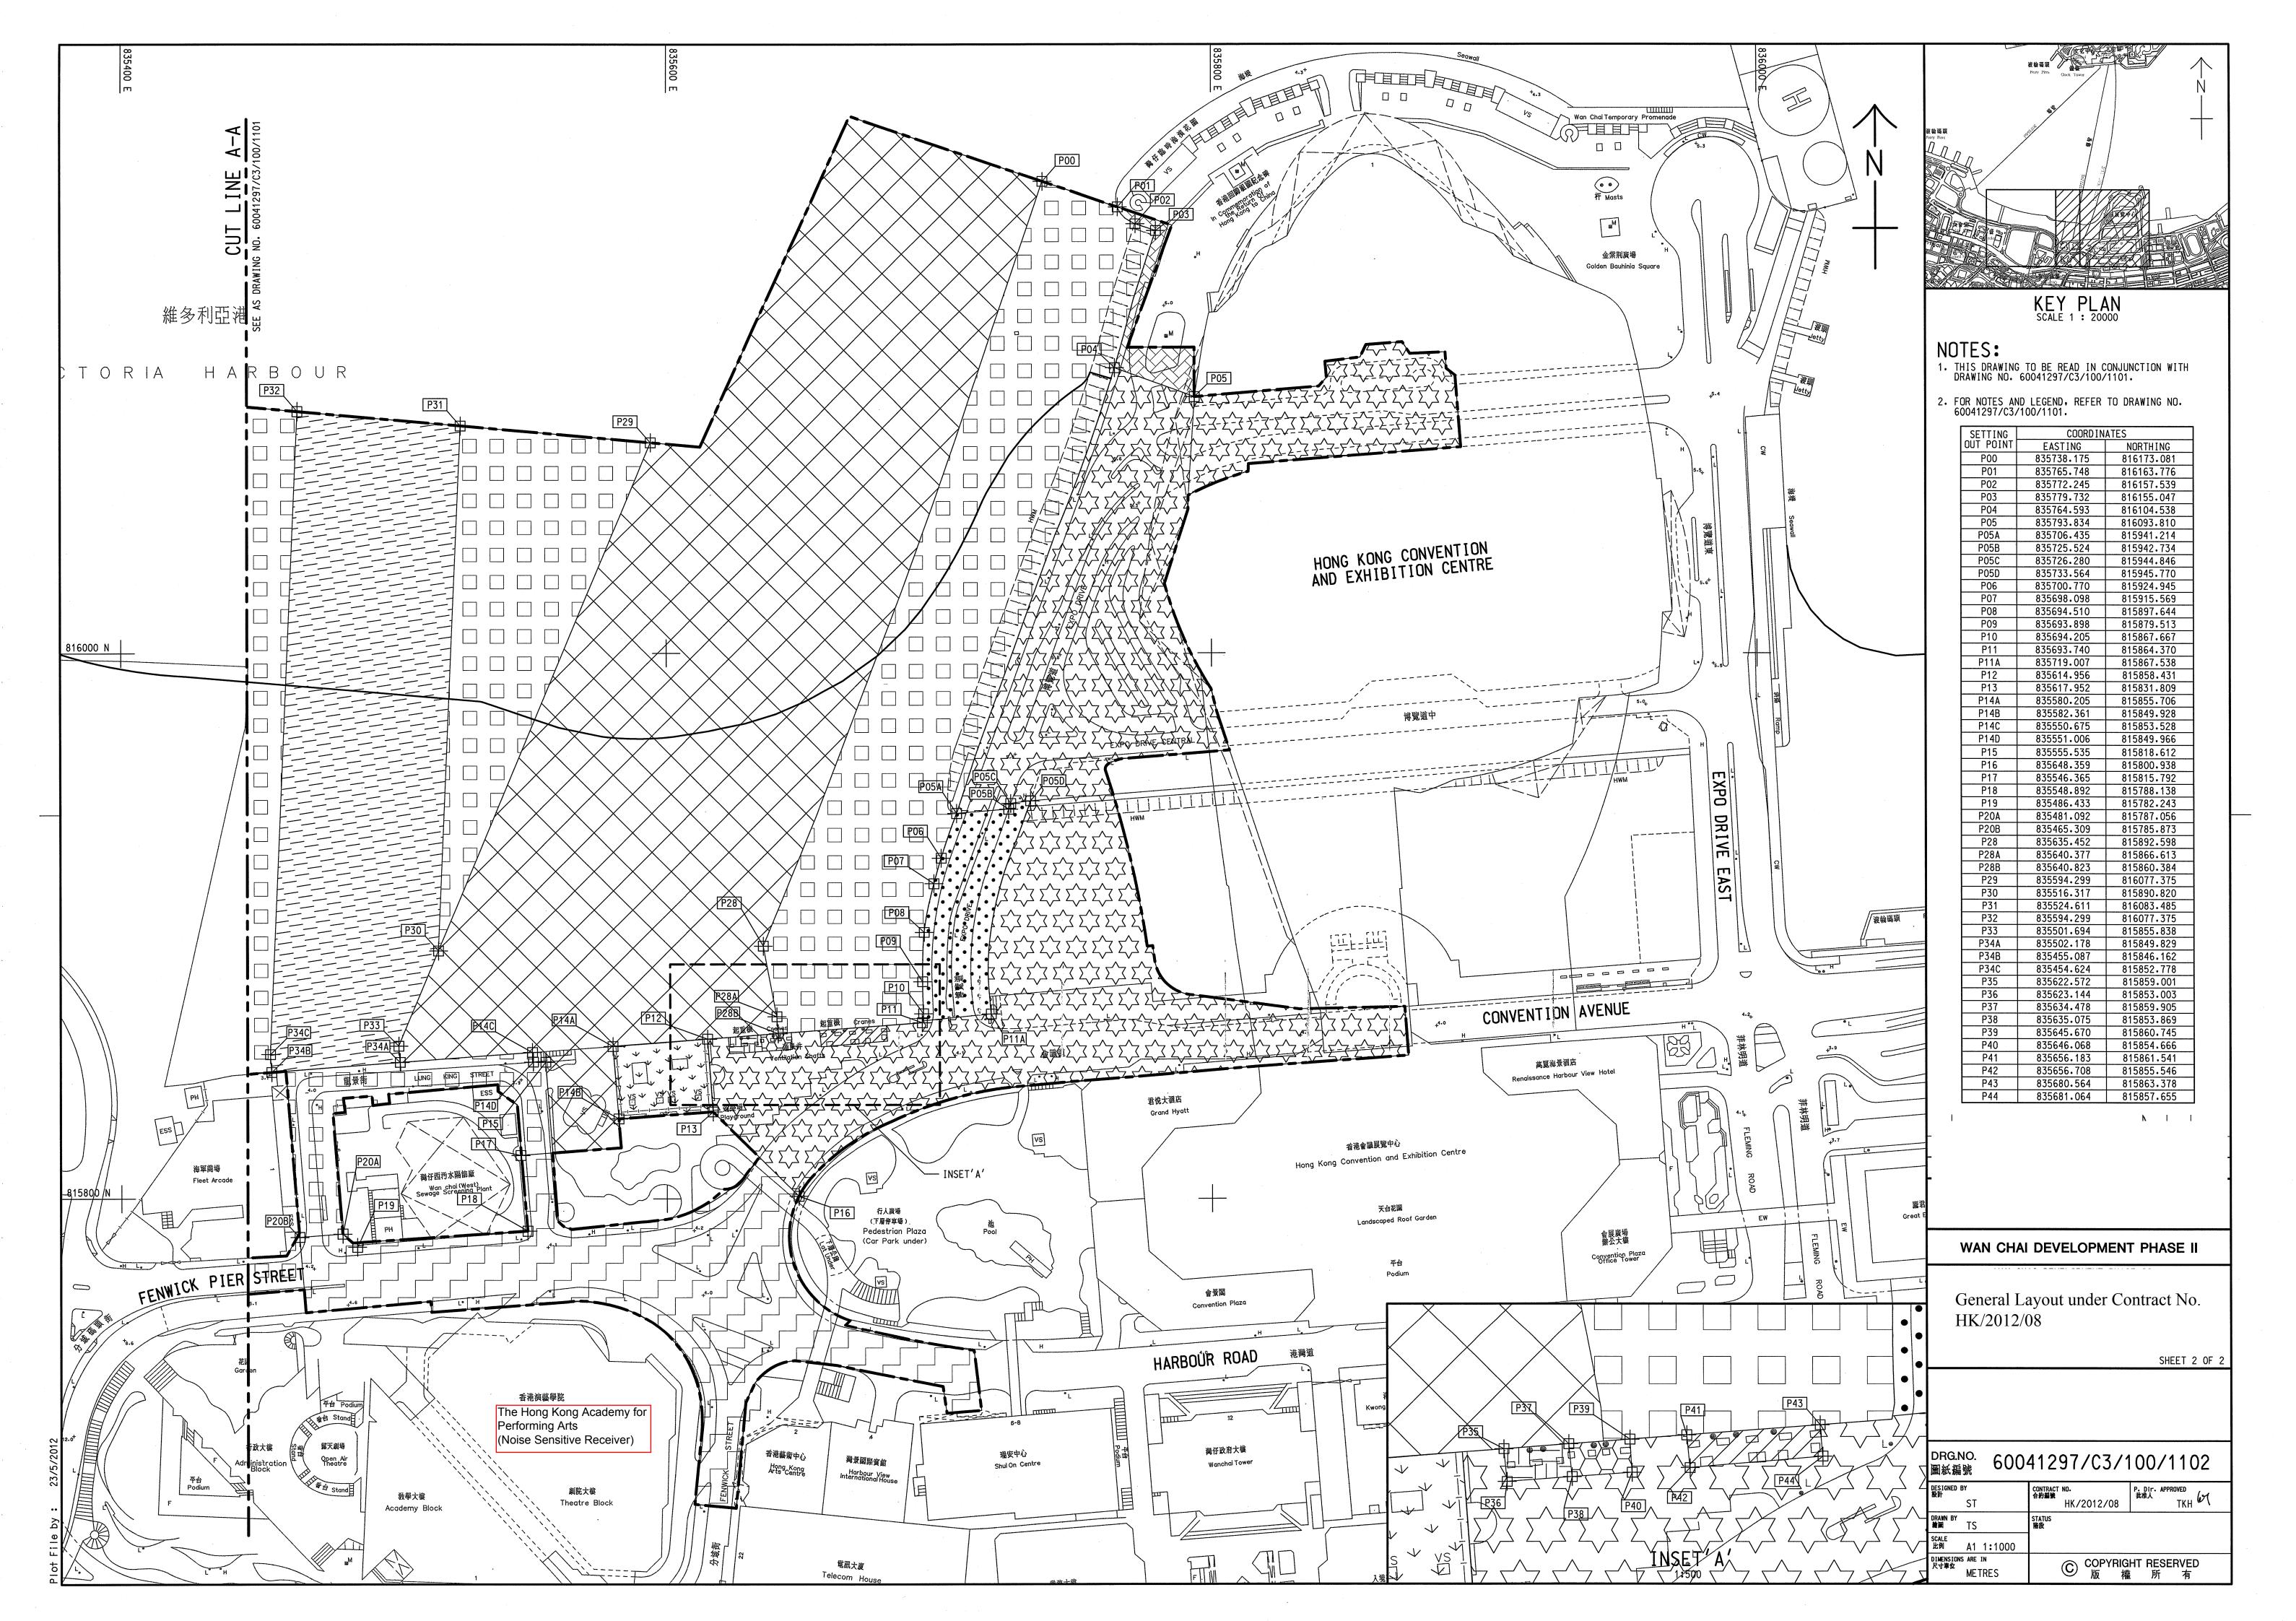
Layout Plan for Works Area under FEP-09/364/2009/B

The works area under FEP-09/364/2009/B is shown in Appendix I.

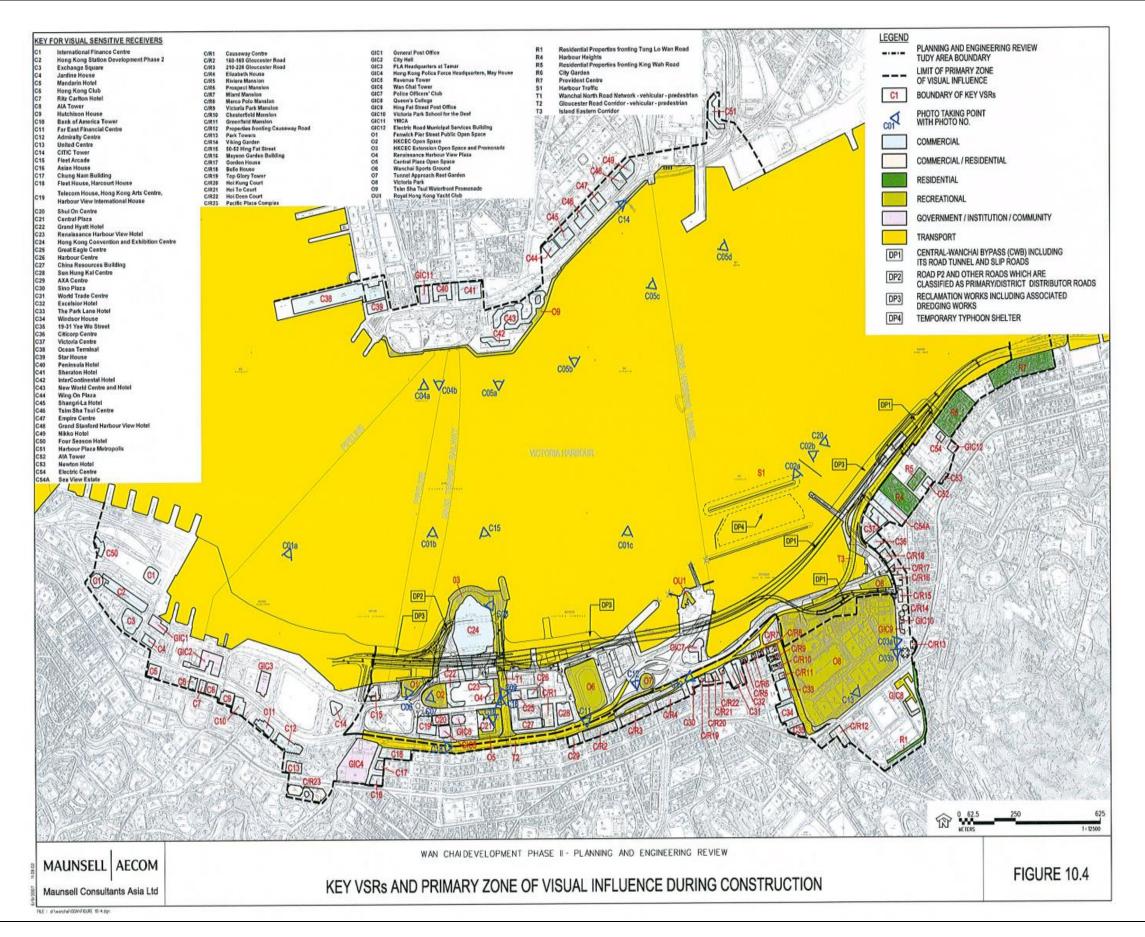
Location Plan of Visual Sensitive Receivers

CITIC Tower (C14), Fleet Arcade (C15), Grand Hyatt Hotel (C22) and Hong Kong Convention and Exhibition Centre (C24) are identified to be the key Visual Sensitive receivers (VSRs) that will be affected during the construction phase of the Project. C14, C15, C22 and C24 are mapped in Appendix II.

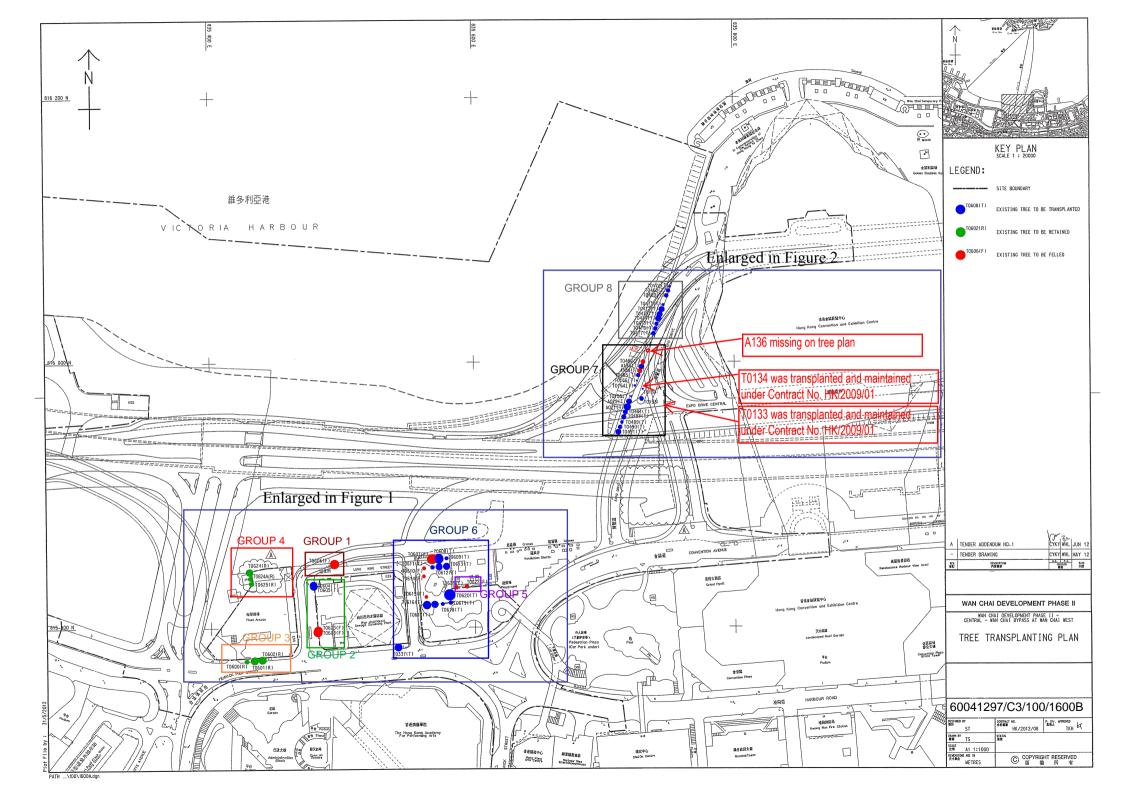
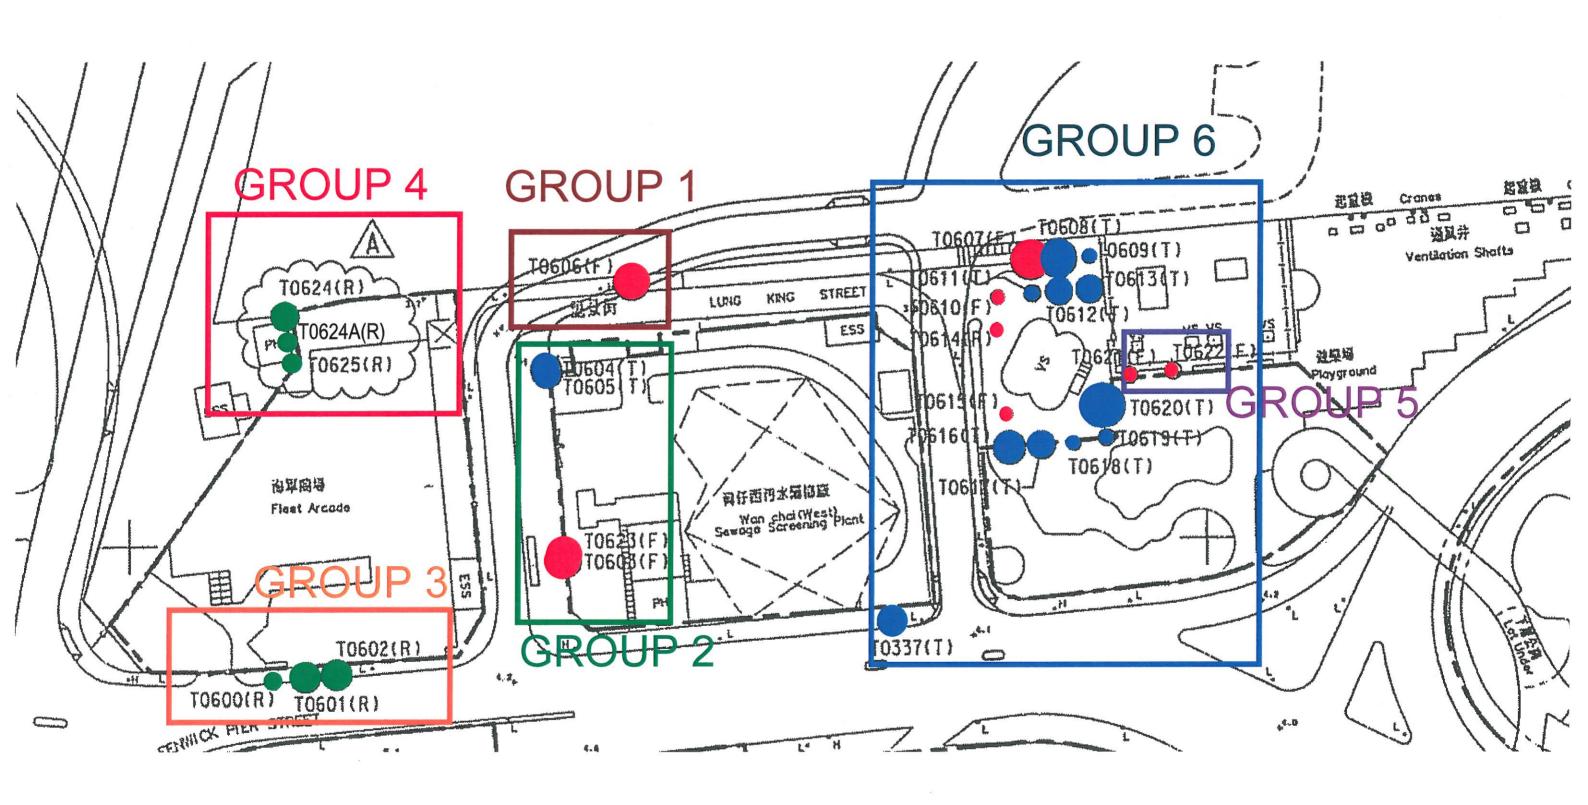
Figure 1 Tree Transplanting Plan (1)

- The trees to be retained, transplanted and felled shall follow the tree survey plan (Drawing No. 60041297/C3/100/1600B) as shown in Appendix III;
- The survey of trees has been conducted and the latest survey result is shown in the tree survey schedule in Appendix IV;

- Existing trees to be retained on site should be carefully protected during construction;
- Trees to be preserved are those with status 'Retain' as per Drawing No. 60041297/C3/100/1600B and those with status 'Transplant' when they are still within the site and during the period of transplanting operations until they are moved to their receptor sites;

- Trees unavoidably affected by the construction works should be transplanted where practicable;
- Trees identified to be transplanted will be labelled with its corresponding tree numbers as marked according to the Drawing No. 60041297/C3/100/1600B;

- Trees identified to be felled will be labelled with their corresponding tree numbers as marked according to the Drawing No. 60041297/C3/100/1600B;
- The trees to be felled are approved by the Lands Department the District Lands Office (DLO);
- The trees to be felled will be cut and removed under close supervision;
- A total of 11 trees will be felled under Contract No. HK/2012/08 according to the Drawing No. 60041297/C3/100/1600B;
- Compensatory tree planting for the proposed tree felling is to be implemented in accordance with the requirements stipulated in DEVB TC (W) No. 10/2013.

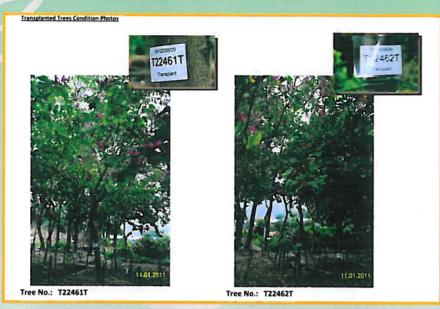
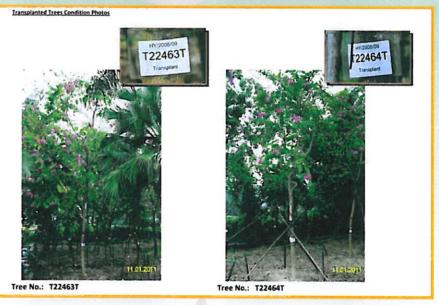
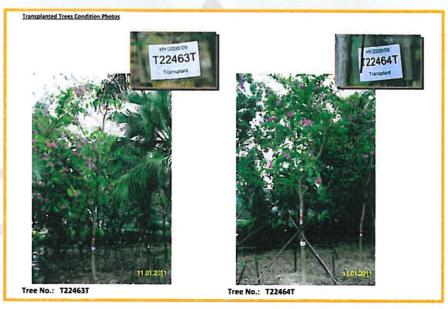
rees transplanted from Site to temporary holding nursery shall be identified with their tags and maintained with horticultural practice during the holding period. Health conditions shall be observed and reported periodically to monitor progress and/ or development until transplanted back to designated locations at Site.

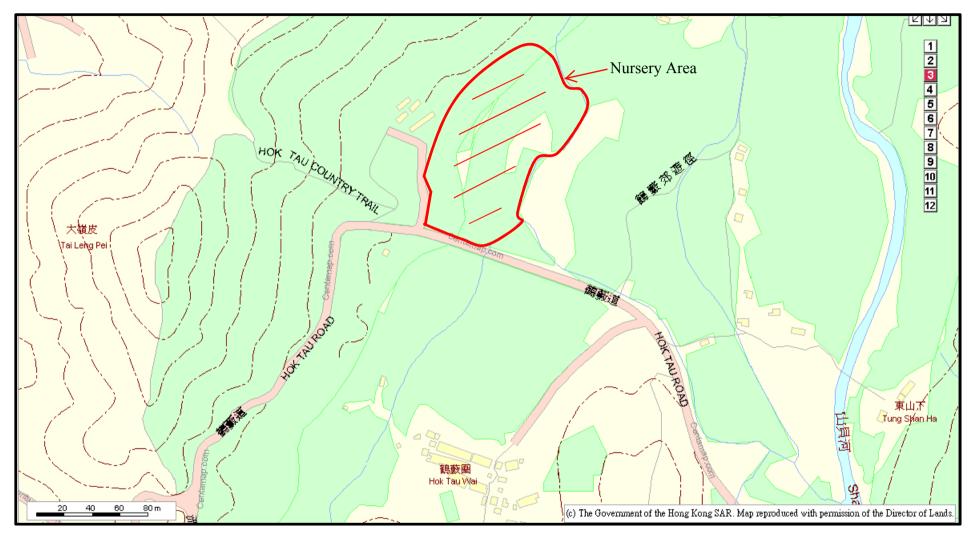
**Layout plan for Nursery Area**

Our holding nursery at Hok Tau, Fan Ling with a total area 22,761 sqm was setup since year 1982. The scope of this nursery is to maintain plant materials / maintain transplanted trees for project during the temporary holding contract period then re-plant back to site; and soil mixing / workshop / other storage purpose.

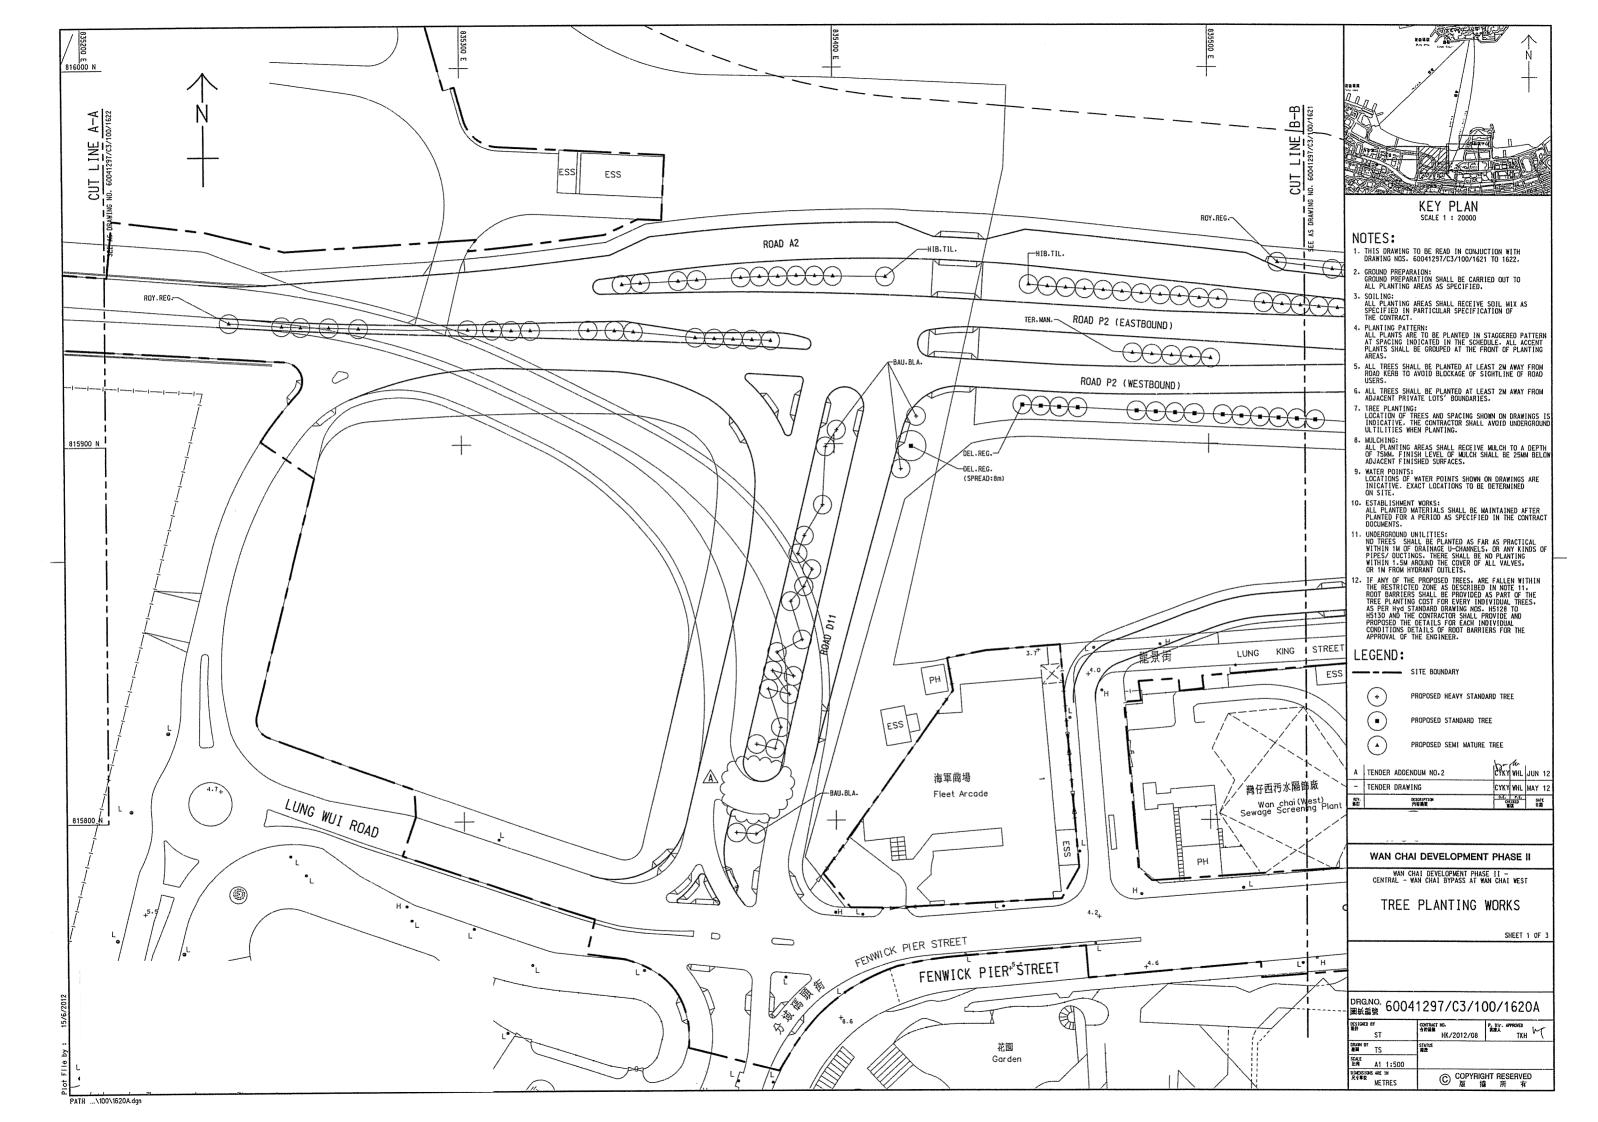
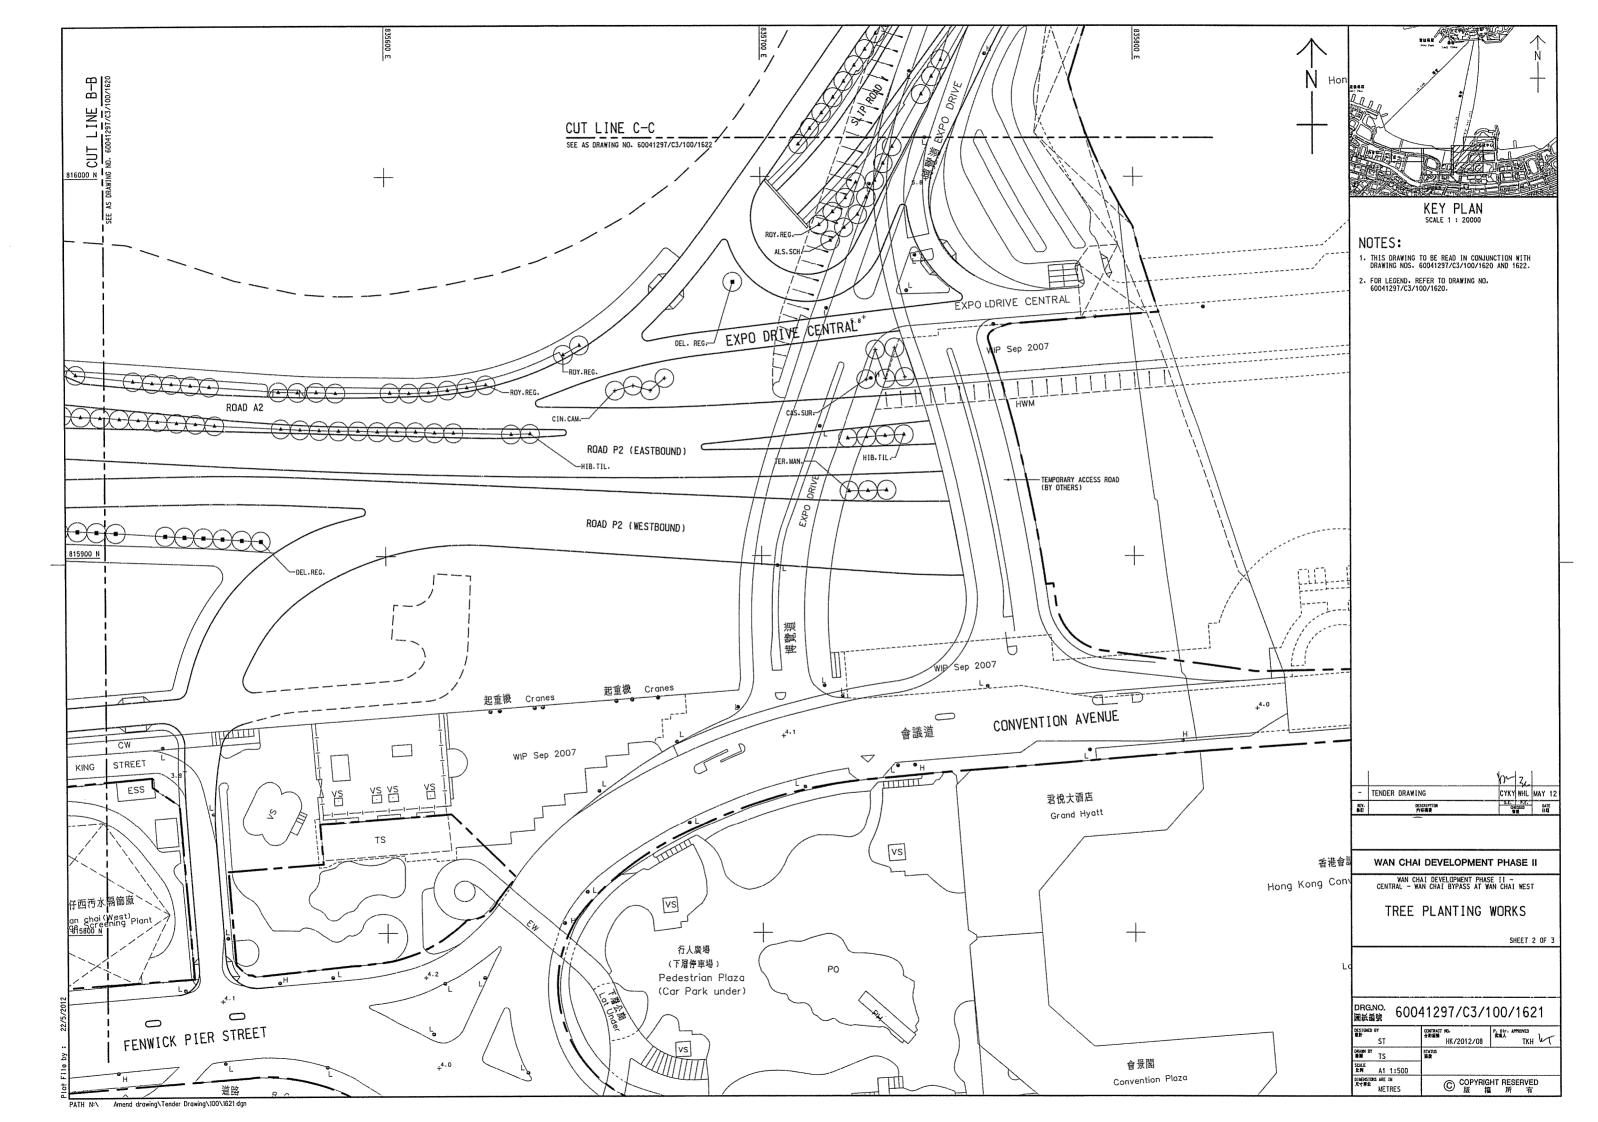
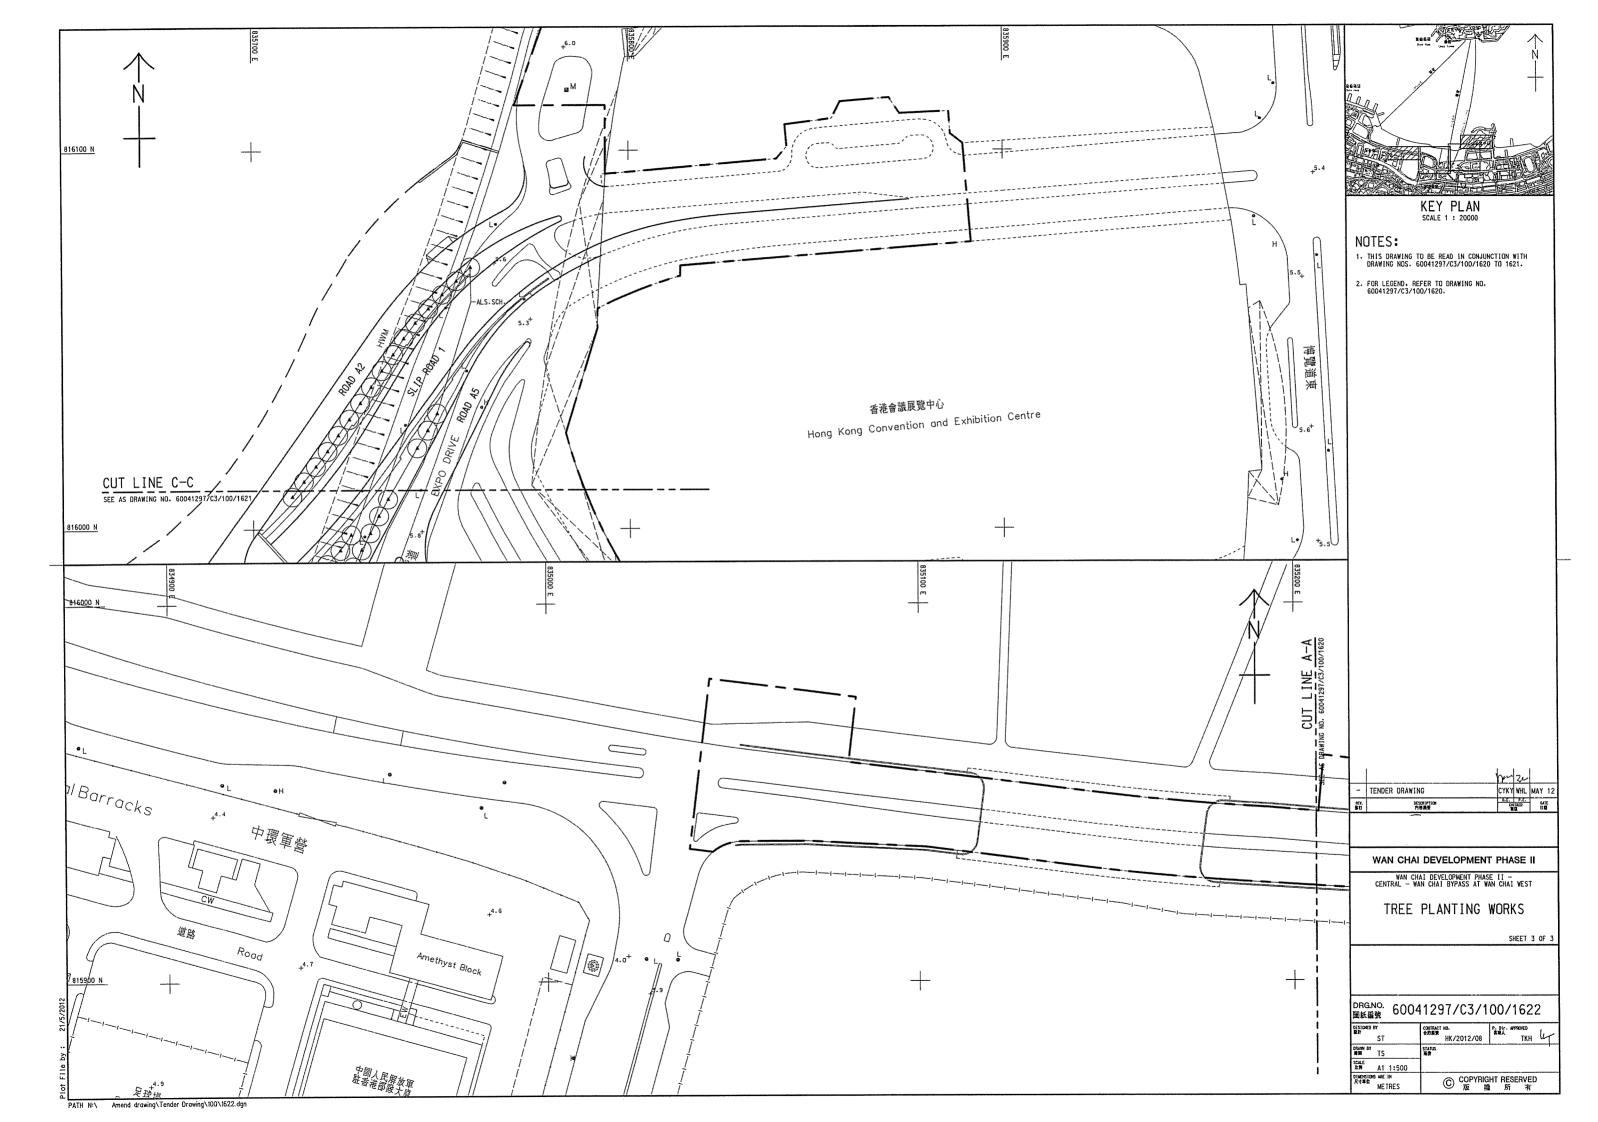
Planting Plans with Plant Schedules for the Proposed Landscape Work

- The planting plans with plant schedules specifying plant species, sizes, spacing and quantities for the proposed landscape works are shown in Appendix VI;

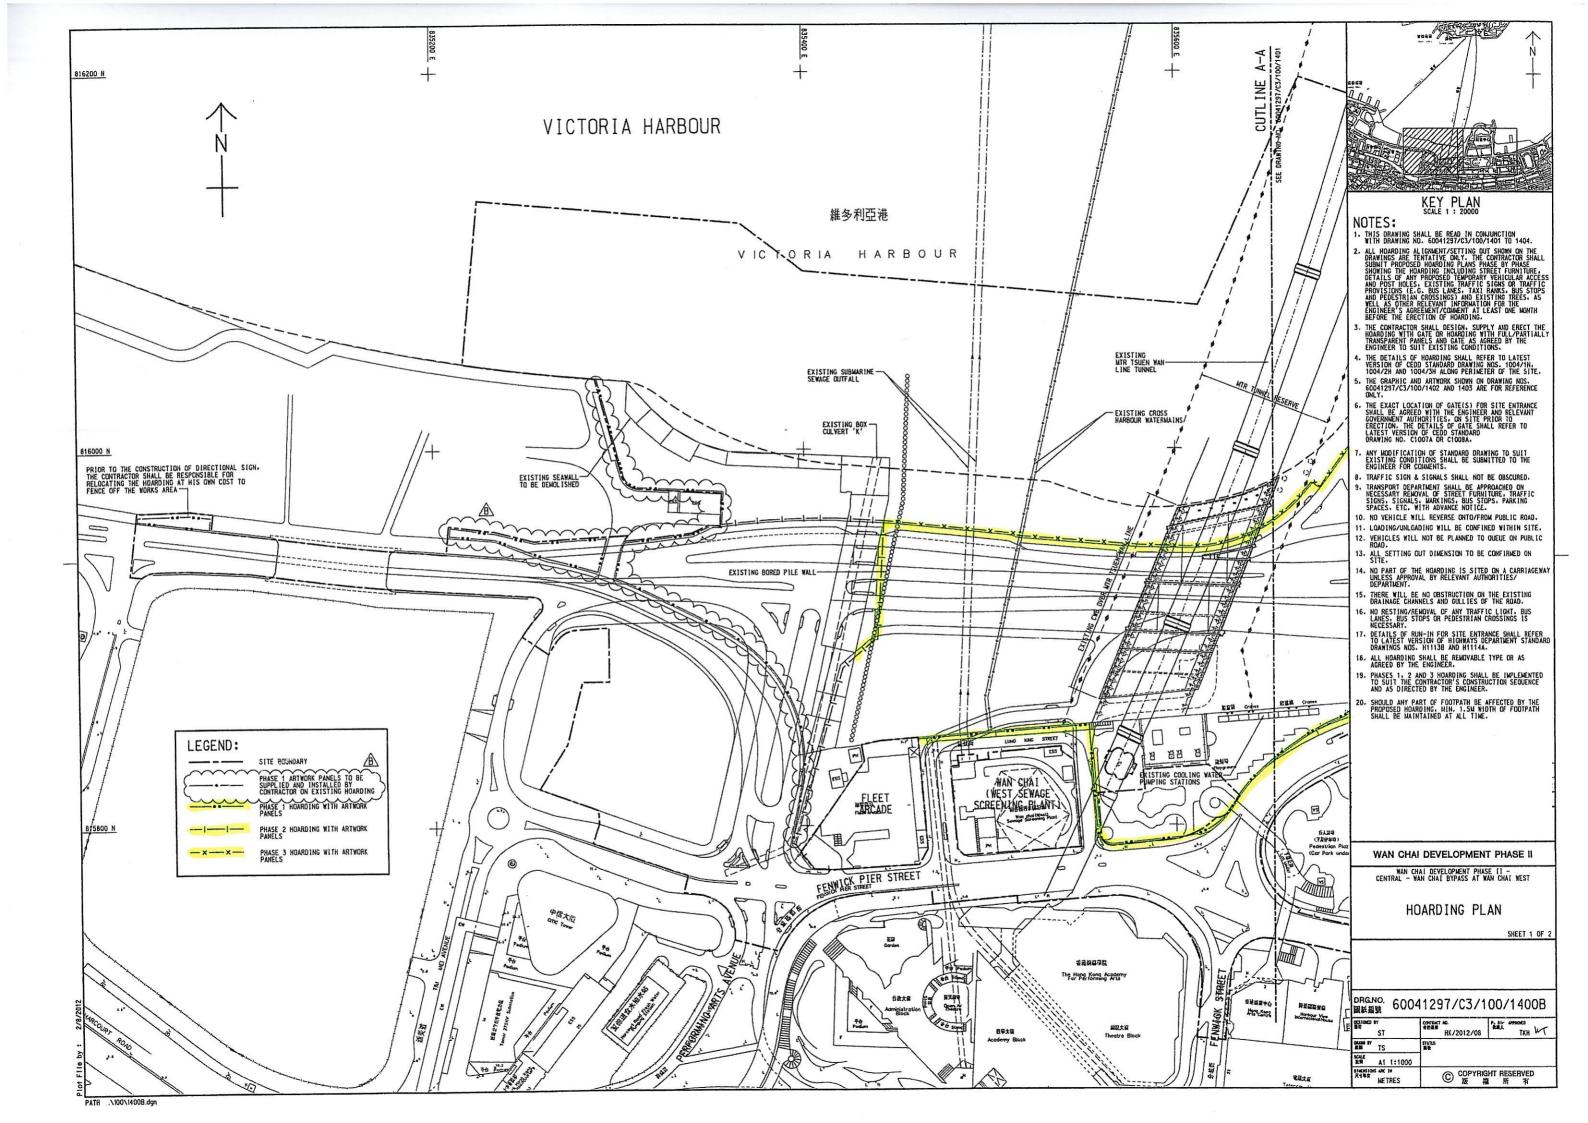
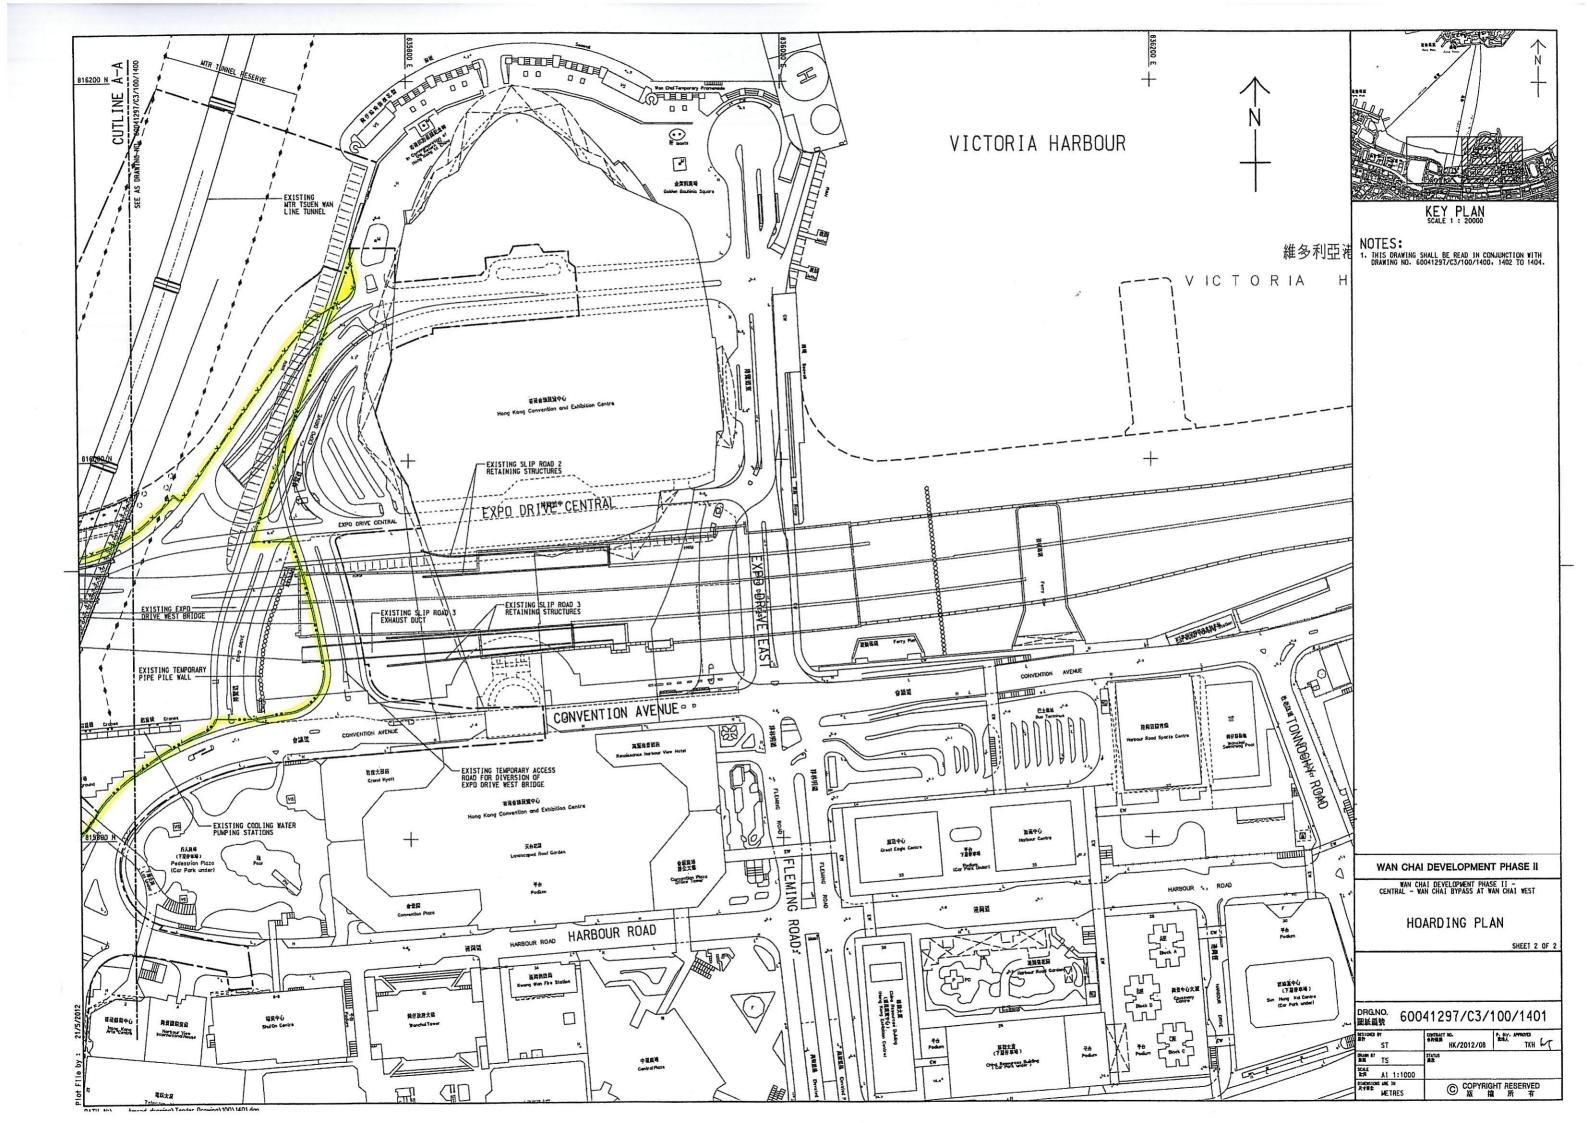
Location Plan of Decorative Screen Hoarding

The location plan of the decorative screen hoarding for WDII under the Project is shown in Appendix VII and the graphic panels for decorative screen hoarding and its fixing details are shown in Appendix VIII. Liaison and discussion with the owner of Fleet Arcade (C15) will be made before and during the construction works in the vicinity for the mitigation measures on the potential visual impact to them.
