# Wan Chai Development Phase II – Central – Wan Chai Bypass at Wan Chai West Contract No. HK/2012/08

# Landscape Plan

#### for FEP-09/364/2009/B

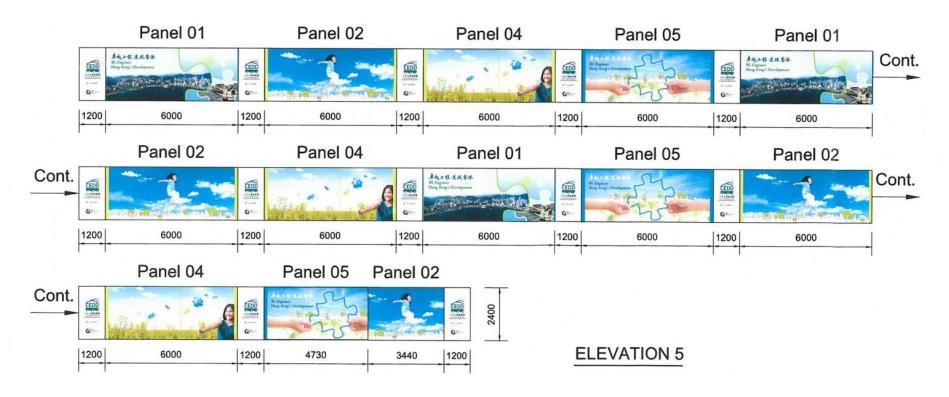
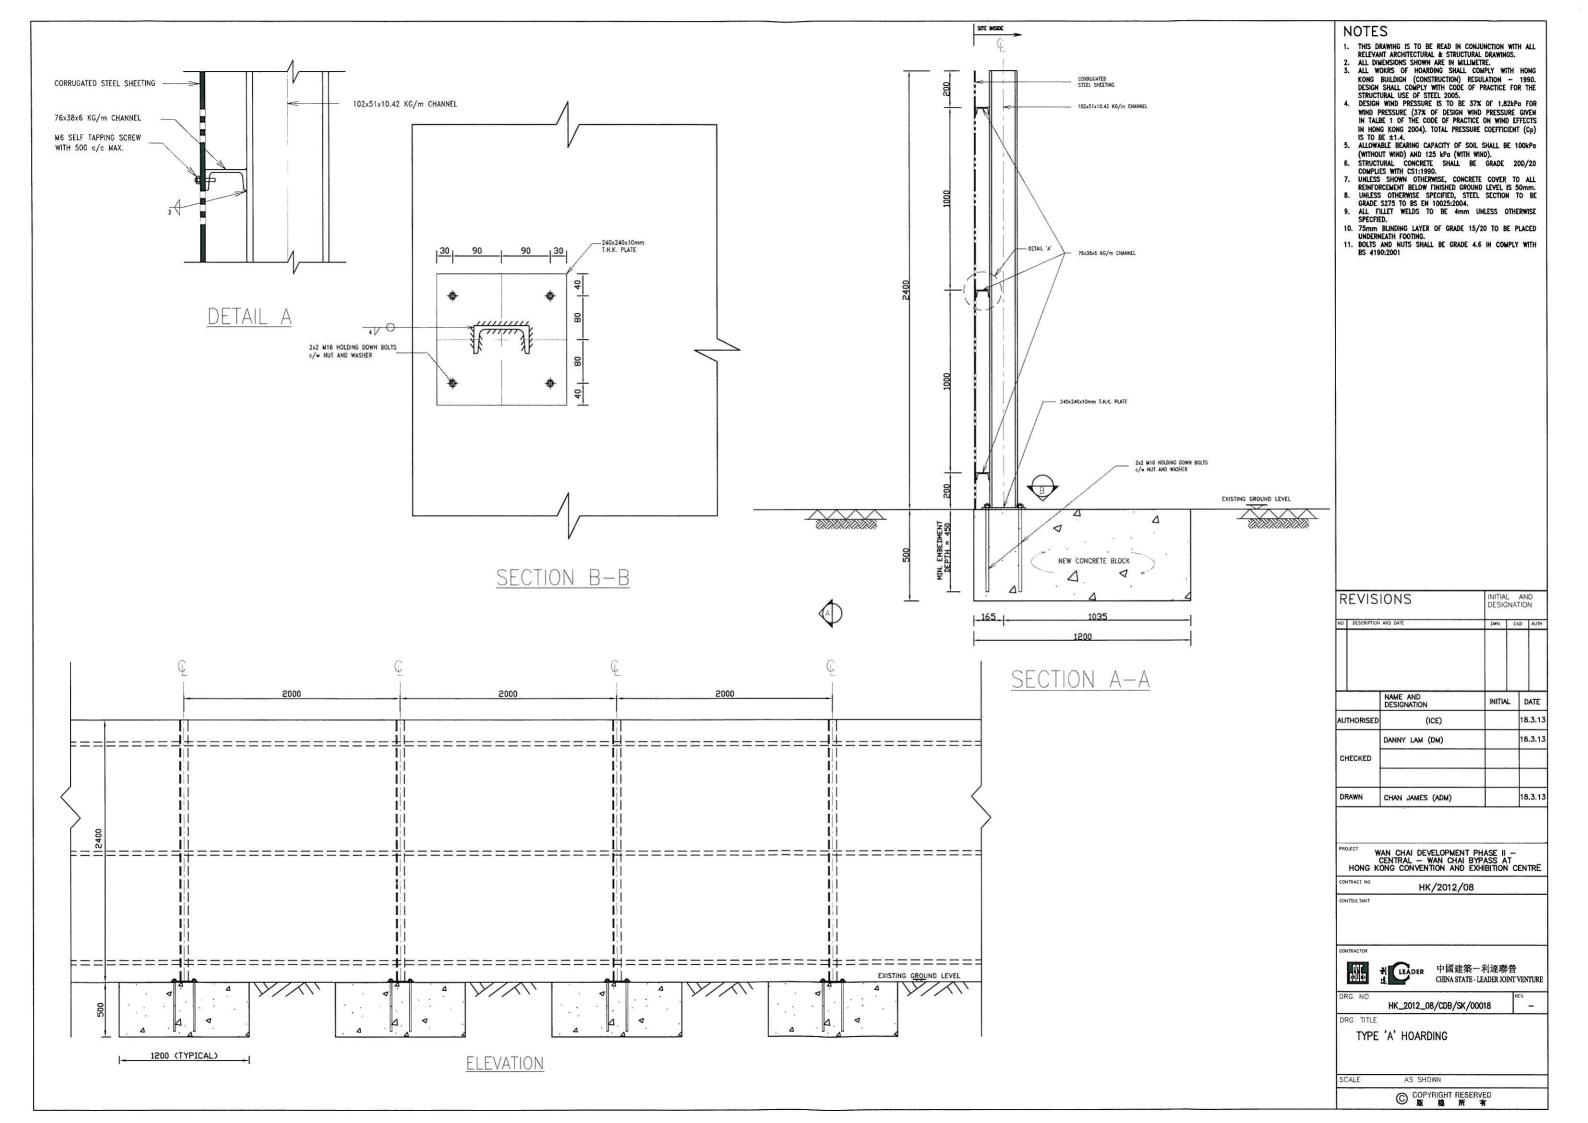
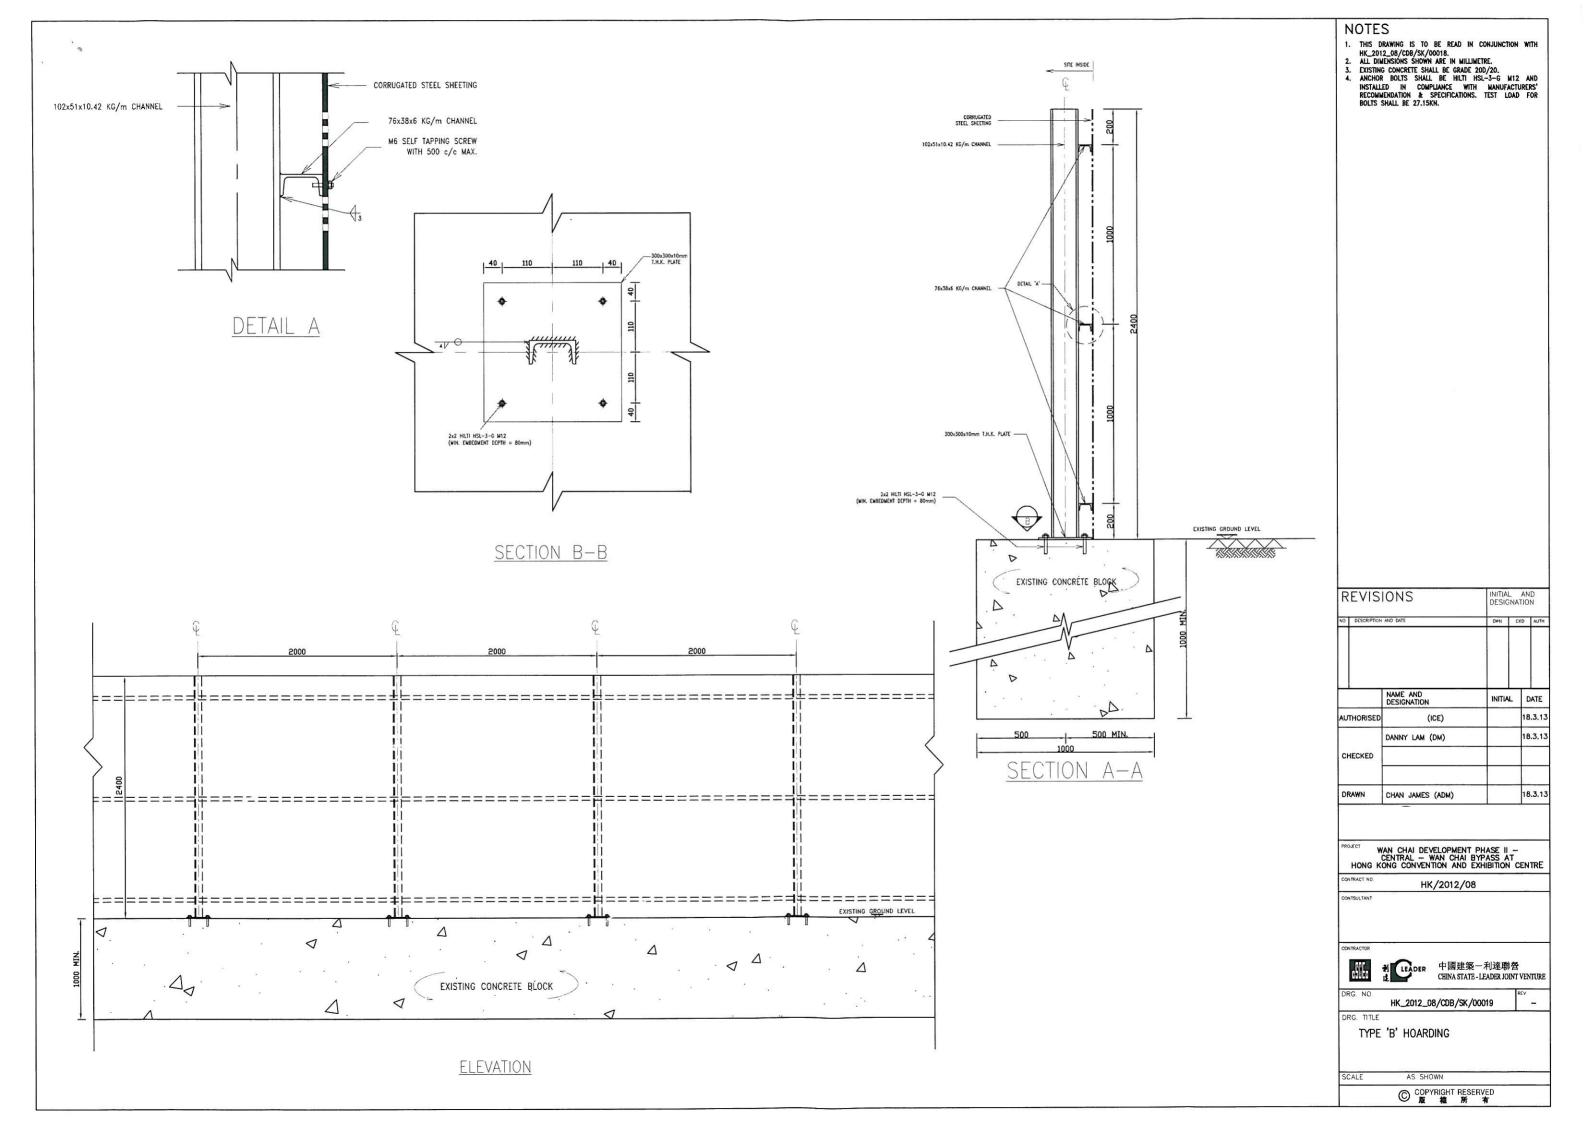
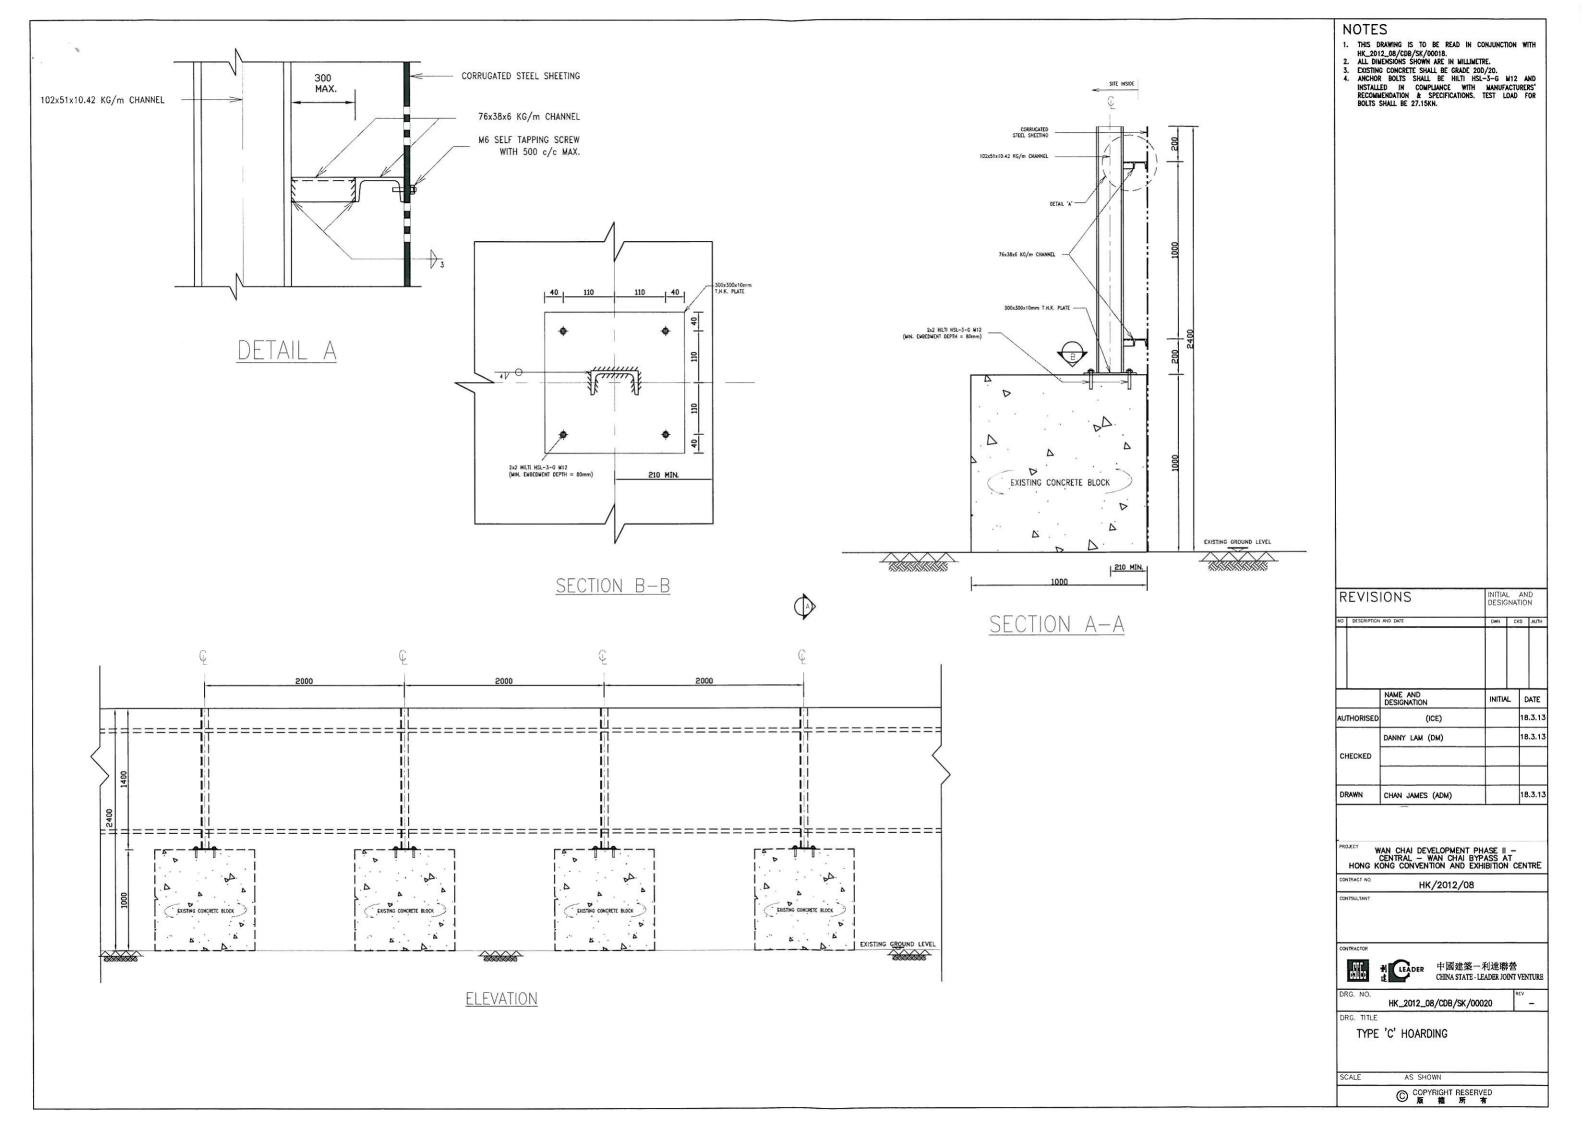
### Typical Panels with Graphics and Artworks

The location plan of the decorative screen hoarding for WDII under the Project is shown in Appendix VII and the graphic panels for decorative screen hoarding and its fixing details are shown in Appendix VIII. Liaison and discussion with the owner of Fleet Arcade (C15) will be made before and during the construction works in the vicinity for the mitigation measures on the potential visual impact to them.

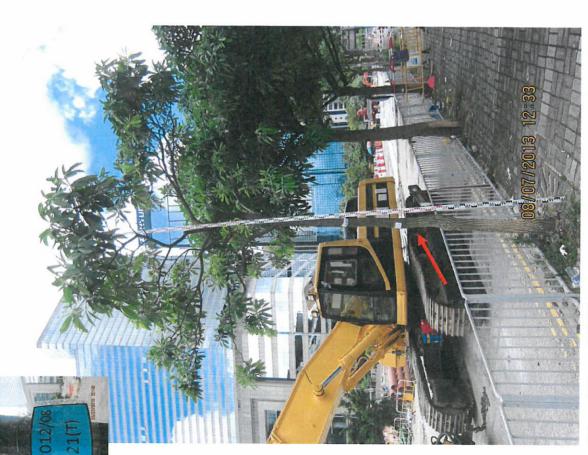
Tree No.: A021

T0620	大葉榕	Ficus virens	350	12	10	Fair	Fair	+4.05mPD	Transplant	Tree crown in contact with the building, broken branches	-
	A021	糖膠樹	Alstonia scholaris	100	2.5	3.5	Fair	Fair	+5.84mPD	Transplant	Paved pit	2014.2.6
	A022	糖膠樹	Alstonia scholaris	96	2	3.5	Poor	Poor	+5.85mPD	Transplant	Dieback, paved pit	2014.2.6
	A134	糖膠樹	Alstonia scholaris	86	1.5	4	Poor	Poor	+6.01mPD	Fell	Imbalanced tree form, wounds, paved pit	-
	A135	糖膠樹	Alstonia scholaris	92	2	4	Fair	Fair	+5.98mPD	Transplant	Paved pit	2014.2.6
		糖膠樹	Alstonia scholaris	108	2	4.5	Fair	Fair	+5.88mPD	Transplant	Missing on tree plan and	2014.2.6
	A136										transplanted to holding nursery	2014.2.0

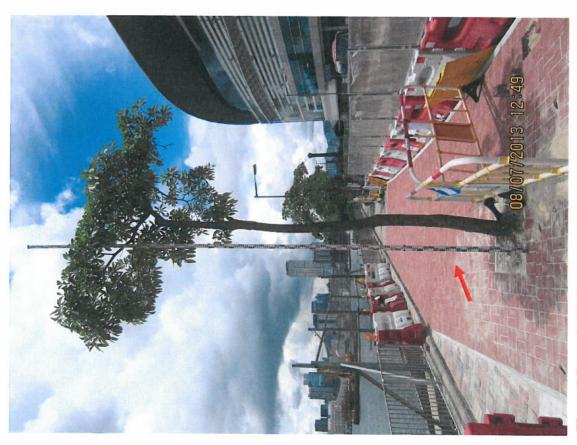
Tree No.: A136

- A total of 37 trees will be transplanted under Contract No. HK/2012/08 according to the Drawing No. 60041297/C3/100/1600B. However, the Tree (A136) which is found on-site is not shown in the tree transplanting plan. This particular tree had been handled with care on site and this tree had been transplanted to the off-site holding nursery upon advice by the Independent Tree Specialist and agreement

with the Engineer. A total of 38 trees are to be transplanted accordingly. The trees T0133 and T0134 which are shown in the tree transplanting plan cannot be found on-site. It was found that these two trees had been transplanted and maintained under Contract No. HK/2009/01. Hence, there will be a total of 36 trees to be transplanted under Contract No. HK/2012/08 including the newly identified tree (A136). Transplanted trees (T0609), (T0611) and (T0612) were identified to be dead at the tree nursery by the Independent Tree Specialist and they were felled on 29 January 2015. These felled trees will be compensated under Contract No. HK/2012/08 based on the Technical Circular (Works) No. 10/2013 – Tree Preservation.

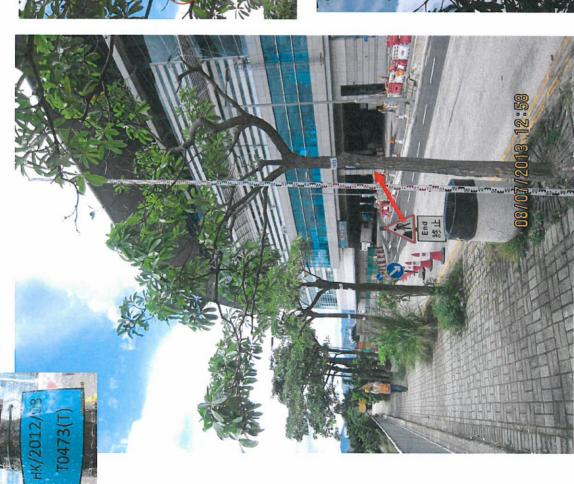
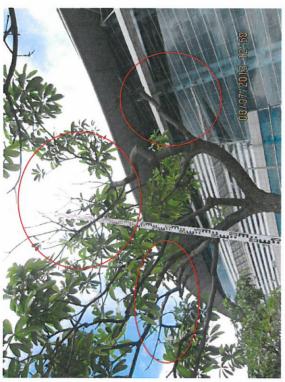
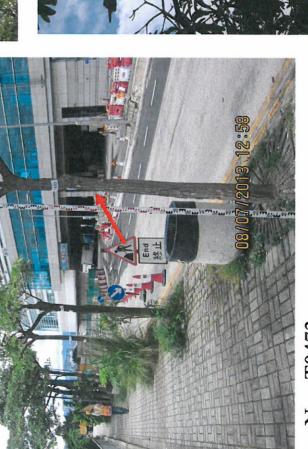
Tree No.: T0473

T0473	糖膠樹	Alstonia scholaris	153	4	3.5	Fair	Fair	+5.75mPD	Transplant	Dieback, paved pit, decayed wound	2014.2.6
	T0474	格形包 糖膠樹	Alstonia scholaris	210	4	5	Fair	Fair	+5.78mPD	Transplant	Imbalanced tree form, paved pit	2014.2.6
	T0475	糖膠樹	Alstonia scholaris	150	2	4	Poor	Poor	+5.82mPD	Transplant	Paved pit	2014.2.6
		糖膠樹	Alstonia scholaris	213	3	4.5	Poor	Poor	+5.85mPD	· ·	Included bark, pests on branch, paved pit,	
	T0477	帖炒倒	Priotoriia scriularis	213	3	4.0	1 001	1 001	+J.JJIIIFD	Transplant	wounds on trunk	2014.2.6

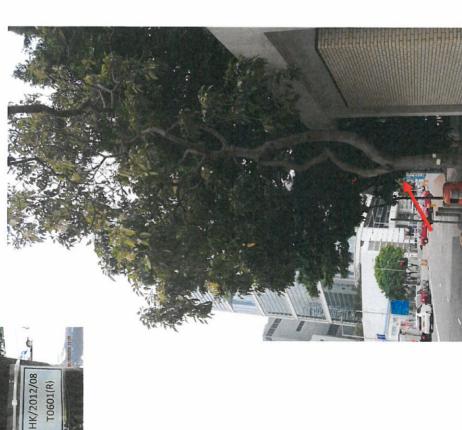
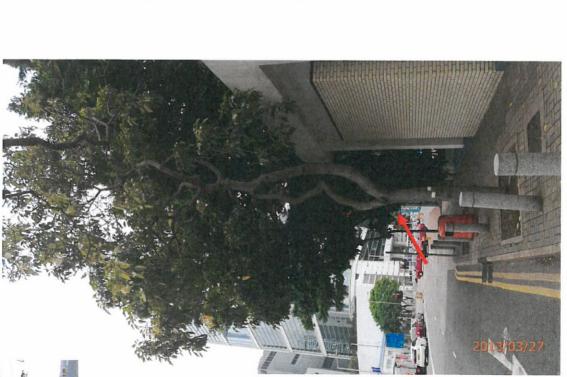
Tree No.: T0601

- Referring to Drawing No. 60041297/C3/100/1600B, 6 numbers of trees would be retained under Contract No. HK/2012/08. However, the trees (T0602) and (T0601) were found to be not in a good condition as advised by the Independent Tree Specialist. The trees (T0602) and (T0601) were felled by LCSD on 11 February 2014 and 24 September 2014 respectively. The advice from LCSD is shown in Appendix XIII. Hence, a total of 4 trees will be retained.

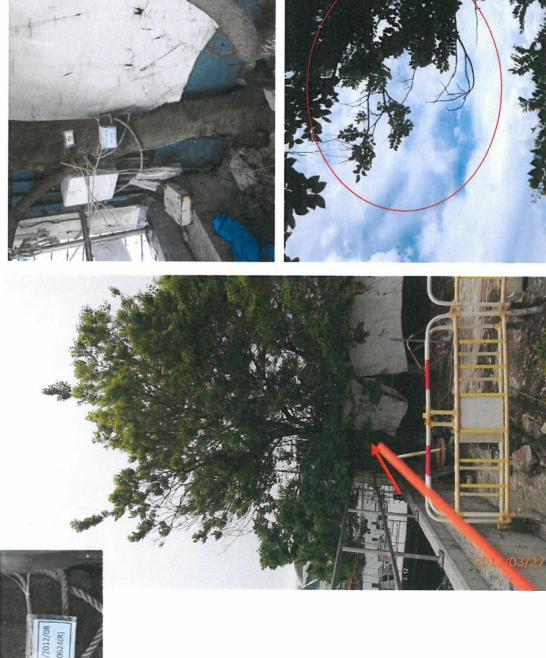
Tree No.: T0624

T0602	石栗	Aleurites moluccana		,	Ů		T GIII		Dead	on 2014.2.11	2014.4.29
	T0624	朴樹	Celtis sinensis	210	13	7	Fair	Fair	+4.33mPD	Retain	Growing close to T0624A, dieback	2014.4.29
4	T0624A	朴樹	Celtis sinensis	120	13	5.5	Fair	Fair	+4.33mPD	Retain	-	2014.4.29
	T0625	青果榕	Ficus variegata	220	8	7	Poor	Poor	+3.73mPD	Retain	Decay wounds on trunk	2014.4.29
5	T0621	黃槿	Hibiscus tiliaceus	200	10	7	Fair	Fair	+3.39mPD	Fell	Curved trunk, tree crown in contact with the building	-
	T0622	番石榴	Psidium guajava	100	4	4	Fair	Fair	+3.41mPD	Fell	Tree crown in contact with the building	-
	T0337	石栗	Aleurites moluccana	-	-	-	-	-	+3.97mPD	Transplant	To be inspected after site possession	-
	T0607	黄槿	Hibiscus tiliaceus	350	10	8	Fair	Fair	+3.44mPD	Fell	Pests	-
	T0608	黄槿	Hibiscus tiliaceus	400	12	9	Fair	Fair	+3.36mPD	Transplant	-	-
				150	4	4	Poor	Fair	+3.26mPD	· ·	Dead at tree nursery as advised by ITS and	_
	T0609	血桐	Macaranga tanarius					_		Transplant	felled on 2015.1.29	_

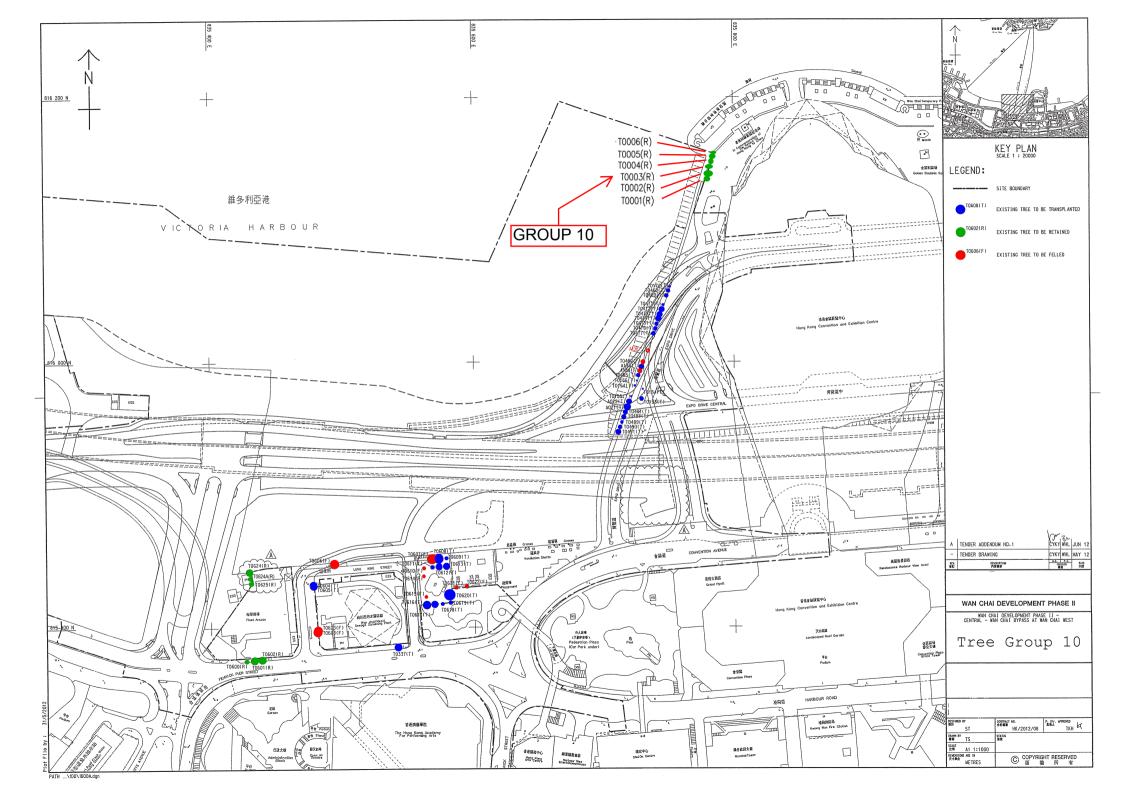
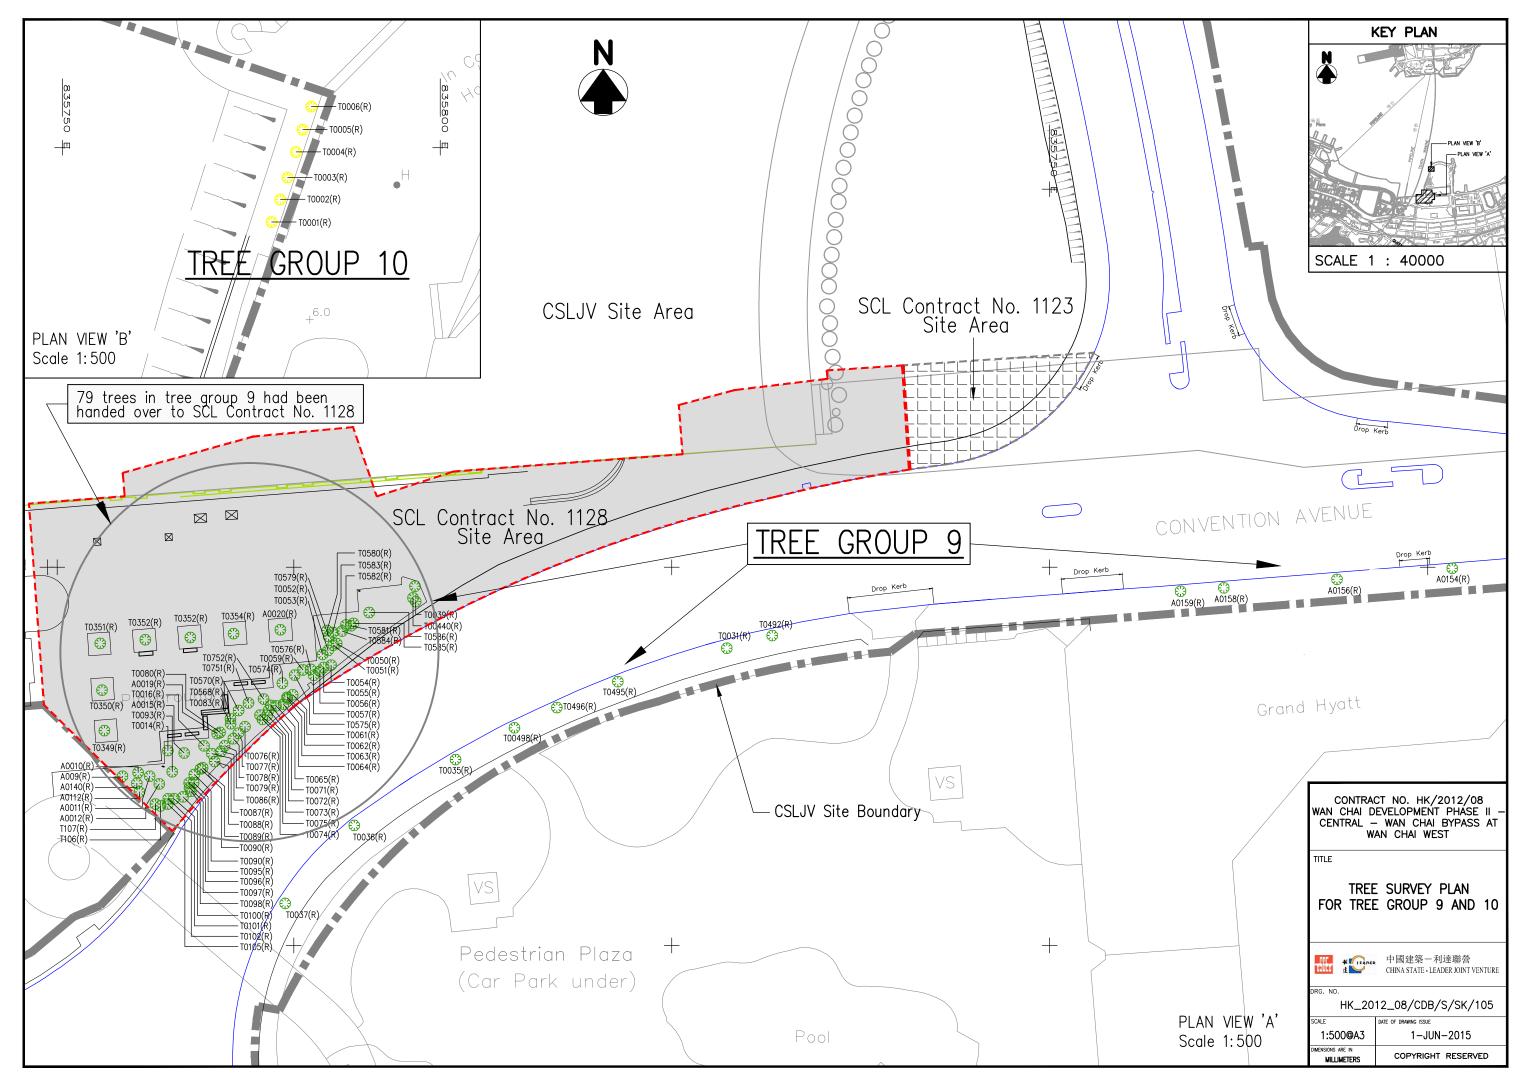
Tree Survey Plan for Tree Groups 9 and 10

trees in tree group 9 had been handed over from CSLJV to SCL Contract No. 1128. The locations of the trees handed over to SCL Contract No. 1128 are shown in Appendix XI.
