Decommissioning of West Portion of the Middle Ash Lagoon at Tsang Tsui, Tuen Mun

Monthly EM&A Report for October 2016

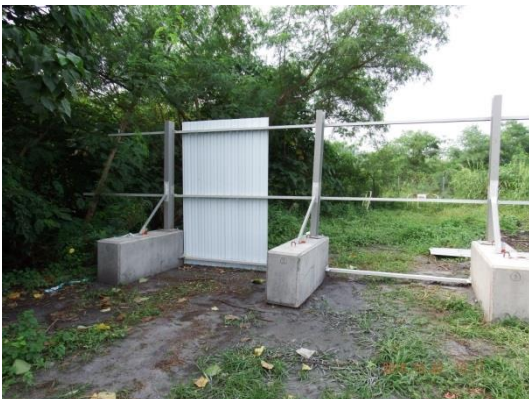
Installation of site hoarding

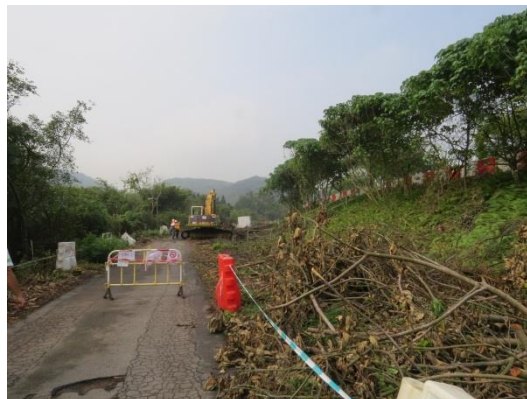
Site clearance

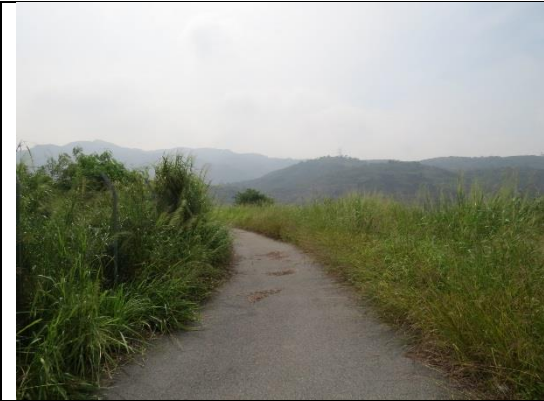
In the West Ash Lagoon, the coverage of water in West Ash Lagoon was above 95%. For habitat condition, emergent vegetation (e.g. *Bidens alba*, *Neyraudia reynaudiana*) were found on the West Ash Lagoon. A total of six Little Grebes were seen but no breeding activities were observed.

| <p>General view of the West Ash Lagoon</p> | <p>Little Grebes in the West Ash Lagoon (Viewpoint A)</p> |

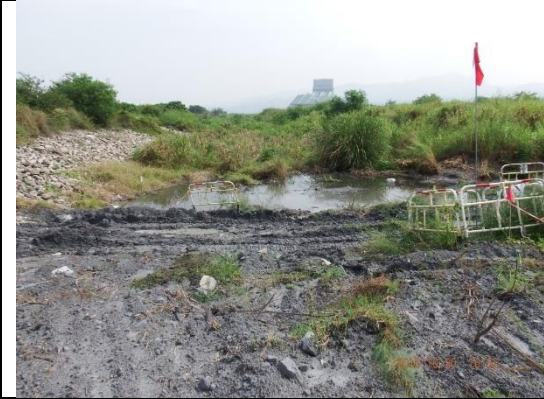
The 30m wide man-made water channel was surveyed. It was in permanent dry condition, covered with rocks and grown with terrestrial vegetation. It is unlikely to be used by Little Grebe.

| <p>The latest status of the man-made water channel at the northern edge of the PFA platform in the Middle Ash Lagoon (Viewpoint B)</p> | <p>Wetland in the eastern part of the Middle Ash Lagoon (Viewpoint C)</p> |

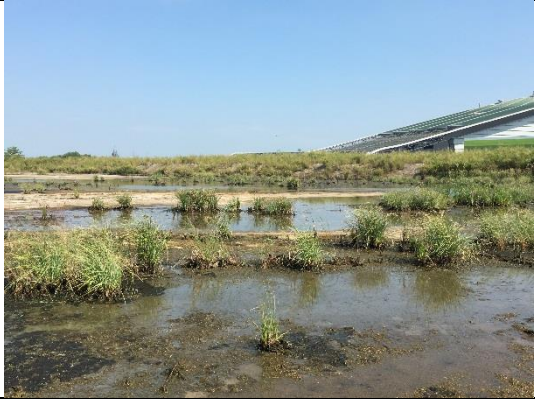
The remaining portion of the Middle Ash Lagoon was also surveyed. For habitat condition, emergent and pioneer vegetation (e.g. *Bidens alba*, *Panicum maximum*) were found on the Middle Ash Lagoon. The coverage of water in Middle Ash Lagoon was approximately less than 5%. A swallow pond and small marsh habitat was retained at the eastern side of the Middle Ash Lagoon. No Little Grebes were seen, no breeding activity, nests and juveniles were noted.
