吉寶西格斯 - 振華聯營公司
KEPPEL SEGHERS - ZHEN HUA JOINT VENTURE

CORAL TRANSLOCATION PLAN

(Clause 2.12, Further Environmental Permit FEP-01/429/2012/A)

KSZHJV	/	312	/	EPR	/	0001	/	E
Issuer		Project Code		Type of Document		Sequential No.		Revision Index

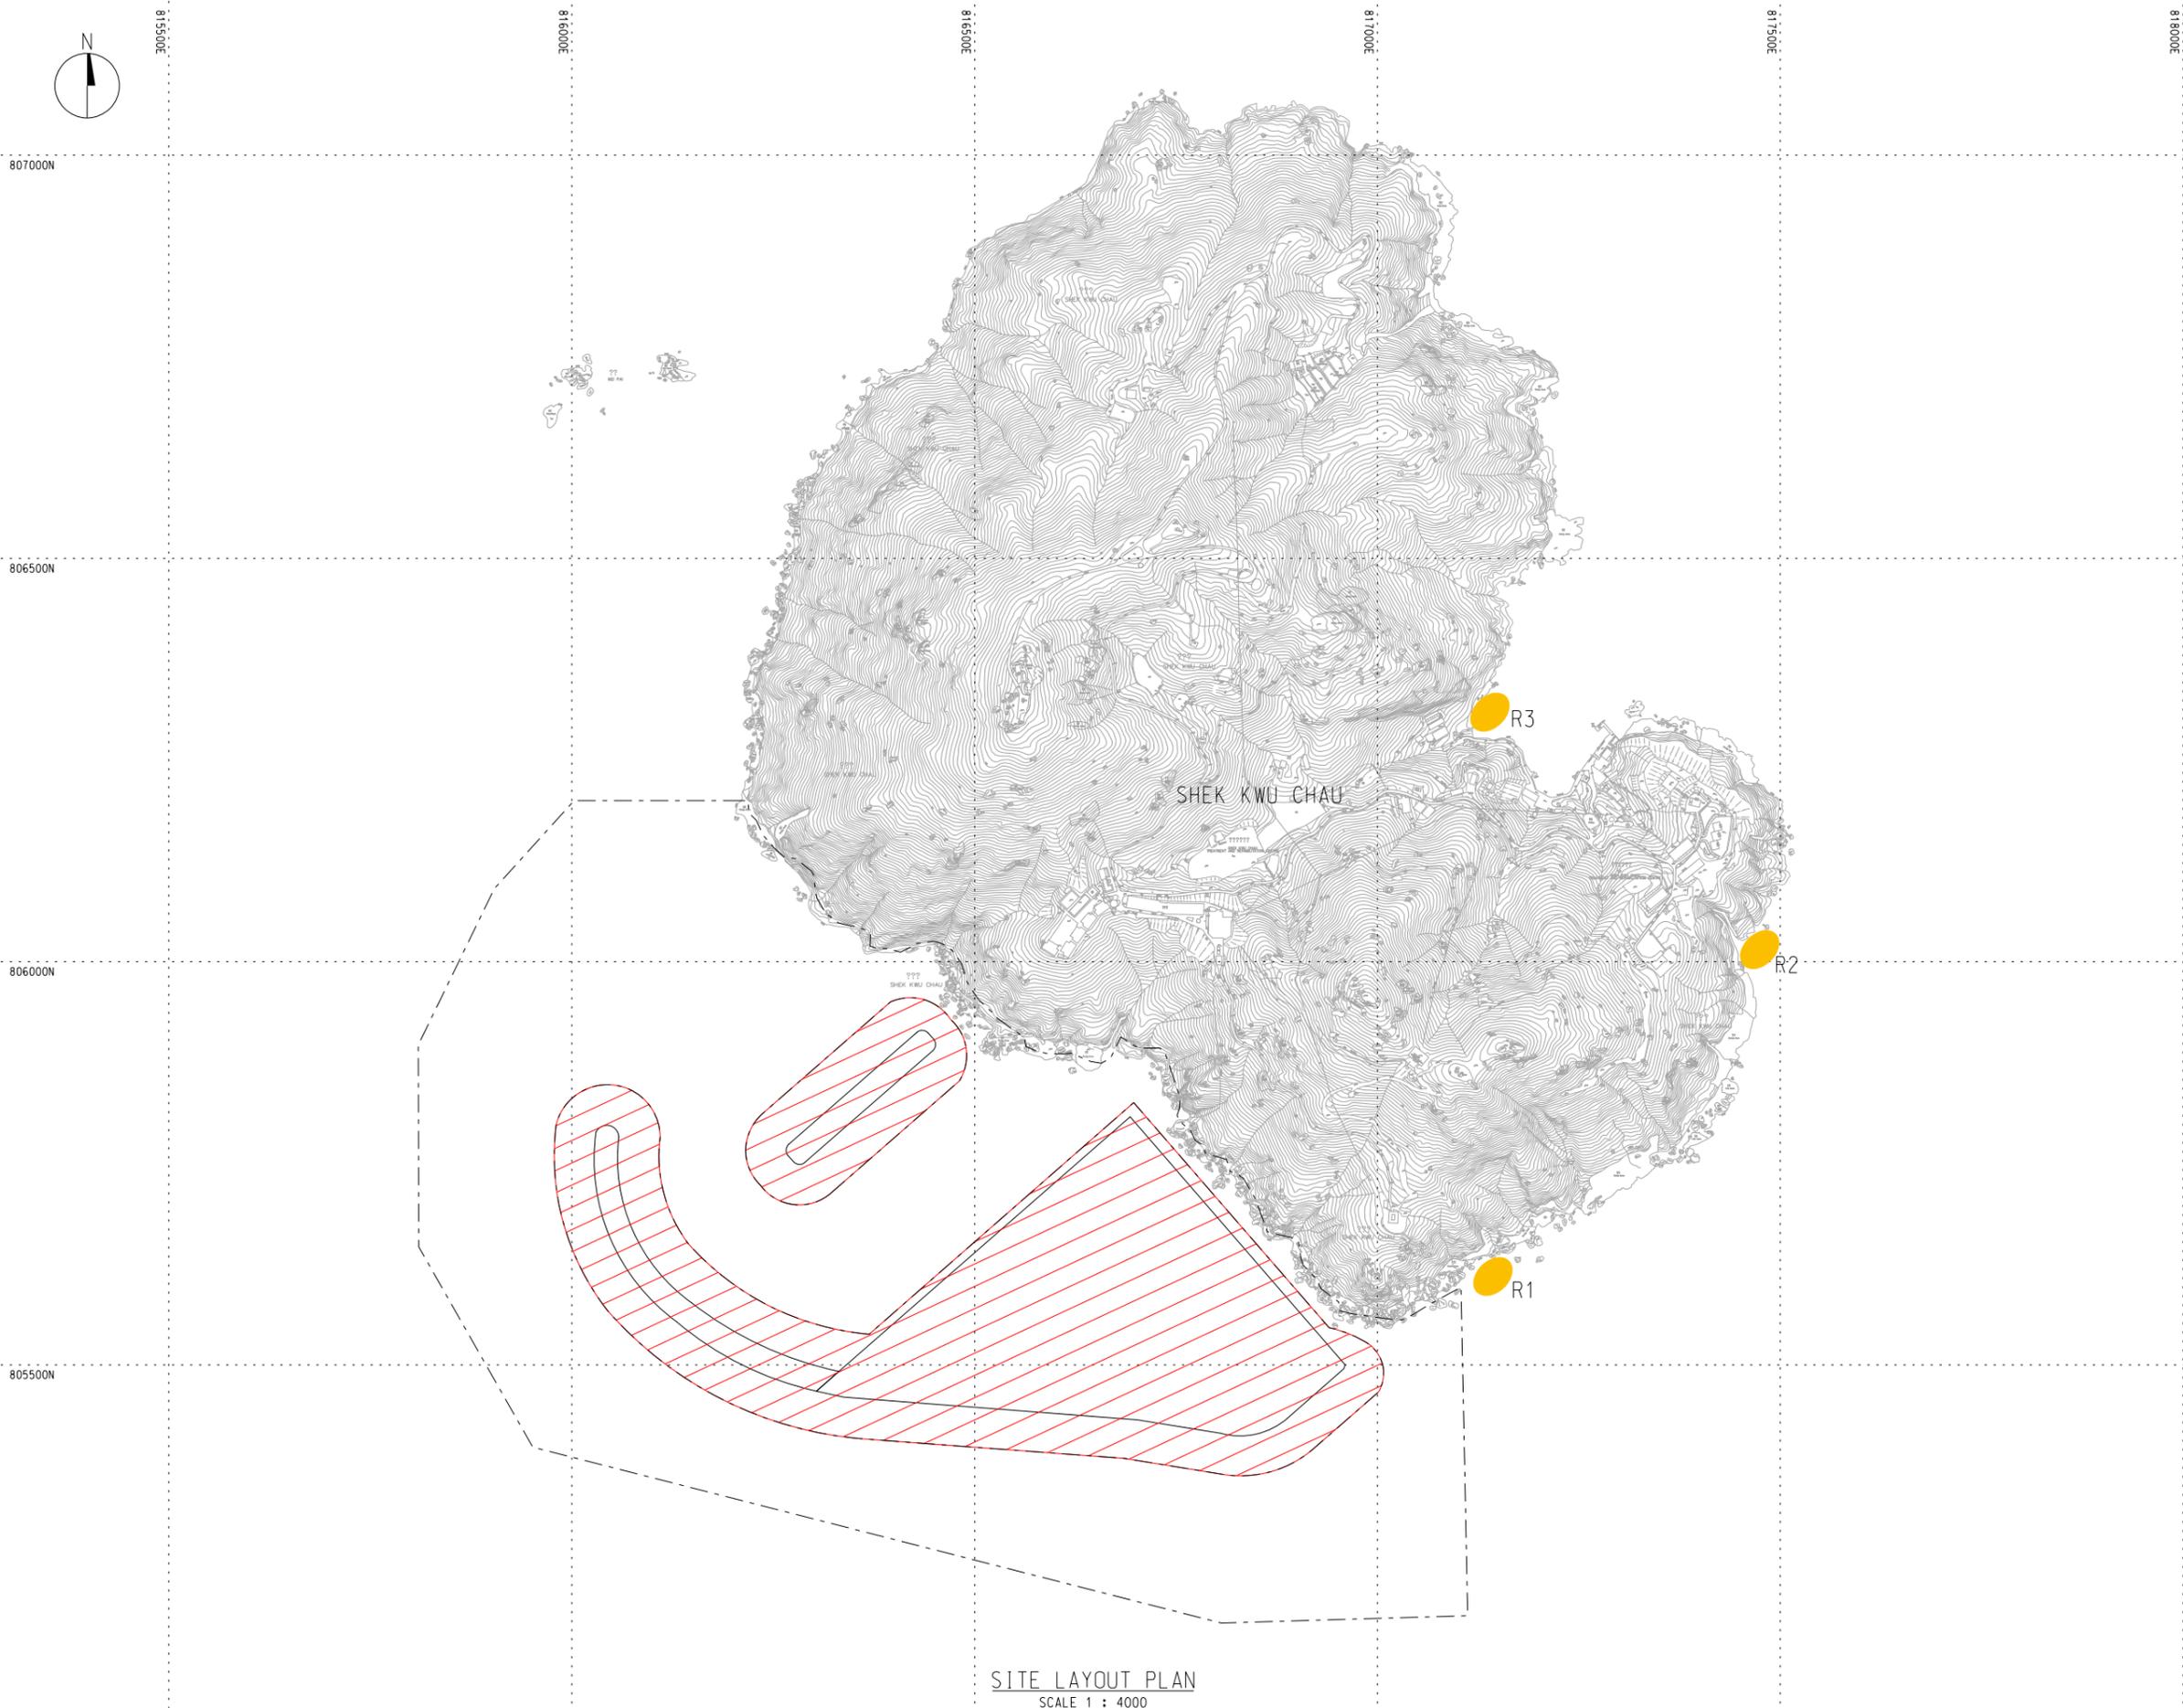
Figure 1 Pre-Translocation Survey Area and Proposed Recipient Sites R1, R2 and R3

TITLE			INTEGRATED WASTE MANAGEMENT FACILITIES PHASE 1 PROPOSED RECIPIENT SITES R1, R2 AND R3		
SCALE @ A1	DRAWING NO.	REV.	1 : 4000	EP/SP/66/12/COR/004	A

- 3.2.1. The Spot-Check and REA surveys were performed in January and February 2018 for potential Recipient Site R1, R2 and R3 (**Figure 1**); and the weather conditions were summarized in **Table 3.2**. Spot-Check surveys were conducted along the hard substrate of the three proposed recipient sites at the south-eastern and eastern coast of SKC. 4 species to 7 species of coral were recorded during the spot-check surveys in the three potential recipient sites (**Table 3.3**). Following the spot-check survey, REA survey was conducted at the same date.

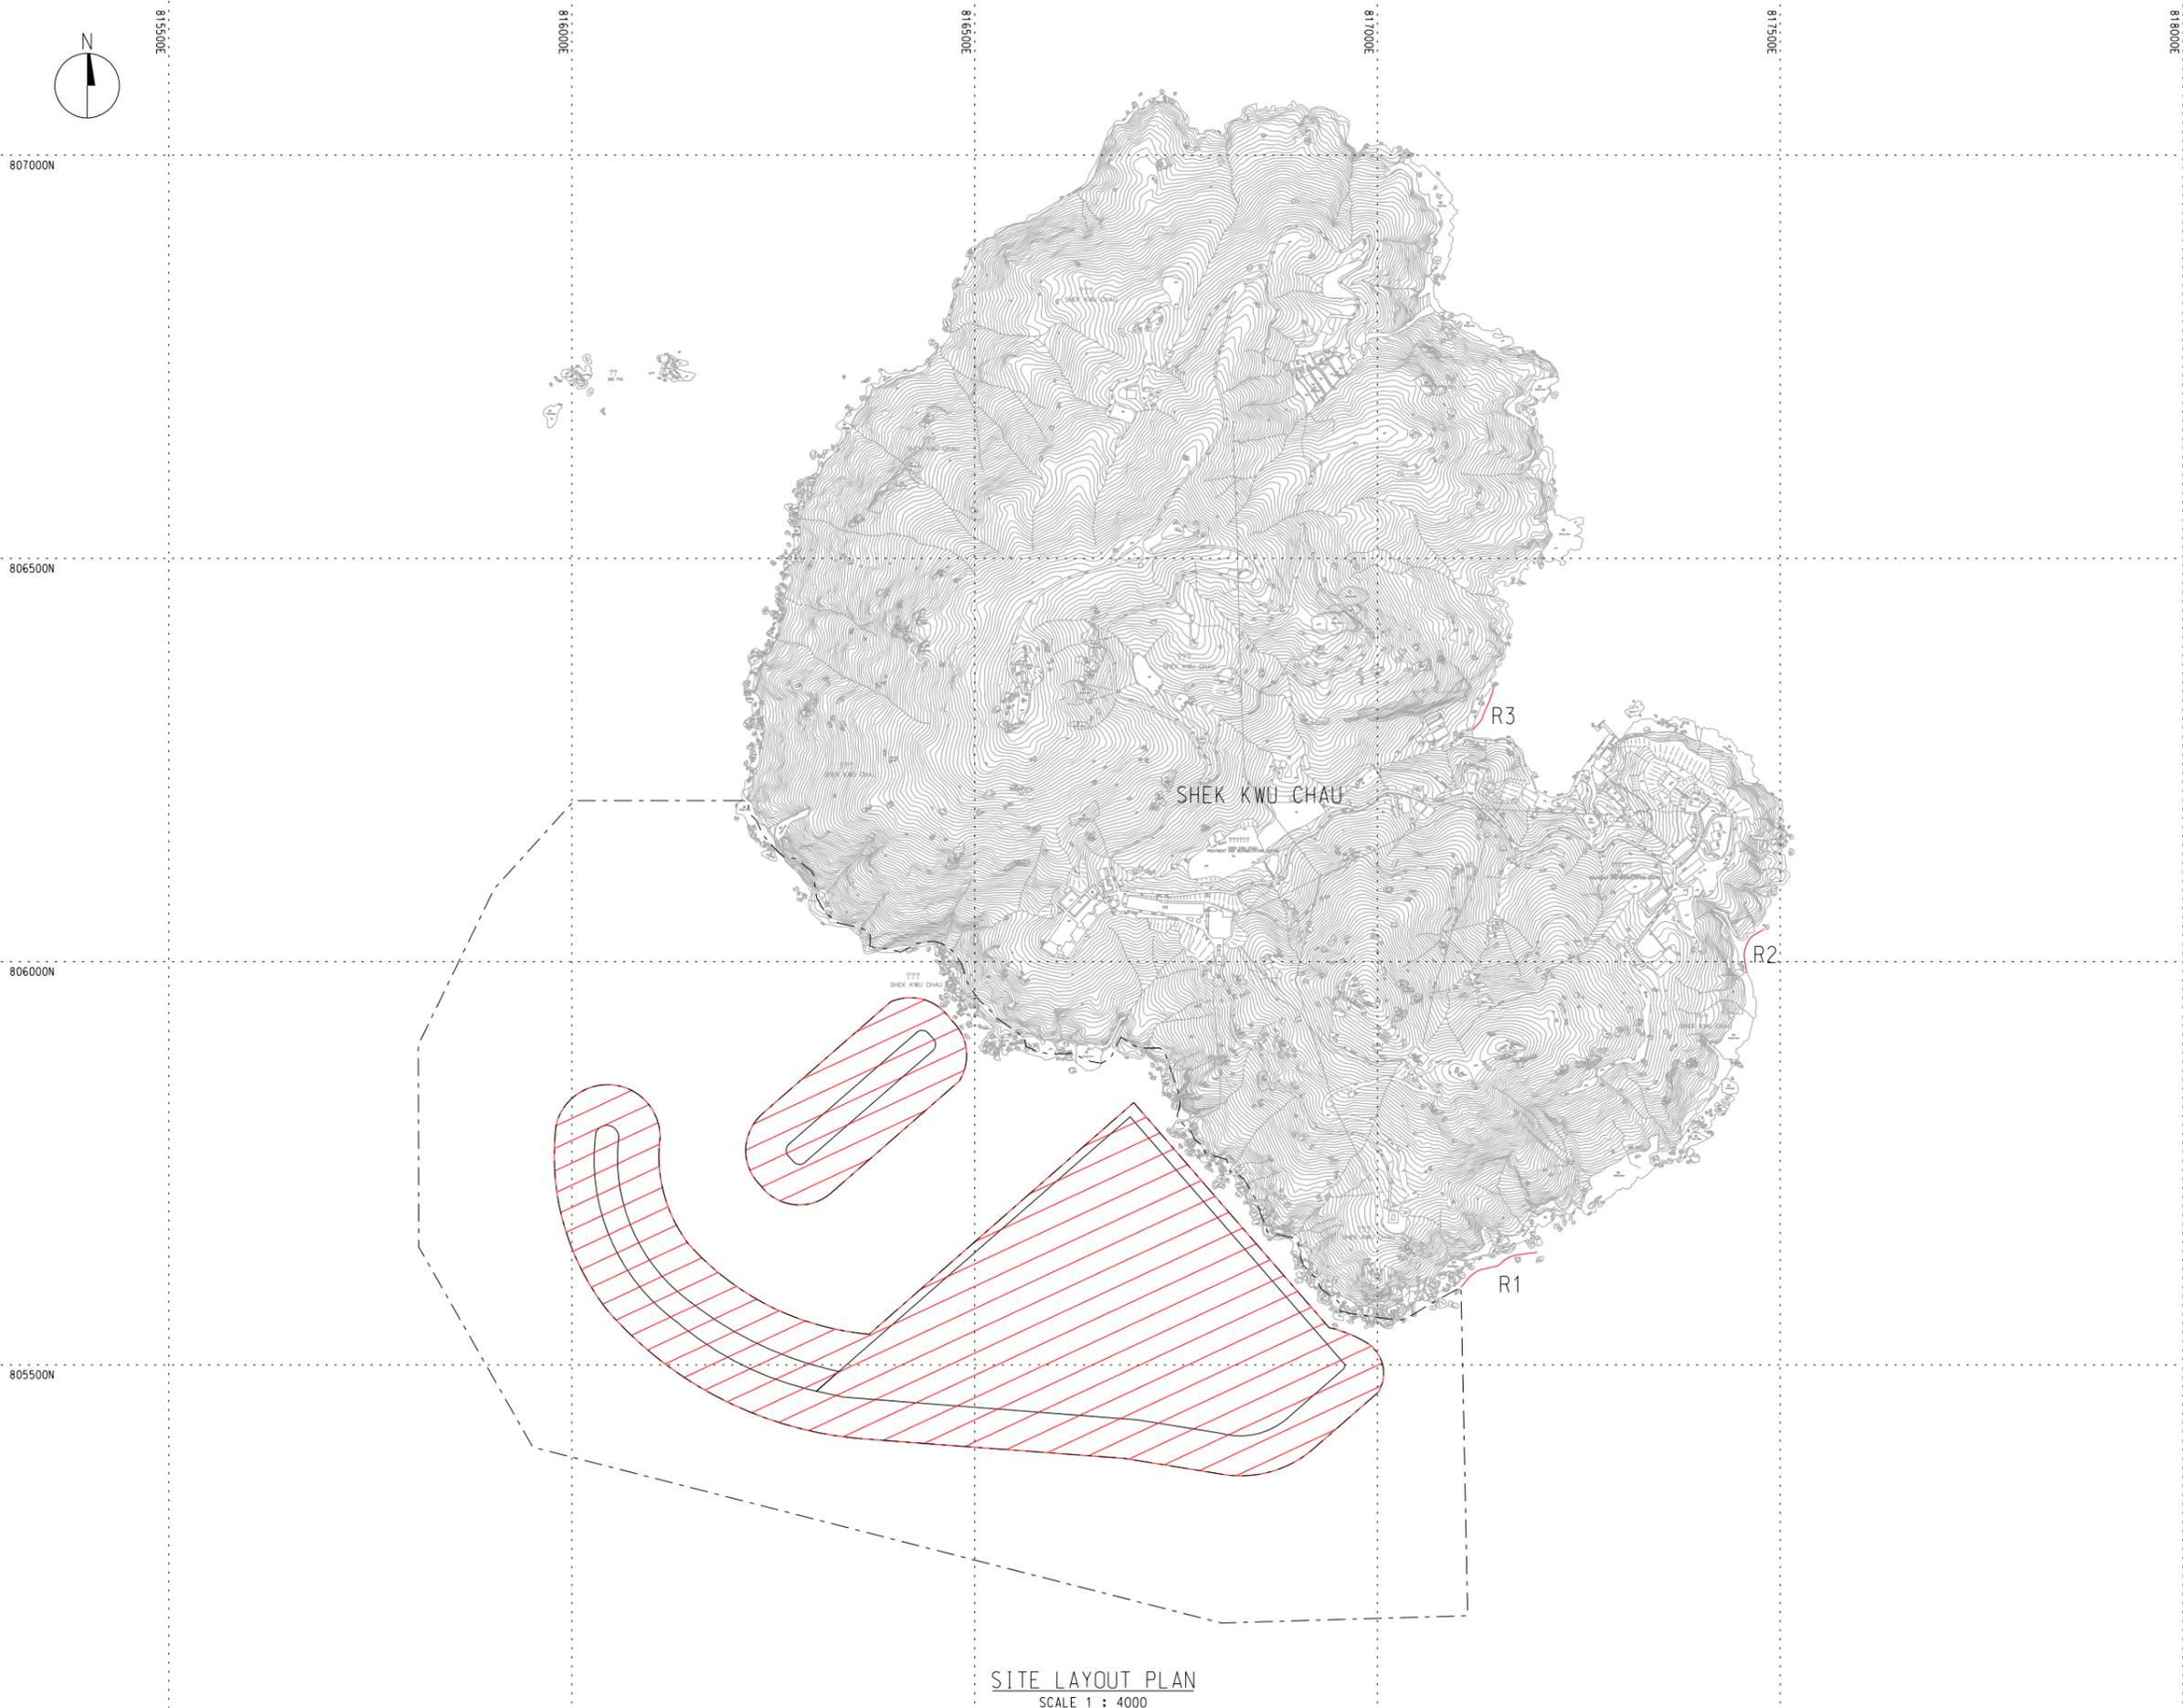
Figure 4 Locations of REA Transects at Proposed Recipient Sites R1, R2 and R3

TITLE			INTEGRATED WASTE MANAGEMENT FACILITIES PHASE 1 REA TRANSECTS AT SITE R1, R2 AND R3		
SCALE @ A1	DRAWING NO.	REV.			
1 : 4000	EP/SP/66/12/COR/003	A

3.2.2. A 100m transect was laid at proposed recipient Site R1 (**Figure 4**). GPS coordinates of REA Transect Starting and Ending, Maximum Depth and Bottom Substrate of the site were summarized in **Table 3.4**. The average water depth of the transect was about 2.5 to 4.5 m.

3.2.5. A 100m transect was laid at proposed recipient Site R2 (**Figure 4**). GPS coordinates of REA Transects Starting and Ending, Maximum Depth and Bottom Substrate of the site were summarized in **Table 3.4**. The average water depth of the transect was about 3 to 4 m.

3.2.8. A 100m transect was laid at proposed recipient Site R3 (**Figure 4**). GPS coordinates of REA Transect Starting and Ending, Maximum Depth and Bottom Substrate of the site were summarized in **Table 3.4**. The average water depth of the transect was about 2.5 to 4 m.

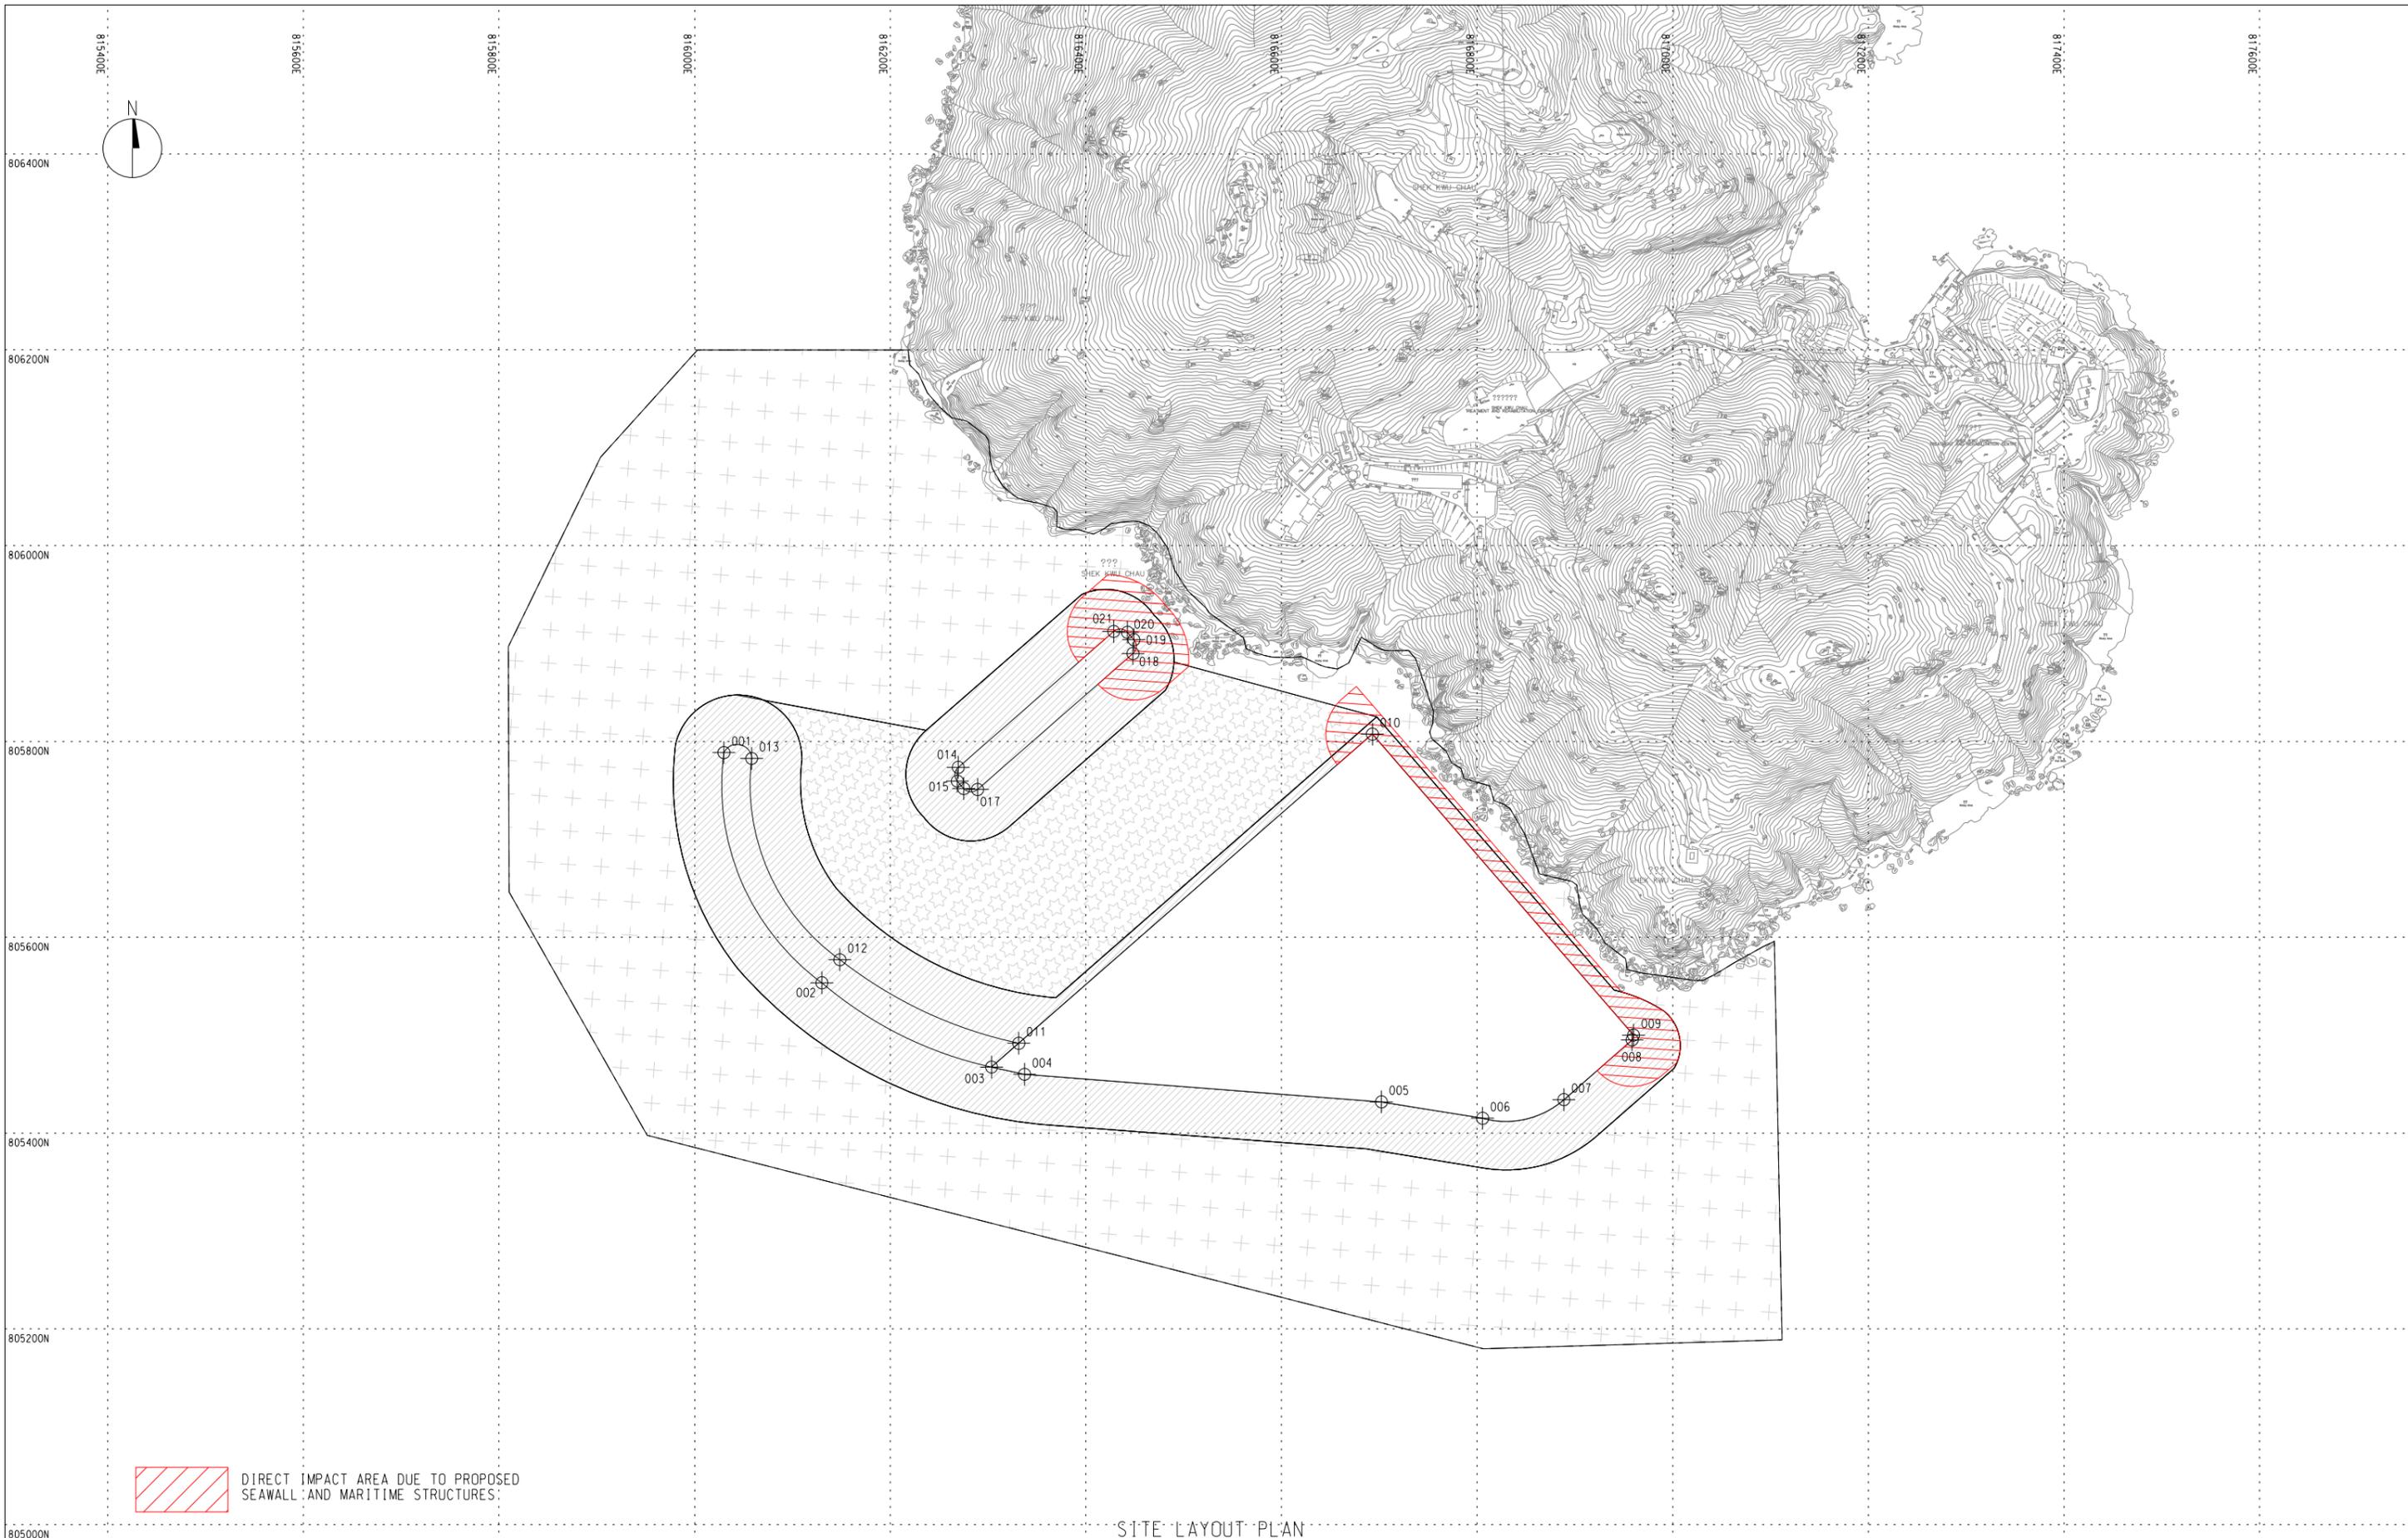
Figure 5 Direct Impact Area

DIRECT IMPACT AREA DUE TO PROPOSED SEAWALL AND MARITIME STRUCTURES

- 4.1.2. The extent of direct impact areas (i.e. areas to be affected by the proposed seawall and maritime structure) is shown in **Figure 5**. Translocatable corals identified in these areas will be translocated to recipient site during the coral translocation work.

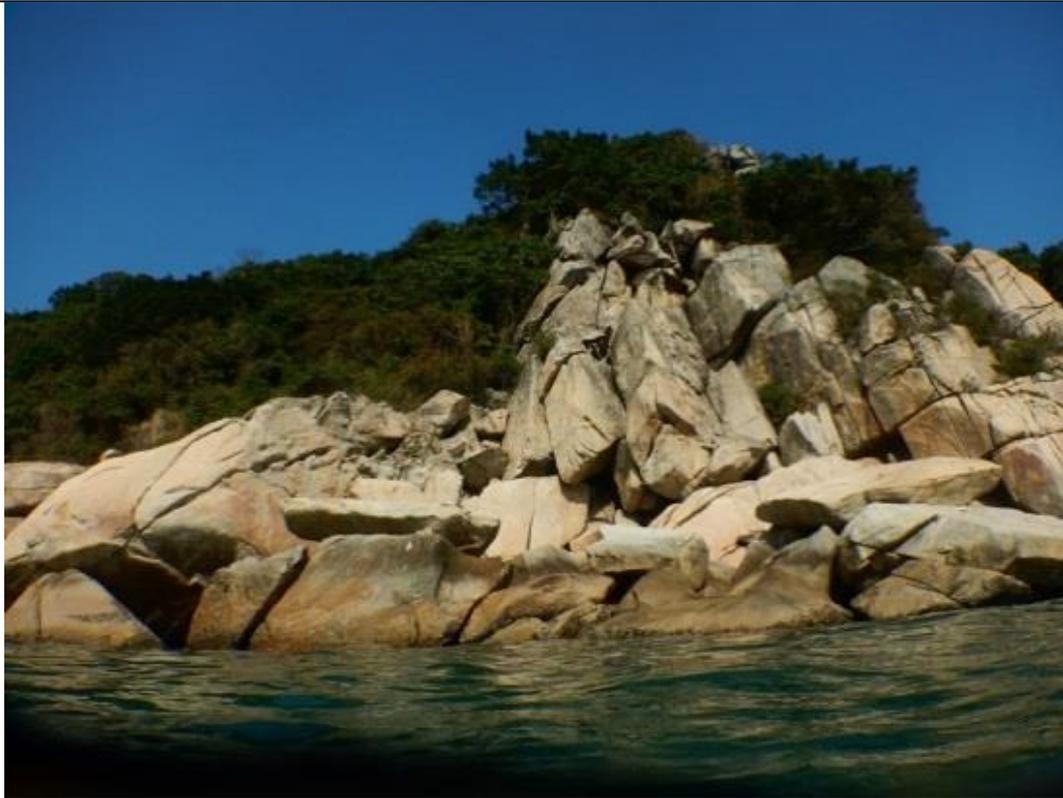
Photo 1. Bedrock at Shek Kwu Chau

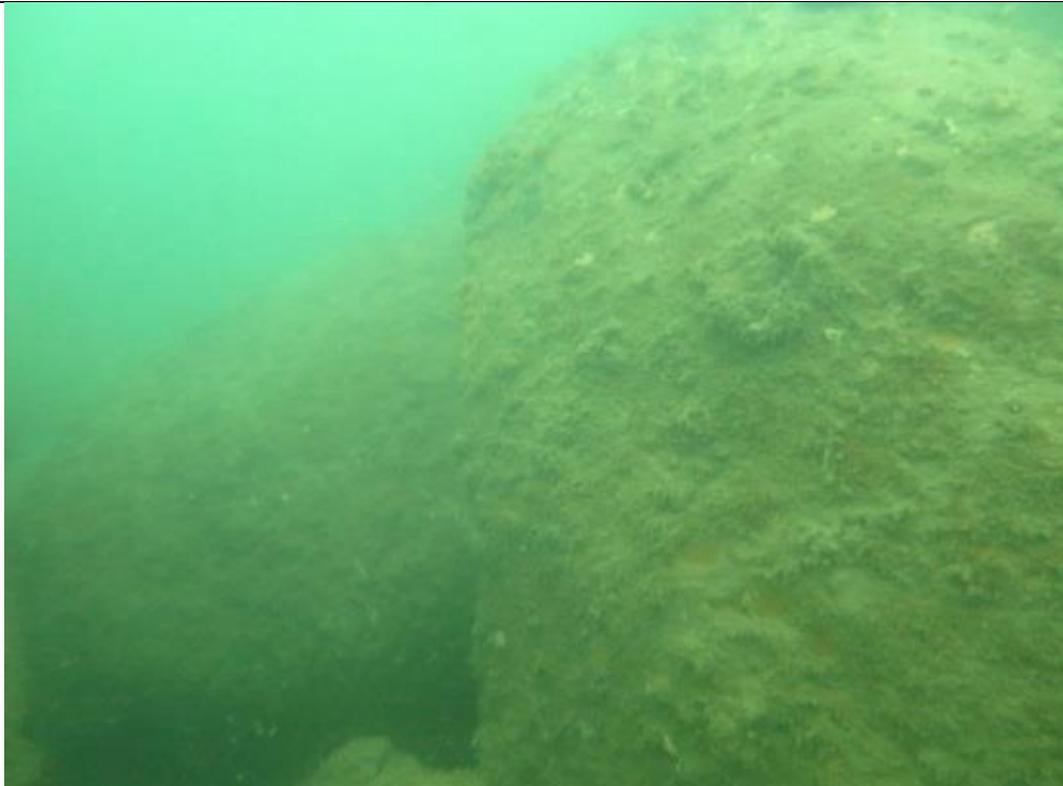
Photo 2. Boulders at Shek Kwu Chau

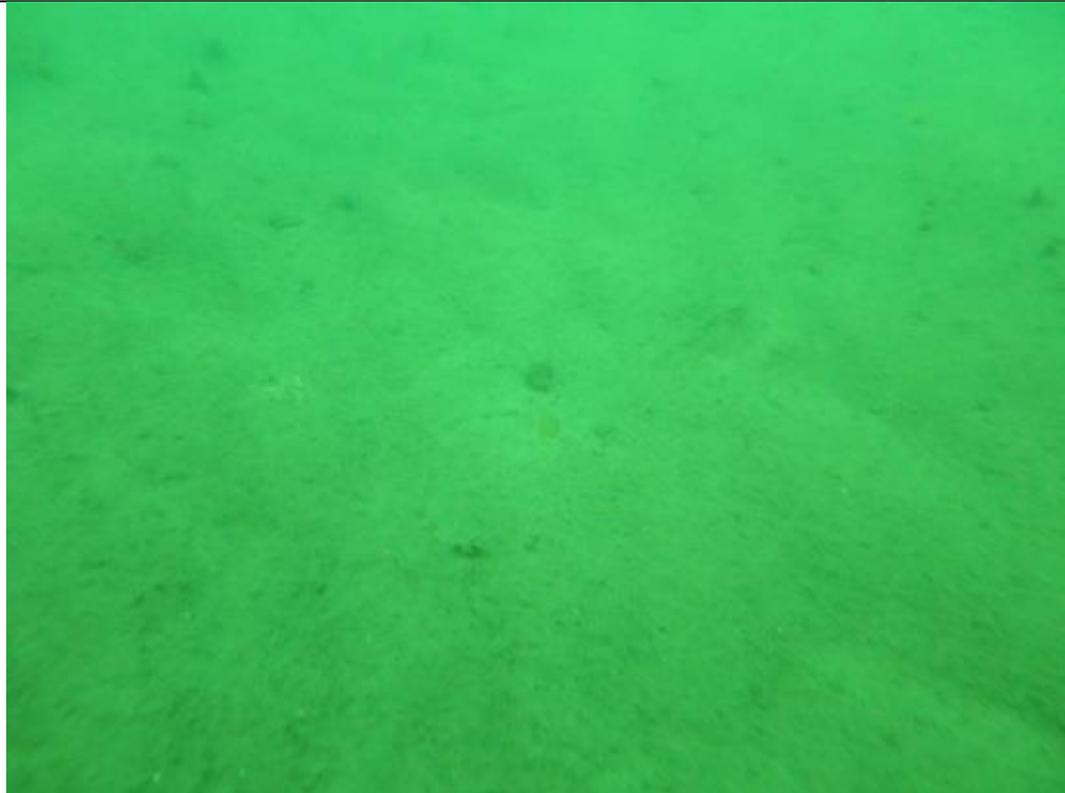
Photo 3. Sandy Bottom at Shek Kwu Chau

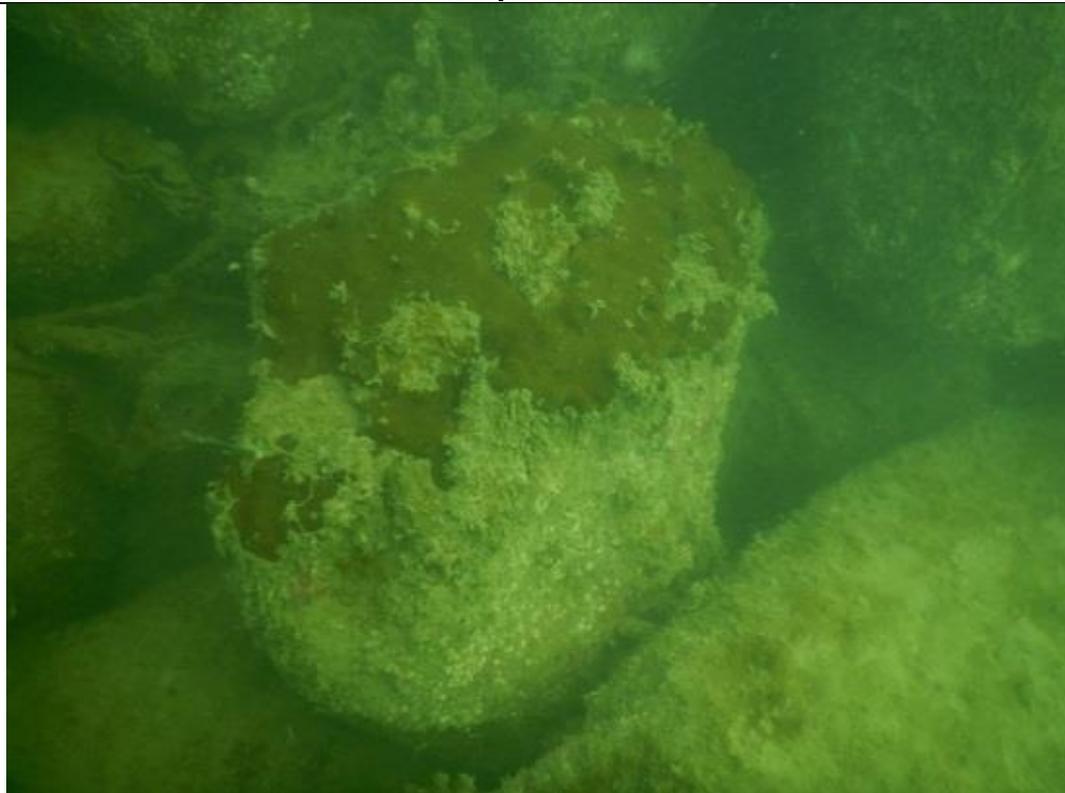
Photo 6. Movable *Psammocora superficialis* at Shek Kwu Chau

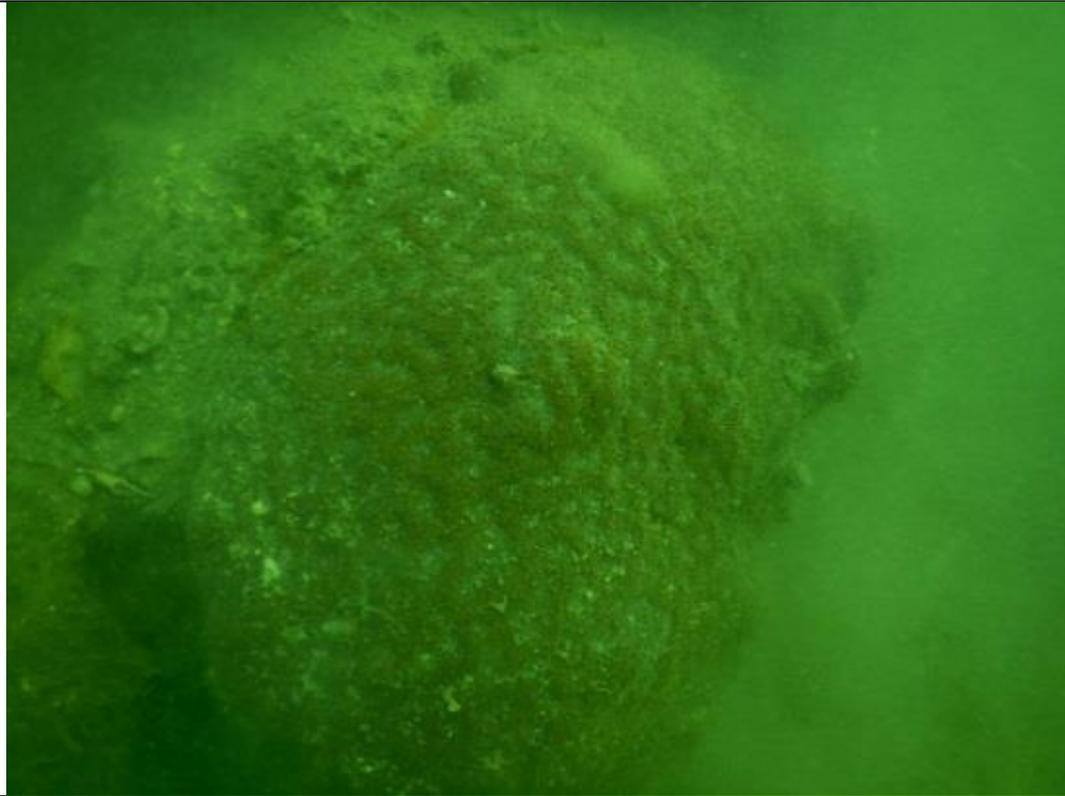
Photo 7. Movable *Coscinaraea n* sp. at Shek Kwu Chau
