Contract No. EP/SP/66/12
Integrated Waste Management Facilities, Phase 1
Monthly EM&A Report No.17

Monthly EM&A Report No.17 (Period from 1 November to 30 November 2019)

(Clause 3.3, Further Environmental Permit FEP-01/429/2012/A)

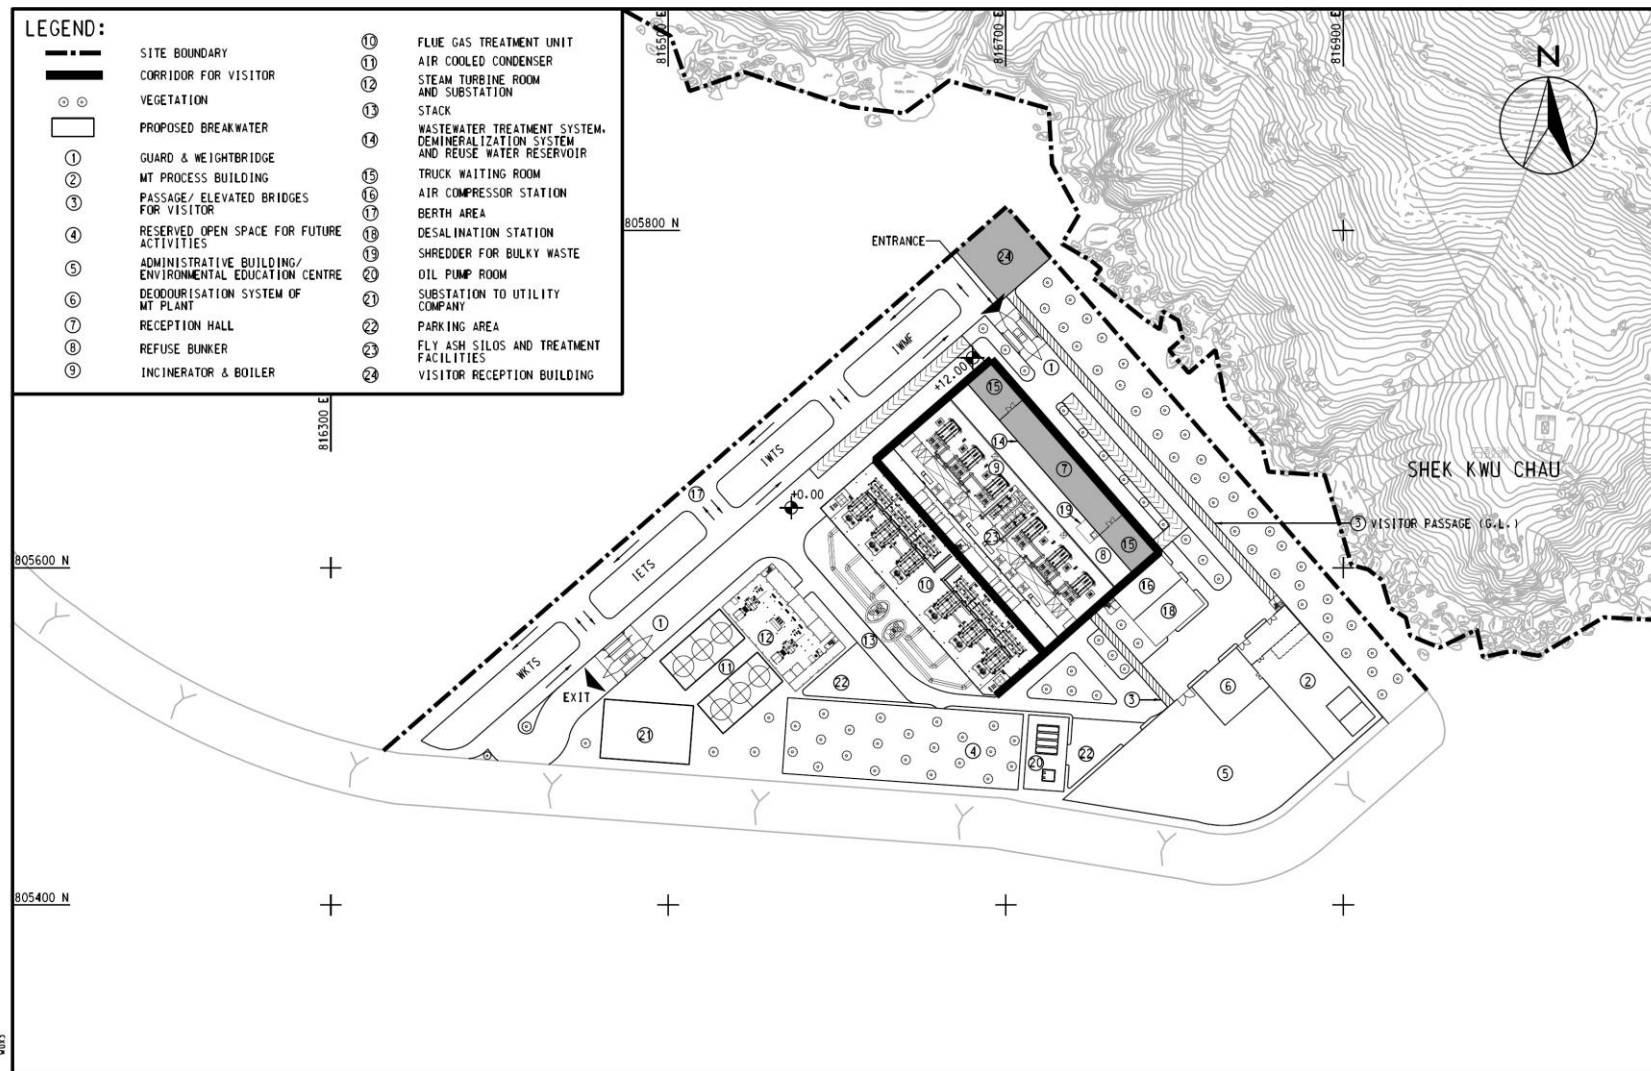
Figure 1.2 General Layout of the IWMF at the Artificial Island near SKC

1.1.4 The location of the IWMF near Shek Kwu Chau (SKC) and general layout of IWMF are shown in **Figure 1.1** and **Figure 1.2** respectively.

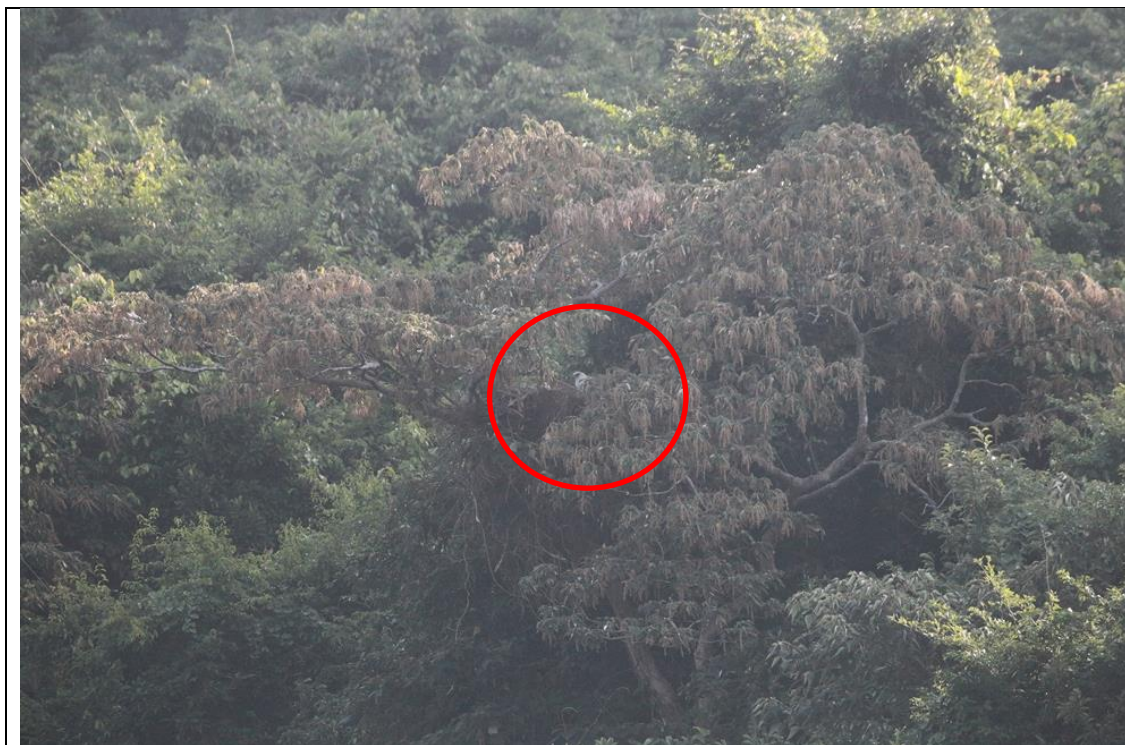
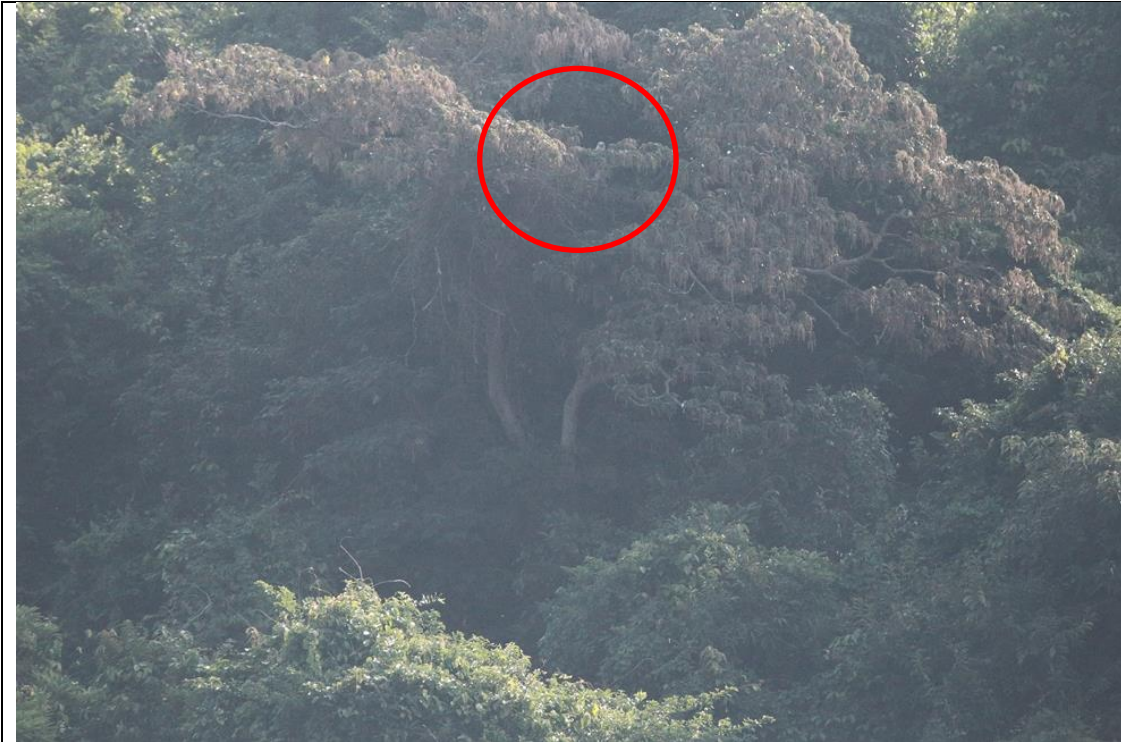
Figure 7.2 Photo Records of WBSE on SKC During the Reporting Period

7.5.2 No abnormal behavior of the recorded adults during the November 2019 construction phase monitoring. Two adults of WBSE were recorded having incubation in the nest (**Figure 7.2**). All marine works during the monitoring period did not show any affects to the WBSE.

Adult WBSEs staying in the nest

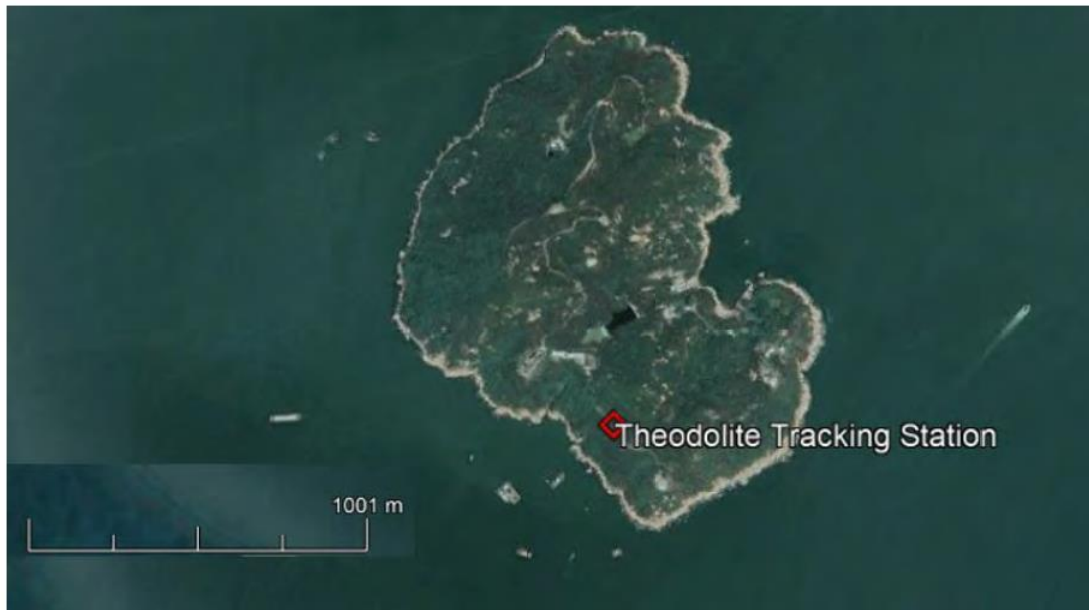
Figure 1 Theodolite Tracking Station (N 22° 11.47'; E 113° 59.33'), Shek Kwu Chau, Hong Kong SAR

- 4.2 The theodolite was positioned at southwest Shek Kwu Chau (SKC) (N 22° 11.47'; E 113° 59.33') which is the vantage point used previously for the baseline theodolite monitoring for this Project, (**Annex I: Figure 1**). Prior to construction at SKC, this point had a relatively unobstructed view of the Project site, however, the observable sea area is now occupied by the IWMF construction works. The works inevitably obstructed the view (**Section 7: Figure 3**), making it challenging to see all the areas that were available during baseline theodolite monitoring.
