Contract No. EP/SP/66/12
Integrated Waste Management Facilities, Phase 1
Monthly EM&A Report No.18

Monthly EM&A Report No.18 (Period from 1 December to 31 December 2019)

(Clause 3.3, Further Environmental Permit FEP-01/429/2012/A)

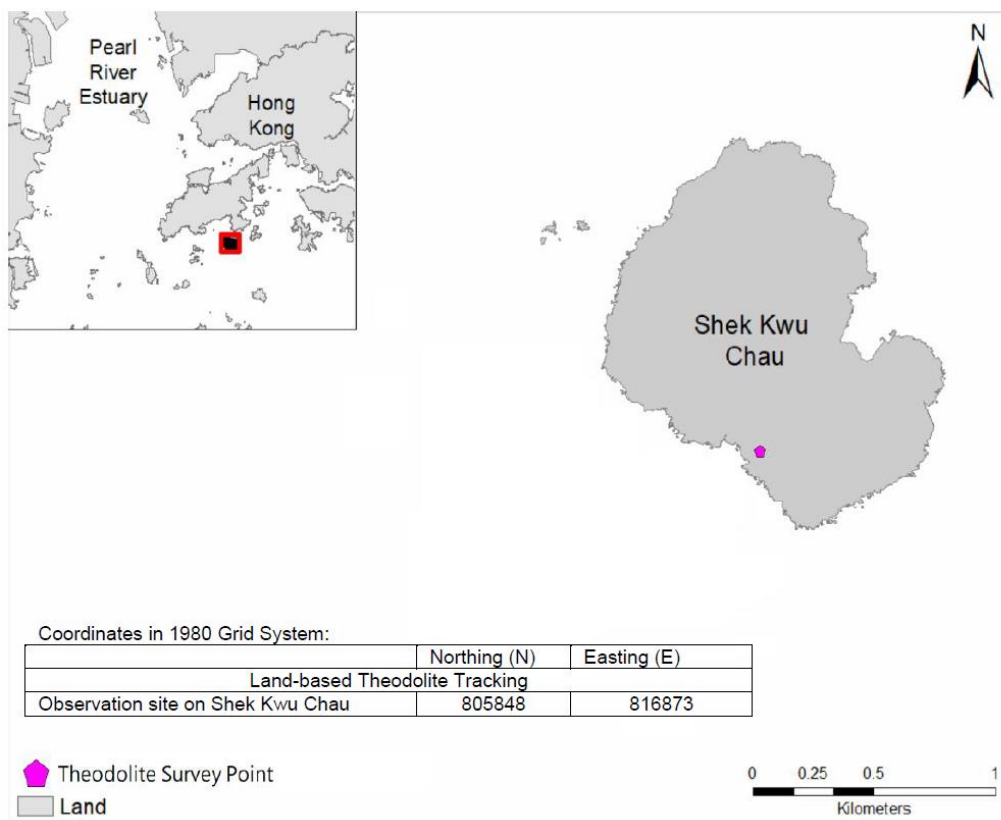
Figure 6.3 Locations of Land-based Theodolite Tracking

6.2.4.1 The Land-based Theodolite Tracking study would use the same station as in the AFCD monitoring study(same as the baseline monitoring location), which is situated at the southwest side of Shek Kwu Chau (GPS position: 22°11.47' N and 113°59.33' E) as shown in below **Figure 6.3**. The station was selected based on its height above sea level (at least 20 metres), close proximity to shore, and relatively unobstructed views of the entire Project Area to the southwest of Shek Kwu Chau. The height of the Shek Kwu Chau Station established by the HKCRP team is 74.6 m high at mean low water, and only a few hundred metres to the IWMF reclamation site, which is ideal for the purpose for the present behavioural and movement monitoring of finless porpoises as well during construction phase considering there as an un-obstructed vantage point at a height above the Project Site.
