Contract No. EP/SP/66/12
Integrated Waste Management Facilities, Phase 1
Monthly EM&A Report No.1

Monthly EM&A Report No.1 (Period from 28 June to 31 July 2018)

(Clause 3.3, Further Environmental Permit FEP-01/429/2012/A)

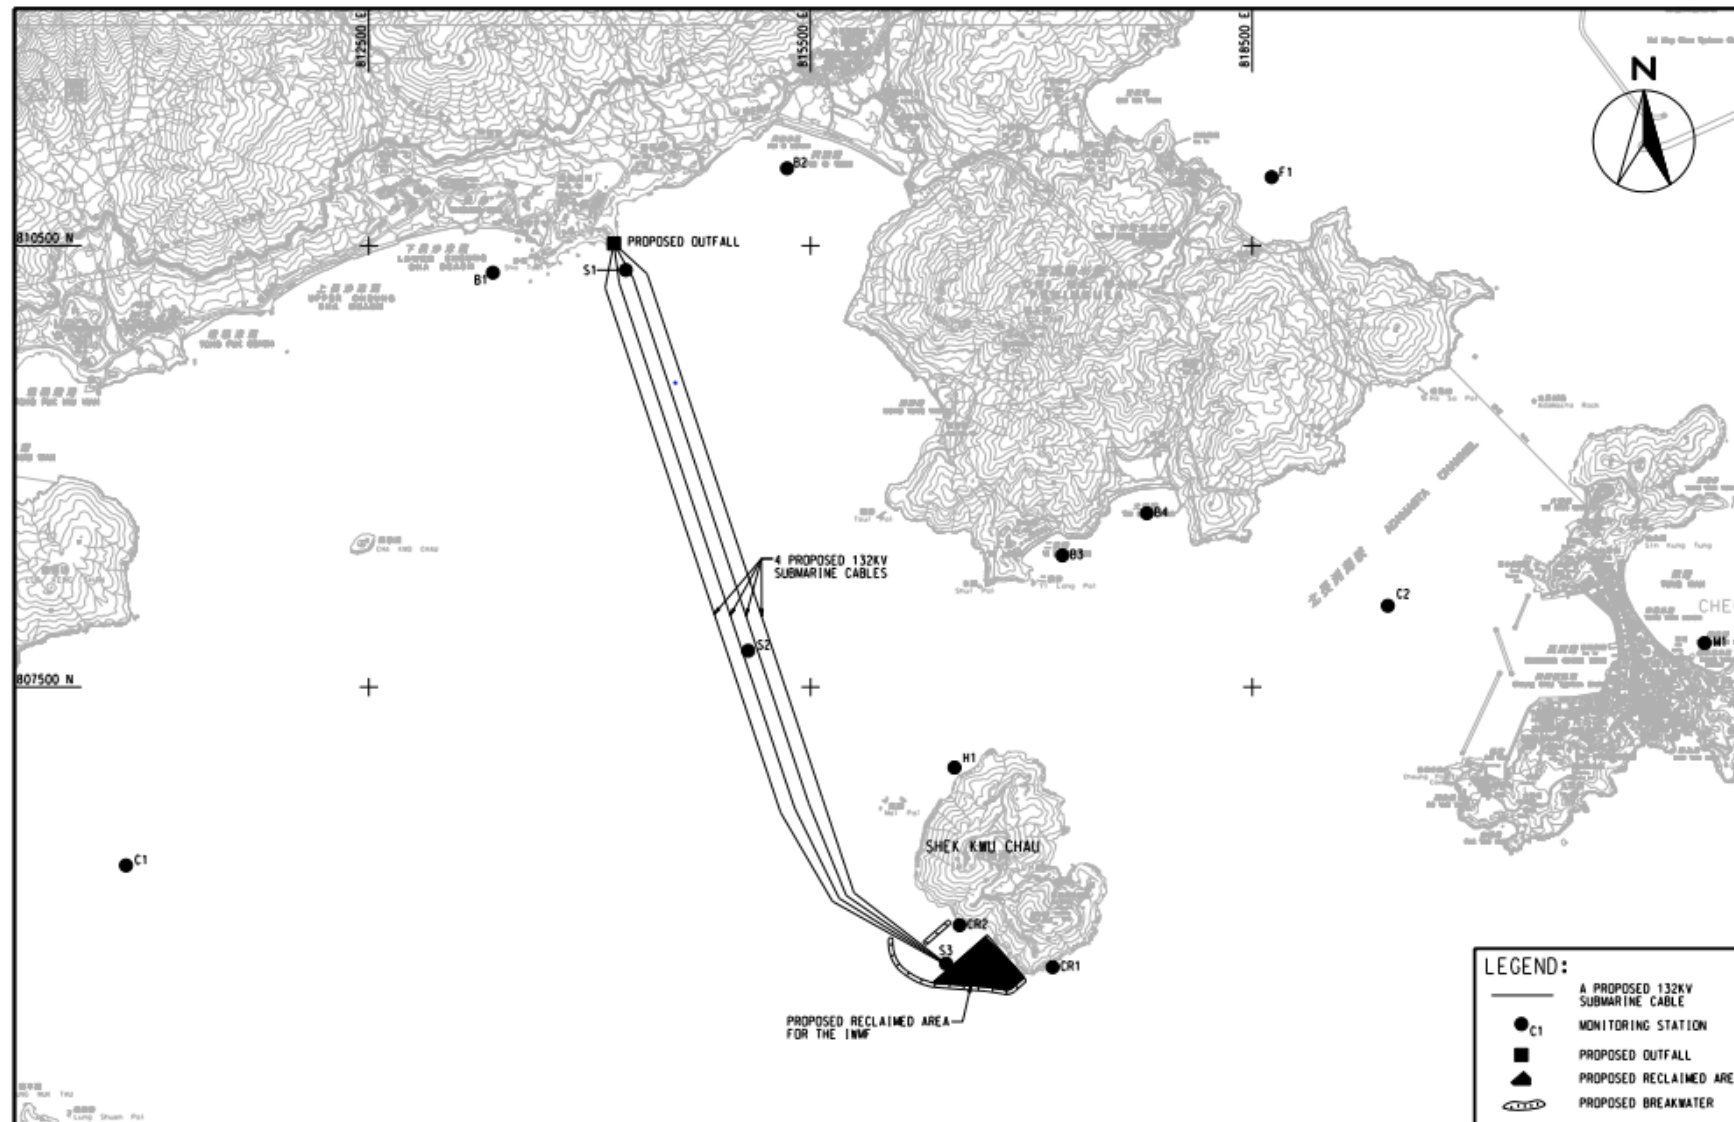
Figure 2.1 Water monitoring locations at Artificial Island near SKC

2.3.1 Impact water quality monitoring was conducted at eleven monitoring locations during general water quality monitoring and fourteen water monitoring locations during regular DCM monitoring, as shown in **Figure 2.1**.

2.3.2 B1 to B4 are located at 4 beaches respectively at the southern shore of Lantau Island. Monitoring station H1 is located at the horseshoe crab habitat at northern SKC, while CR1 and CR2 are located at the coral communities at southwestern shore of SKC. Monitoring station F1 is located at the Cheung Sha Wan Fish Culture Zone while monitoring station M1 is located at Tung Wan at Cheung Chau. S1, S2 and S3 are located at the northern landing site, midway and southern landing site of the proposed submarine cable, respectively. S1, S2 and S3 are required for monitoring due to the laying of submarine cable. Control stations C1 and C2 at far field locations are for comparison.

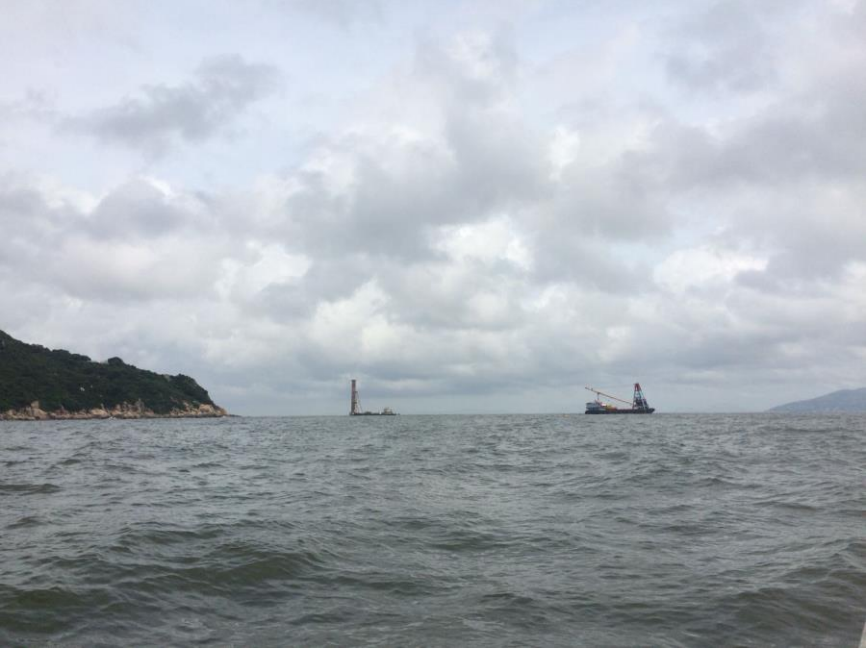
<p>(Sourced from: http://current.hydro.gov.hk/en/map.html)</p> <p>Site condition on 12/7:</p>

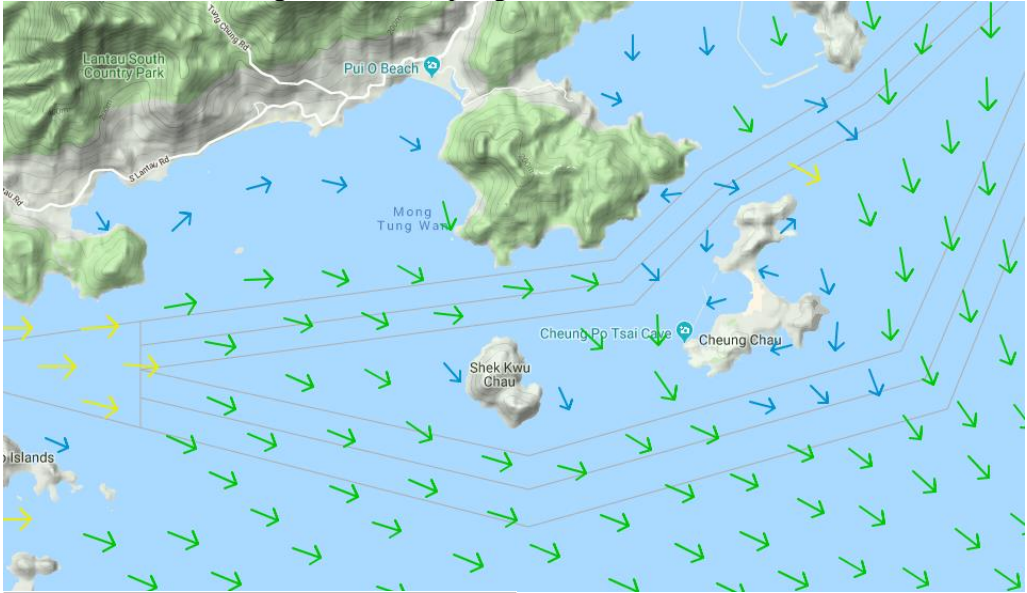
<p>Remarks</p>	<p>Current direction during mid-ebb sampling on 30/7:</p>
