Contract No. EP/SP/66/12  
Integrated Waste Management Facilities, Phase 1

## Monthly EM&A Report No.3 (Period from 1 September to 30 September 2018)

(Clause 3.3, Further Environmental Permit FEP-01/429/2012/A)

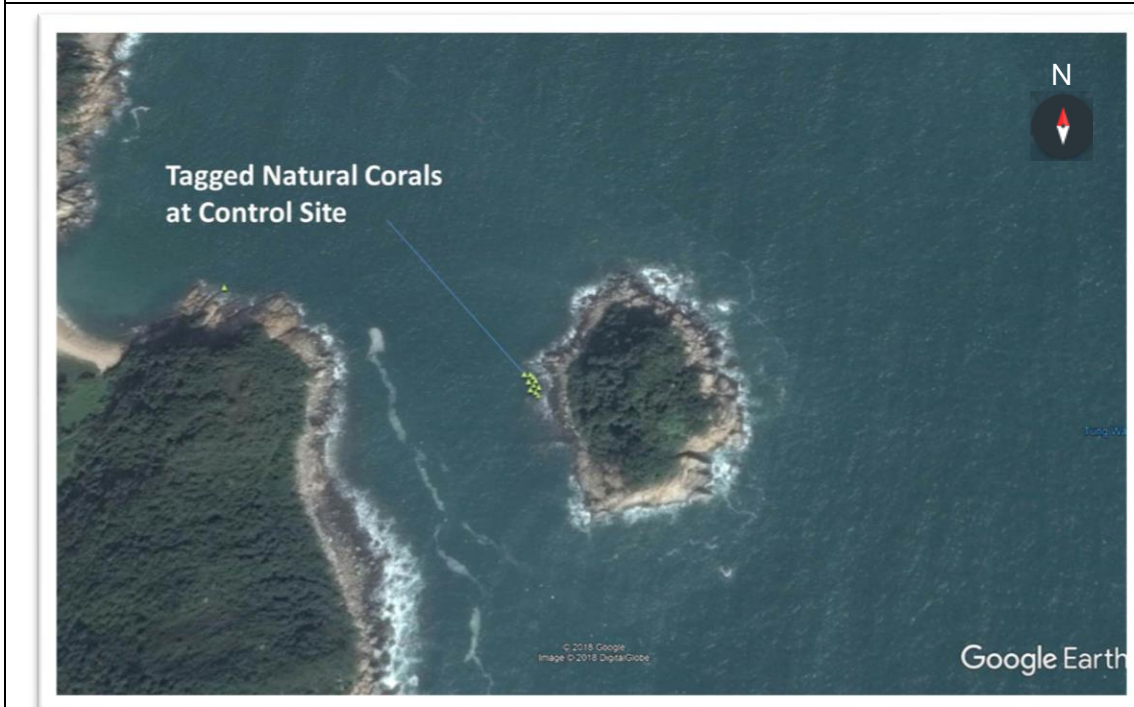
**Figure 5.2 Tagged Natural Corals at Control Site Near Yuen Kong Chau**

5.3.1 Location of the ten tagged coral colonies at each of the proposed indirect impact site, control site and the recipient site R3 are shown in **Figure 5.1**, **Figure 5.2** and **Figure 5.3** respectively:

5.6.1 The third month construction phase monitoring was performed on 20<sup>th</sup> September 2018 for the both Indirect Impact Site and Control Site (**Figure 5.1** and **5.2** respectively); and the weather conditions were summarized in **Table 5.6**.

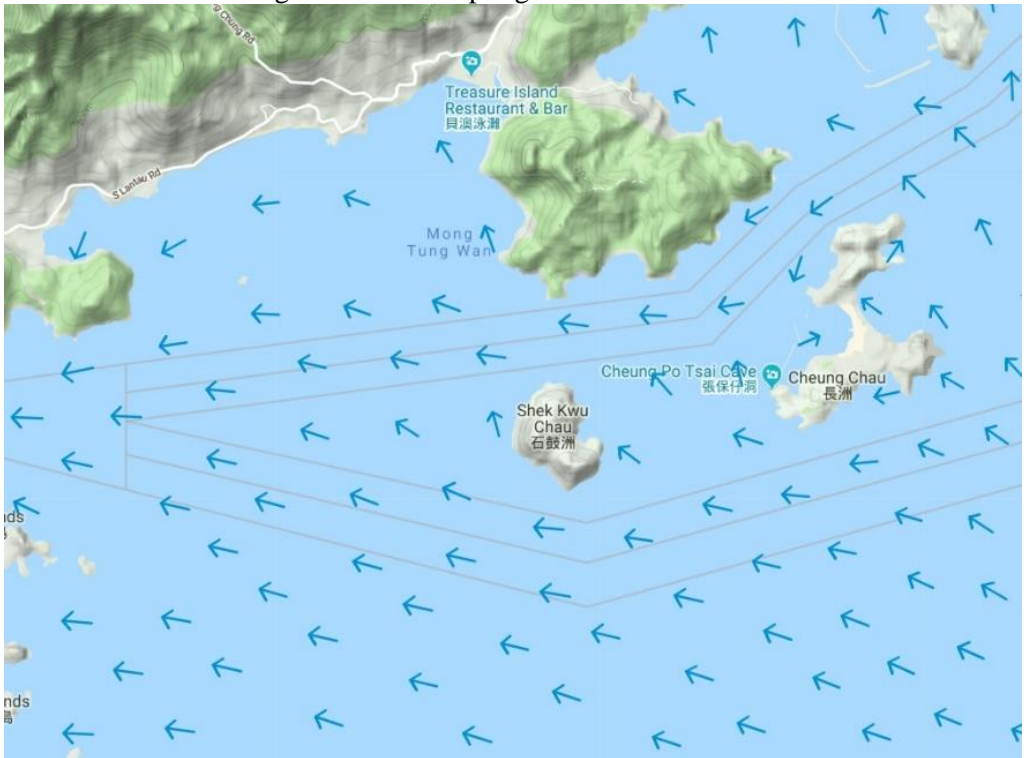
Remarks Current direction during mid-flood sampling on 18/9:
