Contract No. EP/SP/66/12
Integrated Waste Management Facilities, Phase 1
Monthly EM&A Report No.4

Monthly EM&A Report No.4 (Period from 1 October to 31 October 2018)

(Clause 3.3, Further Environmental Permit FEP-01/429/2012/A)

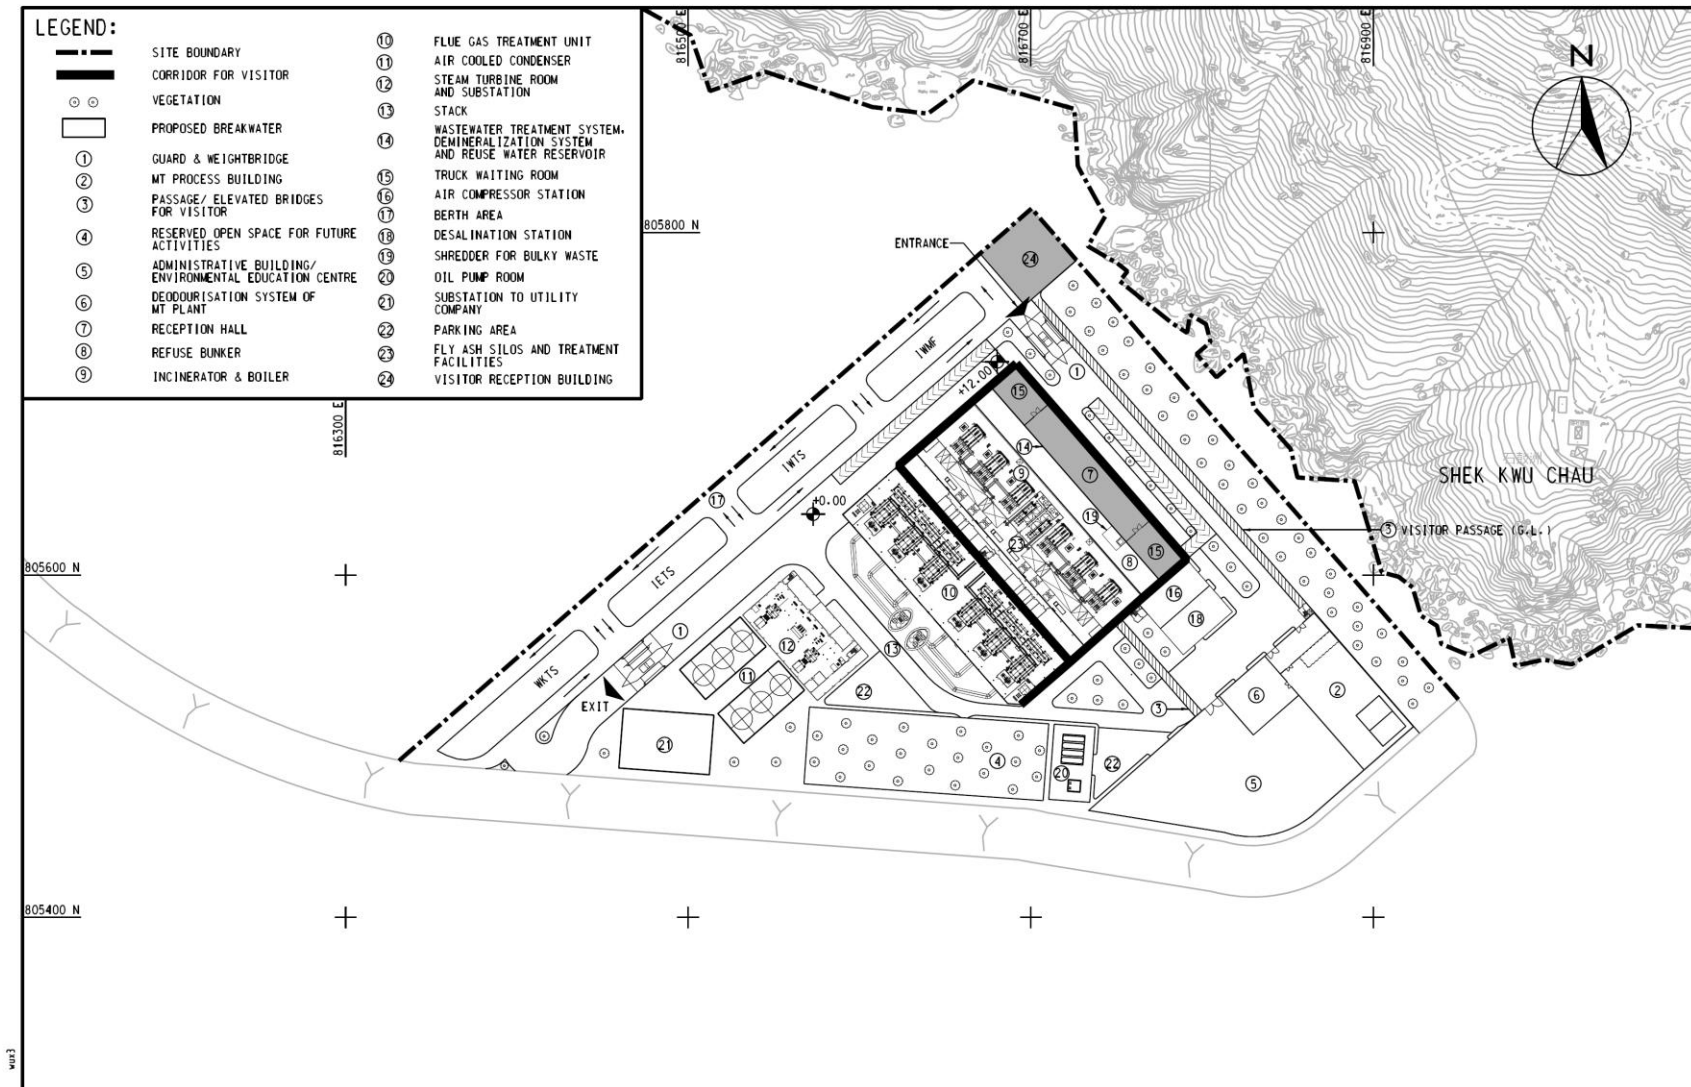
Figure 1.2 General Layout of the IWMF at the Artificial Island near SKC

- All other design and works required for the operation and maintenance of the Facility
 - according to the Contract requirements
- 1.1.4 The location of the IWMF near Shek Kwu Chau (SKC) and general layout of IWMF are shown in **Figure 1.1** and **Figure 1.2** respectively.

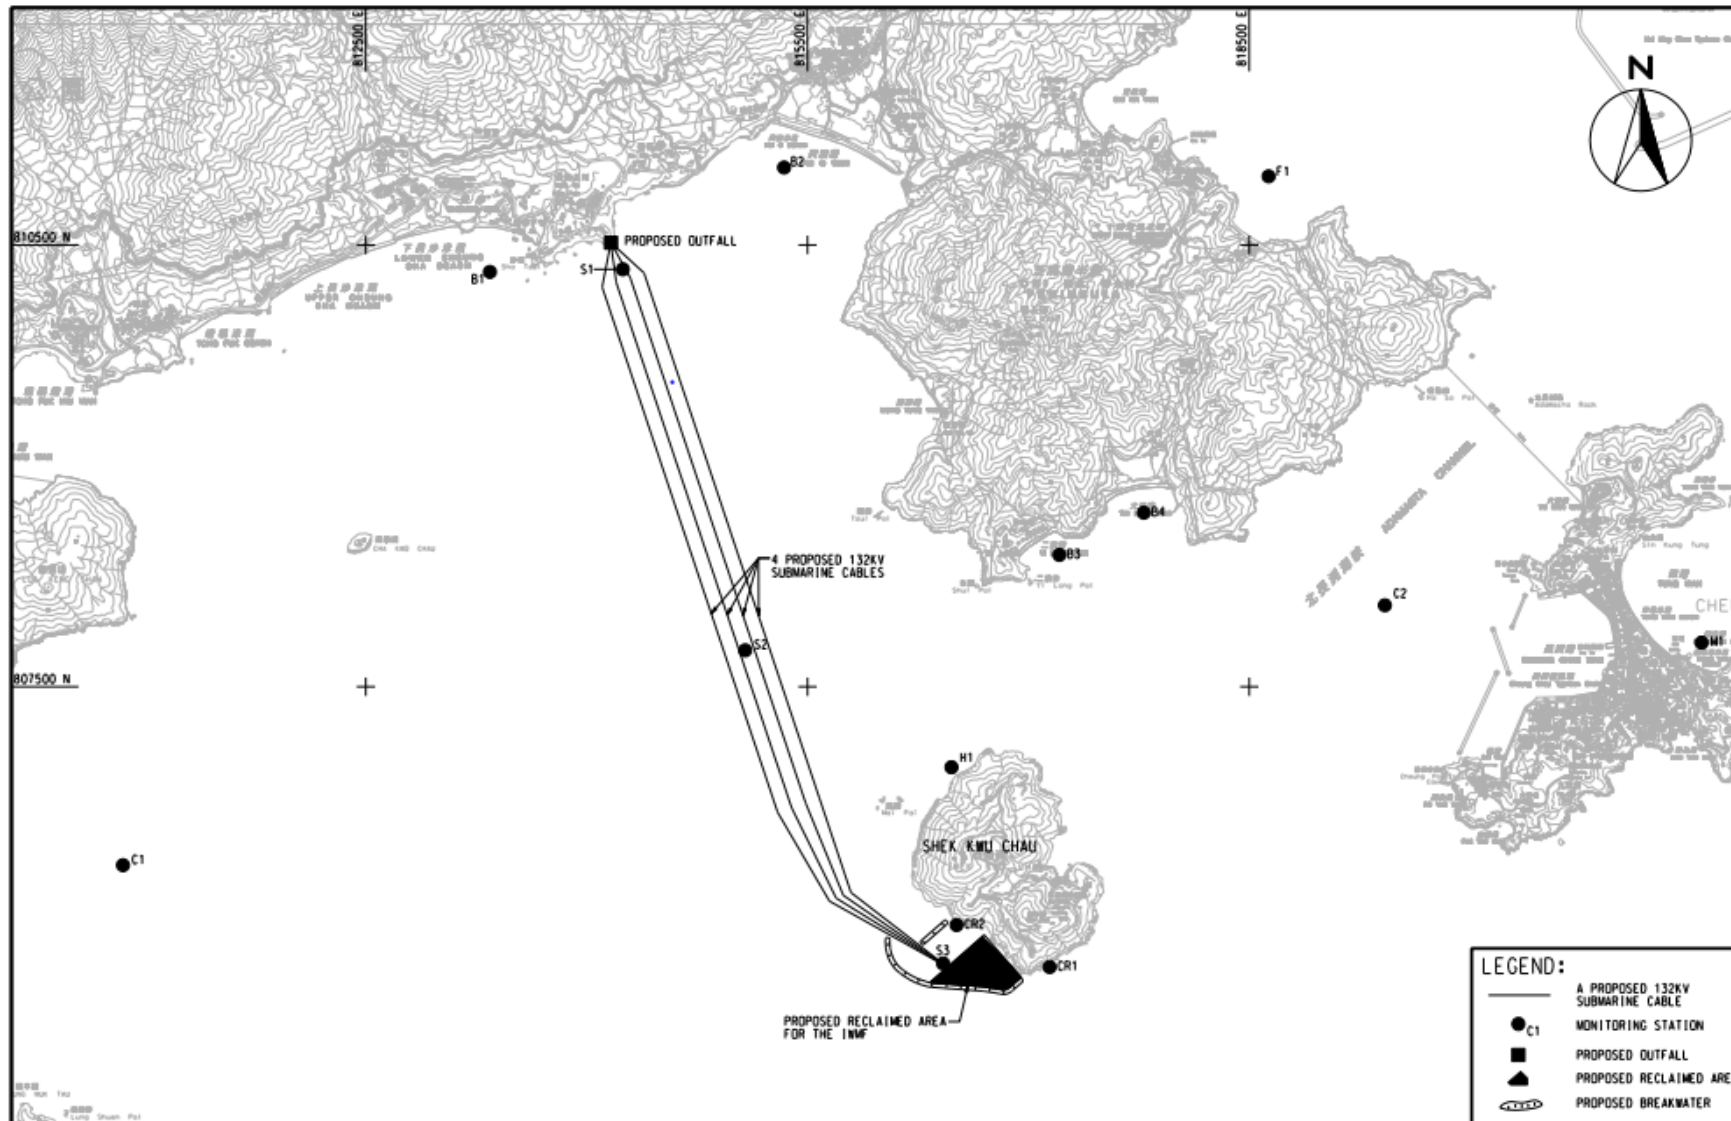
Figure 2.1 Water monitoring locations at Artificial Island near SKC

2.3.1 Impact water quality monitoring was conducted at eleven monitoring locations (B1-B4, H1, C1, C2, F1, CR1, CR2 & M1) during general water quality monitoring and was conducted at fourteen water monitoring locations (B1-B4, H1, C1, C2, F1, S1-S3, CR1, CR2 & M1) during regular DCM monitoring, as shown in **Figure 2.1**.

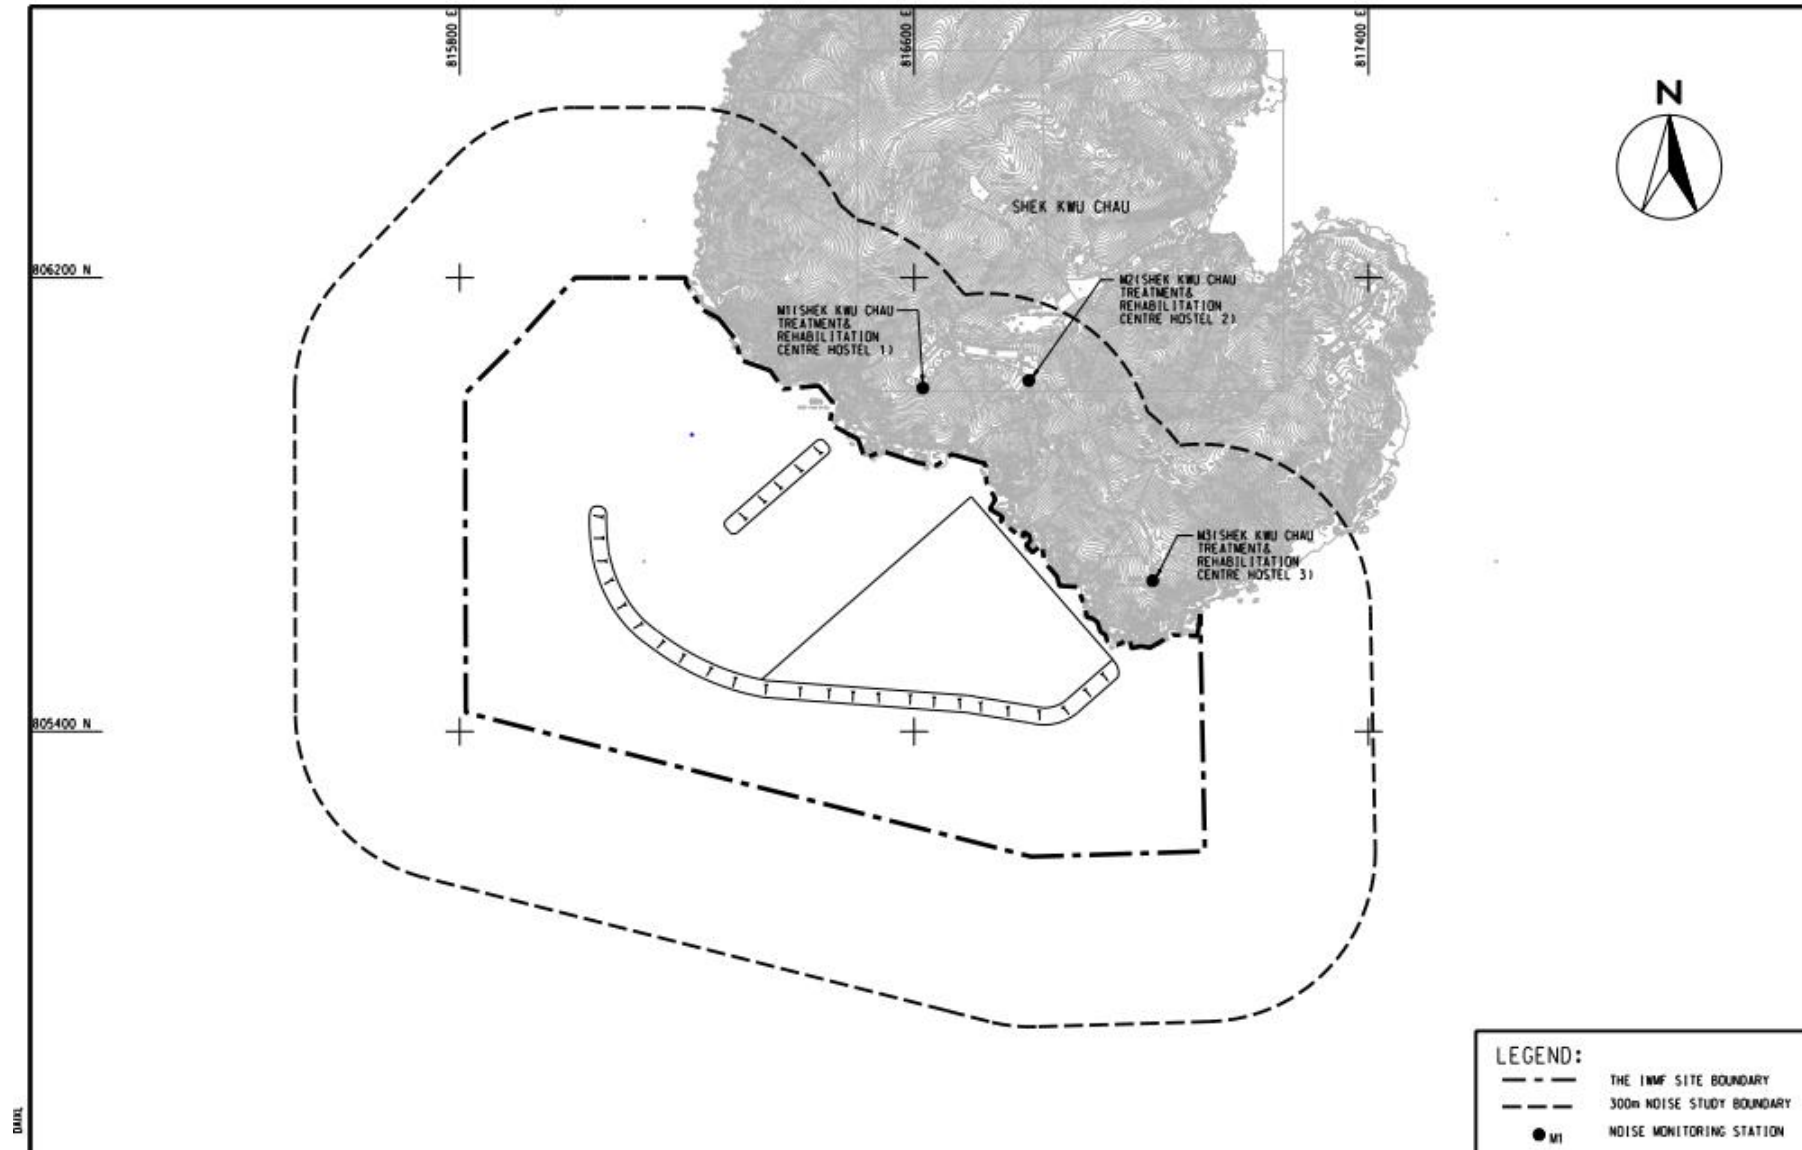
Figure 3.1 Noise monitoring locations at SKC

3.3.1 Three noise monitoring locations for impact monitoring at the nearby sensitive receivers are shown in **Figure 3.1**

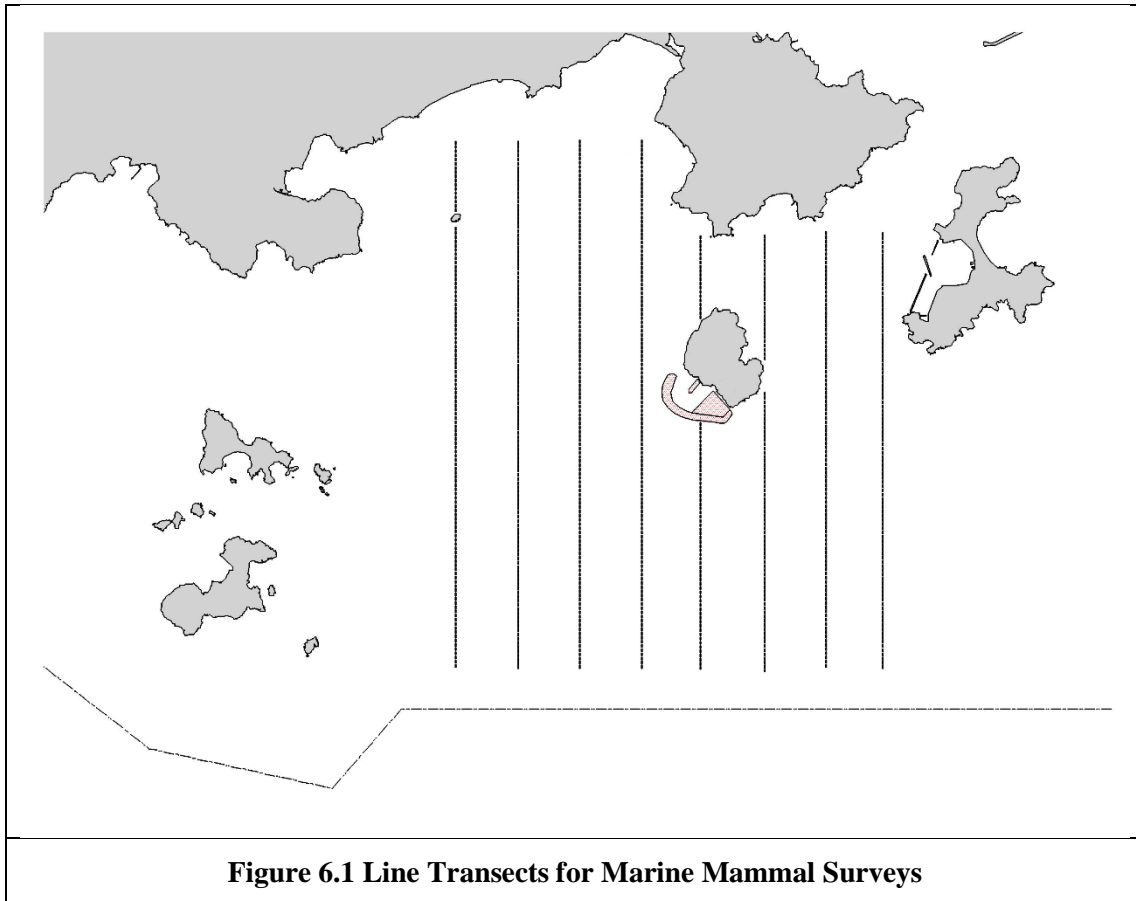
Eight transect lines are set at Southeast Lantau survey area, including Shek Kwu Chau, waters between Shek Kwu Chau and the Soko Islands, inshore waters of Lantau Island (e.g. Pui O Wan) as well as southwest corner of Cheung Chau as shown in **Figure 6.1** below:

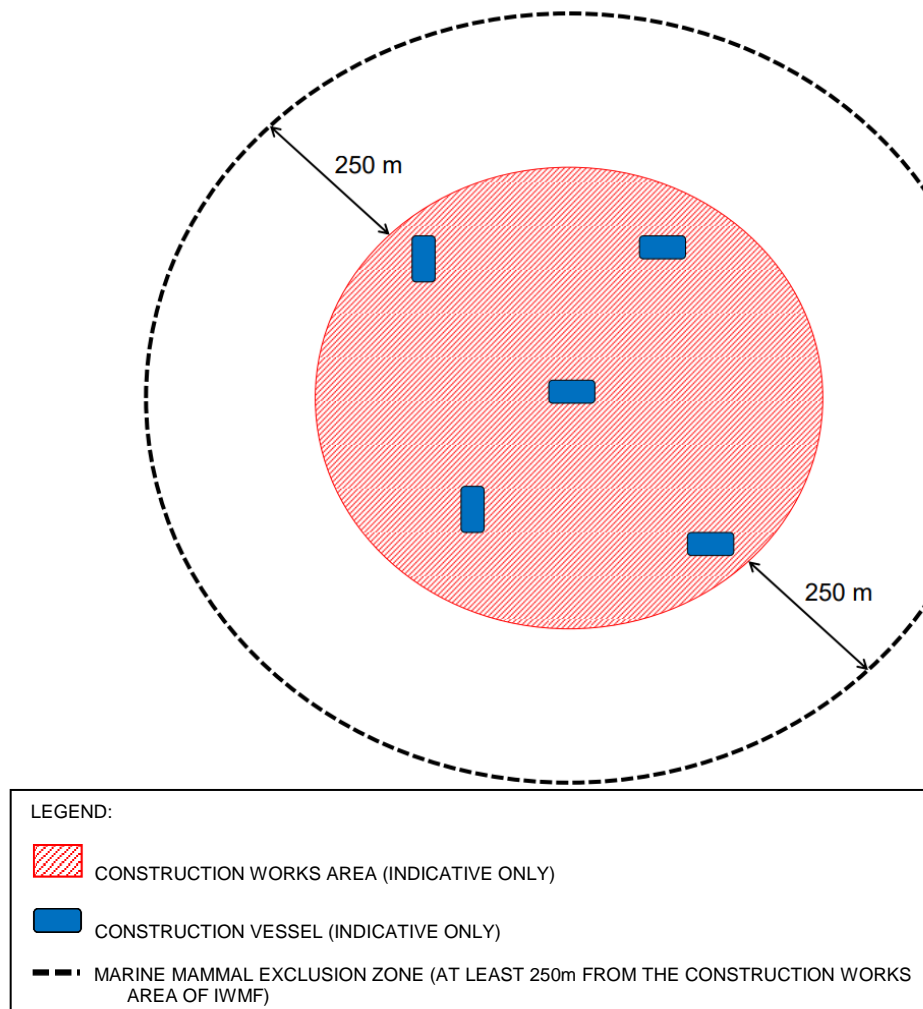
Figure 6.4 Illustration of Typical MMEZ

During the installation/re-installation/relocation process of floating type silt curtains, in order to avoid the accidental entrance and entrapment of marine mammals within the silt curtains, a monitored exclusion zone of 250 m radius from silt curtain should be implemented. The exclusion zone should be closely monitored by an experienced marine mammal observer (MMO) for at least 30 minutes before the start of installation/re-installation/relocation process. If a marine mammal is noted within the exclusion zone, all marine works should stop immediately and remain idle for 30 minutes, or until the exclusion zone is free from marine mammals. The experienced marine mammal observer should be well trained to detect marine mammals. Binoculars should be used to search the exclusion zone from an elevated platform with unobstructed visibility. The marine mammal observer(s) shall be independent of the construction contractor and shall form part of the Environmental Team and have the power to call-off construction activities.

A MMEZ with 250 m distance from the boundary of a work area shall be established during the above situation. A typical MMEZ is indicated in **Figure 6.4** for reference. The MMEZ serves as a monitoring approach to provide appropriate and immediate actions once finless porpoise or Chinese White Dolphin is sighted within the MMEZ. All MMEZ will be monitored by competent Marine Mammal Observers (MMOs) to be provided by the Environmental Team (ET) for the IWMF and trained by the Marine Mammal Monitoring Specialist of the ET who is independent from JV.

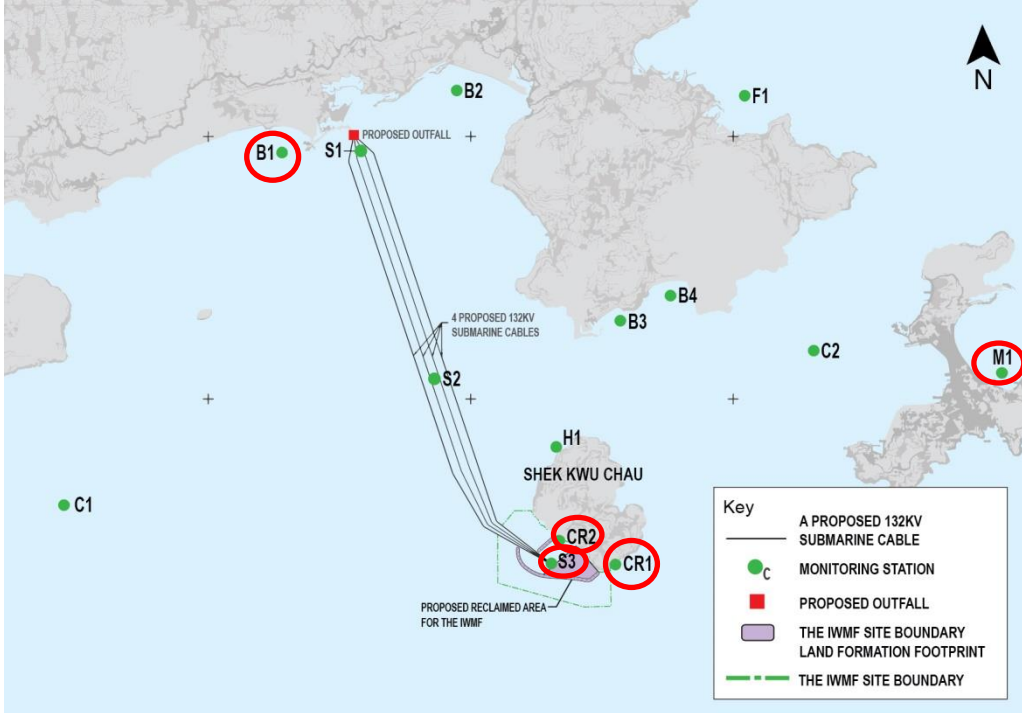
<p>Monitoring Location</p>	<p>B1, M1, CR1, CR2 & S3</p>

<p>Parameter</p>	<p>Suspended Solid (SS)</p>		
<p>Action & Limit Levels</p>	<p>Action Level $\geq 10.6 \text{ mg/L}$ (120% of C2)</p>		<p>Limit Level $\geq 11.4 \text{ mg/L}$ (130% of C2)</p>
<p>Measurement Level</p>	<p>Impact Station(s) with Exceedance</p> <p>12.5 mg/L (B1) 13.5 mg/L (M1) 12.5 mg/L (CR1) 12.5 mg/L (CR2) 12.5 mg/L (S3)</p>	<p>Control Stations</p> <p>14.0 mg/L (C1) 8.8 mg/L (C2)</p>	<p>Impact Station(s) without Exceedance</p> <p>10.0 mg/L (B2) 6.8 mg/L (B3) 8.8 mg/L (B4) 6.8 mg/L (F1) 10.0 mg/L (H1) 8.5 mg/L (S1) 8.8 mg/L (S2)</p>
<p>Possible reason for Action or Limit Level Non-compliance</p>	<p>Works scheduled on site on 20/9 include ground investigation (GI) work of one borehole drilling, one sample coring and DCM injection for static loading test.</p> <p>Dominating sea current direction was found to be from Southeast to Northwest at waters around Shek Kwu Chau.</p> <p>B1 and M1 are located at unrelated stream direction (neither upstream nor downstream, far away) to the works location, exceedance of these monitoring locations are deemed to be unrelated to the Project.</p> <p>CR1, CR2 and S3 are located close to the Project site. Installation of DCM clusters was commenced, while no observation of silt plume was made during the sampling event.</p> <p>When comparing the monitoring results of the Wet Season Baseline conducted from Aug 2018 to Sep 2018 as detailed in the Baseline Monitoring Report (Rev. C), 95 percentile (12 mg/L) and 99 percentile (14 mg/L) of the SS baseline results demonstrated that the concerned SS exceedances have lied in the range of possible natural fluctuation of background SS level in wet season.</p>

<p>Actions taken / to be taken</p>	<p>Rectification actions regarding to the improper implementation of silt curtain system shall be carried out immediately, it is suggested by ET that environmental department of the Contractor shall provide proper training to their frontline staffs on the correct silt curtain deployment/checking procedure, especially on the use of silt curtain checklist and record keeping.</p> <p>The contractor has also been reminded that all measures recommended in the deposited Silt Curtain Deployment Plan shall be fully and properly implemented for the Project as per Clause 2.6A of the FEP.</p>
<p>Remarks</p>	<p>Current direction during mid-flood sampling on 20/9:</p>

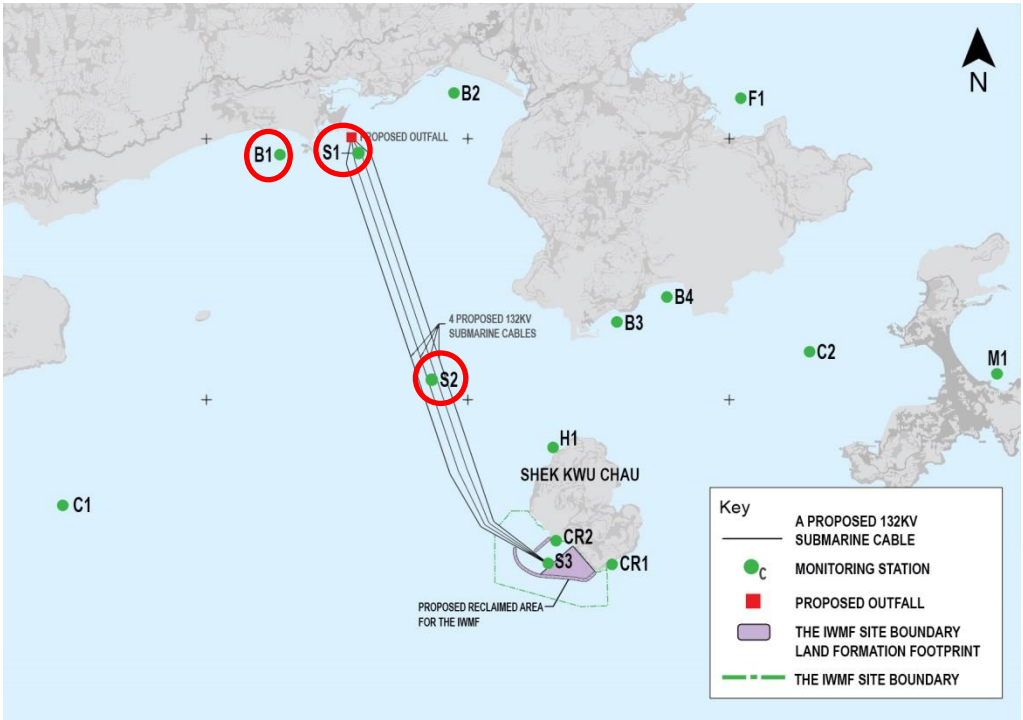
Project	Integrated Waste Management Facilities, Phase 1		
Date	27 September 2018 (Lab result received on 3 October 2018)		
Time	11:52 – 15:22 (Mid-Ebb)		
Monitoring Location	B1, S1 & S2

Parameter	Suspended Solid (SS)		
Action & Limit Levels	Action Level		Limit Level
	≥ 8.8 mg/L (120% of C1)		≥ 10 mg/L
Measurement Level	Impact Station(s) with Exceedance	Control Station	Impact Station(s) without Exceedance

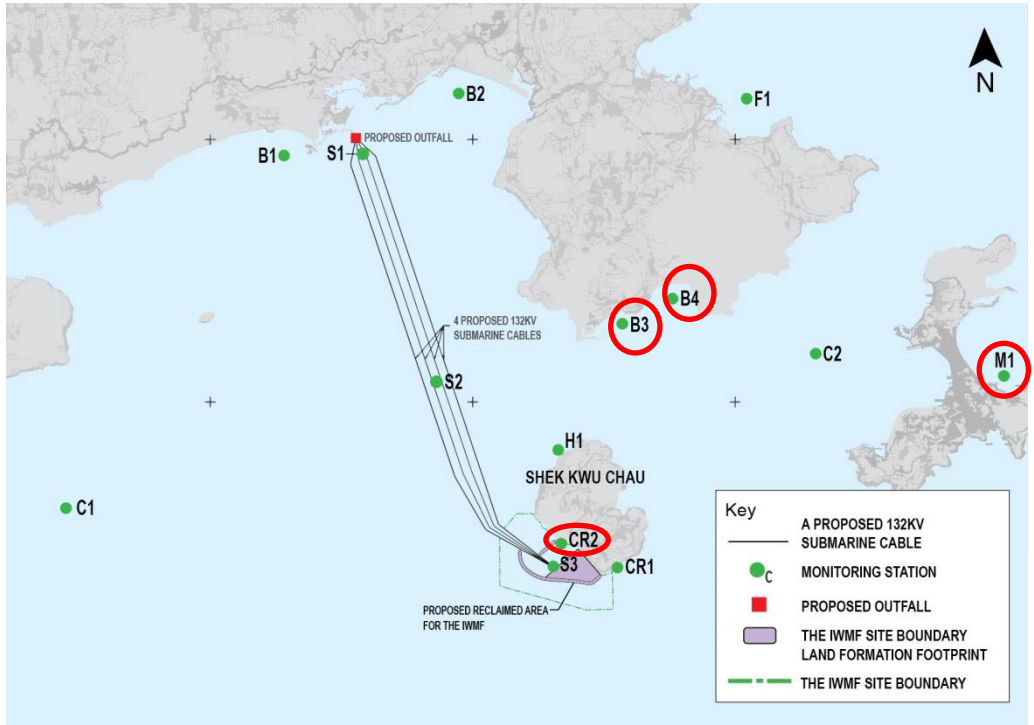
<p>The map shows the Shek Kwu Chau area with various monitoring stations marked by green dots. Stations B3, B4, and M1 are circled in red. A red square indicates the proposed outfall. A legend (Key) defines symbols: a line for a proposed 132KV submarine cable, a green dot for a monitoring station, a red square for a proposed outfall, a purple outline for the IWMF site boundary, and a green dashed line for the IWMF site boundary. Other labels include 'PROPOSED RECLAIMED AREA FOR THE IWMF' and 'SHEK KWU CHAU'.</p>
