Contract No. EP/SP/66/12
Integrated Waste Management Facilities, Phase 1

Monthly EM&A Report No.5 (Period from 1 November to 30 November 2018)

(Clause 3.3, Further Environmental Permit FEP-01/429/2012/A)

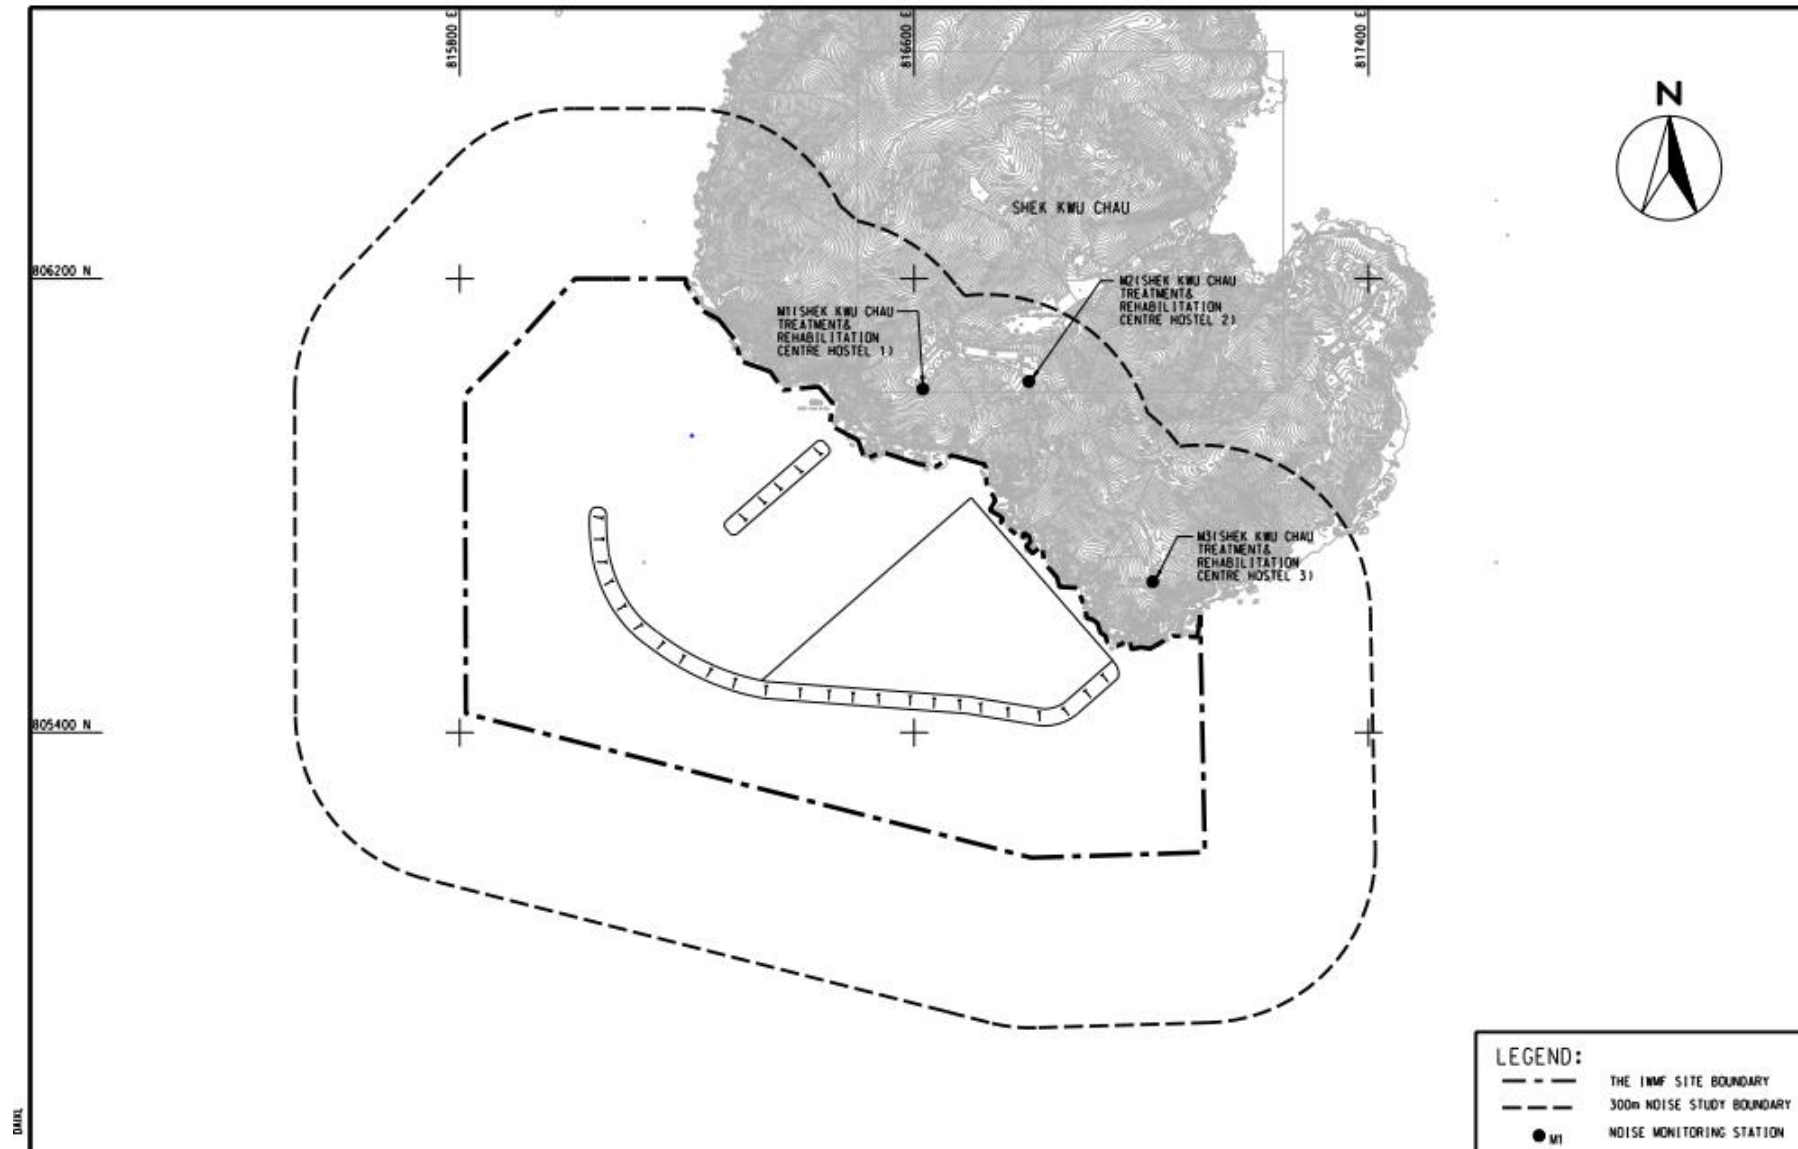
Figure 3.1 Noise monitoring locations at SKC

3.3.1 Three noise monitoring locations for impact monitoring at the nearby sensitive receivers are shown in **Figure 3.1**

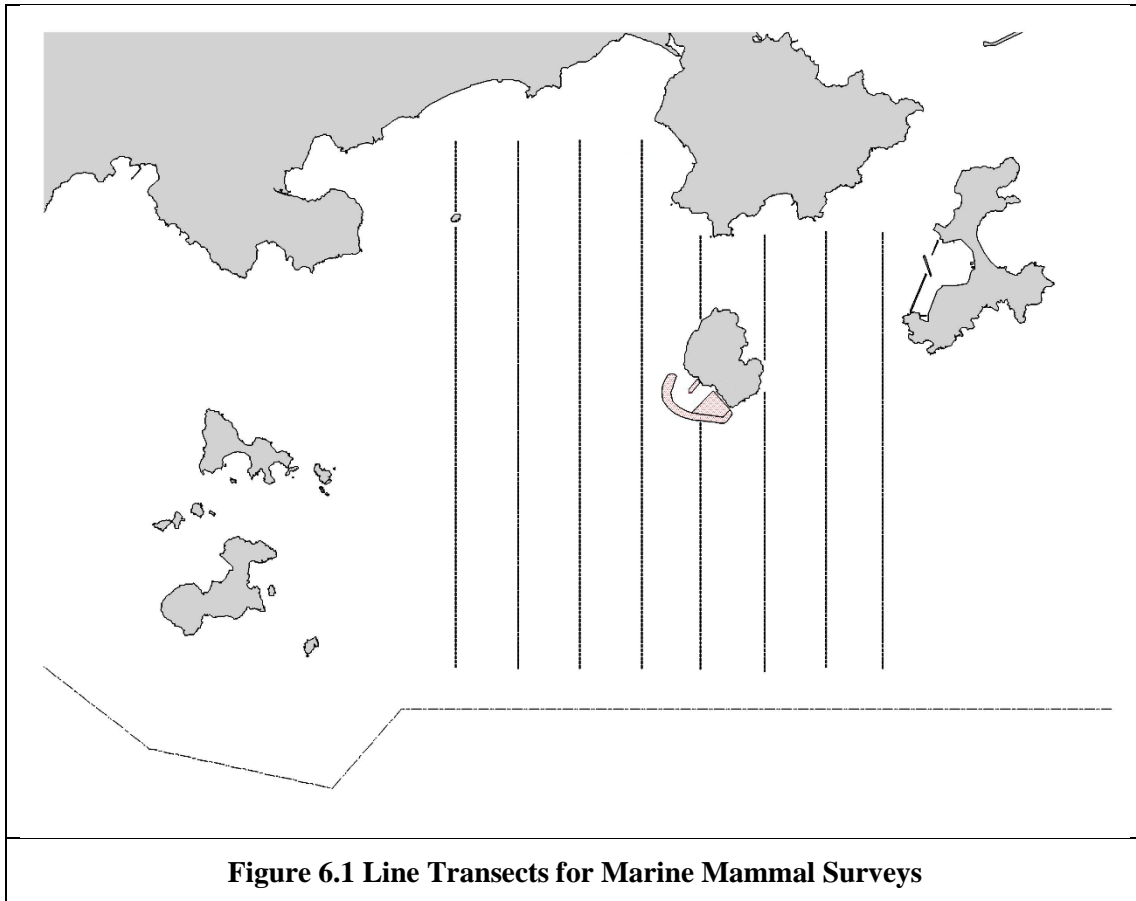
Eight transect lines are set at Southeast Lantau survey area, including Shek Kwu Chau, waters between Shek Kwu Chau and the Soko Islands, inshore waters of Lantau Island (e.g. Pui O Wan) as well as southwest corner of Cheung Chau as shown in **Figure 6.1** below:

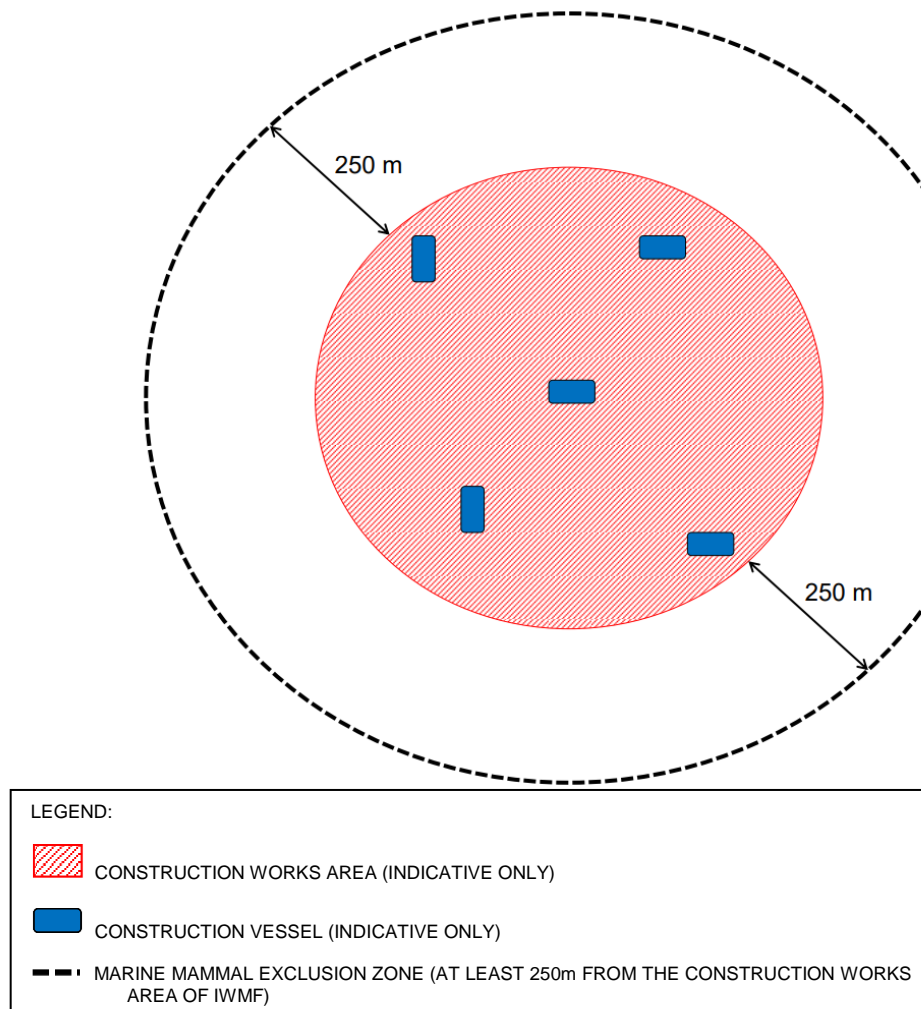
Figure 6.4 Illustration of Typical MMEZ

A MMEZ with 250 m distance from the boundary of a work area shall be established during the above situation. A typical MMEZ is indicated in **Figure 6.4** for reference. The MMEZ serves as a monitoring approach to provide appropriate and immediate actions once finless porpoise or Chinese White Dolphin is sighted within the MMEZ. All MMEZ will be monitored by competent Marine Mammal Observers (MMOs) to be provided by the Environmental Team (ET) for the IWMF and trained by the Marine Mammal Monitoring Specialist of the ET who is independent from JV.

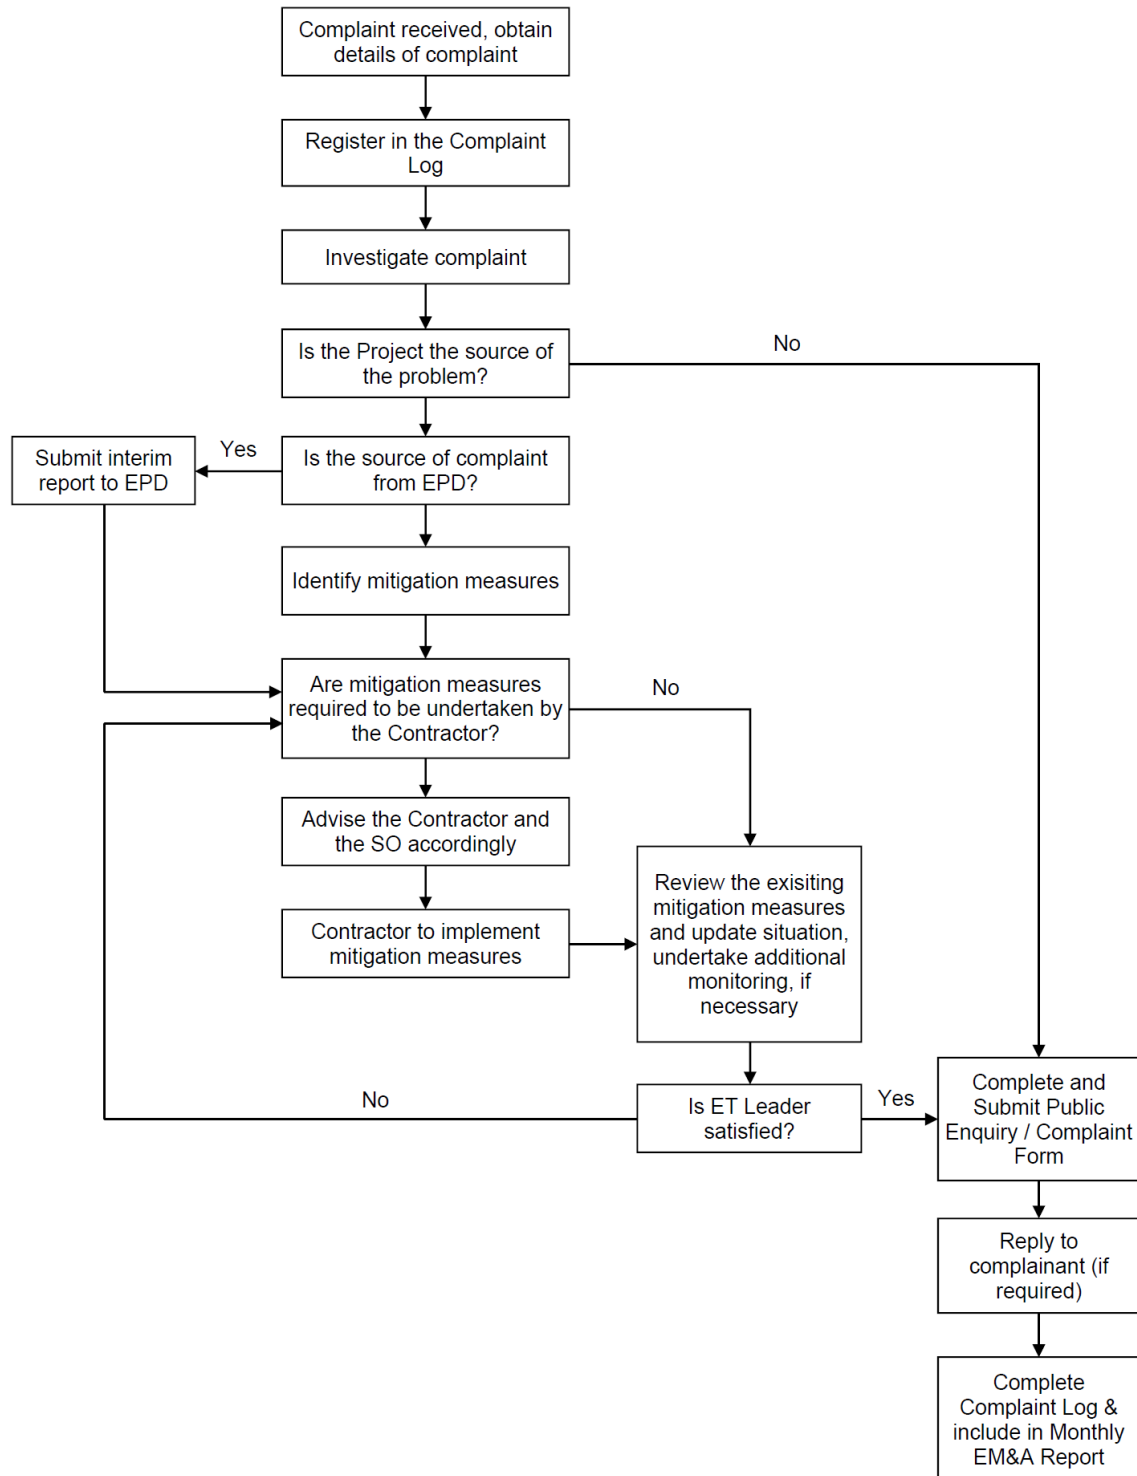
Figure 8.1 Environmental Complaint Handling Procedure

8.1 The Environmental Complaint Handling Procedure is shown in below **Figure 8.1**:

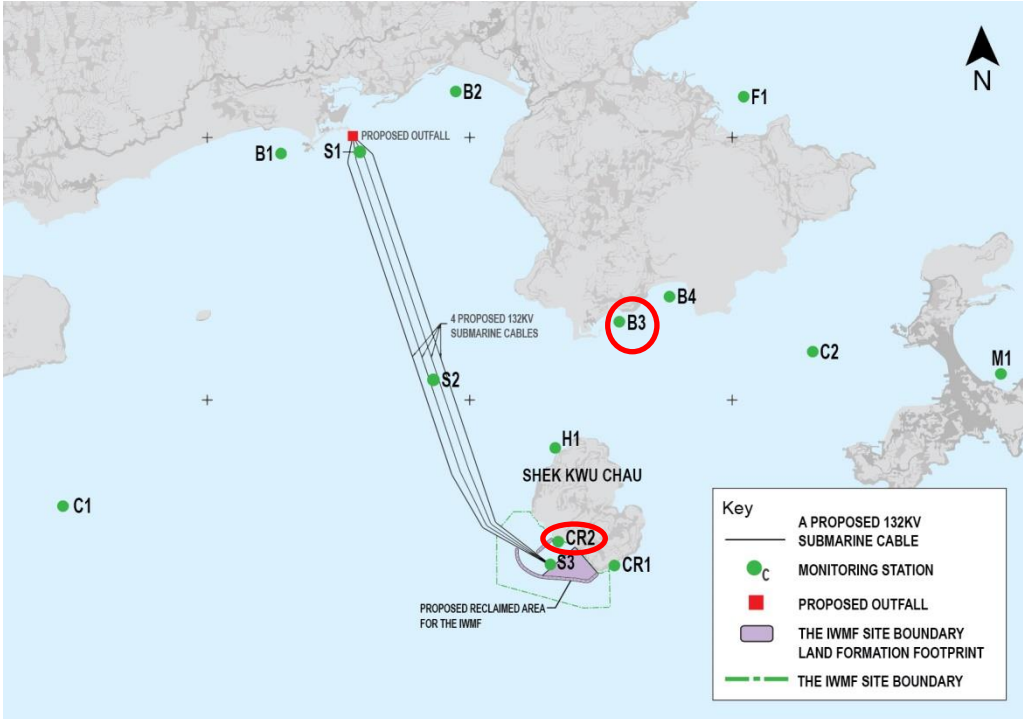
Parameter	Suspended Solid (SS)		
Action & Limit Levels	Action Level		Limit Level
	≥ 12.2 mg/L (120% of C2)		≥ 13.2 mg/L (130% of C2)
Measurement Level	Impact Station(s) of Exceedance	Control Stations	Impact Station(s) without Exceedance

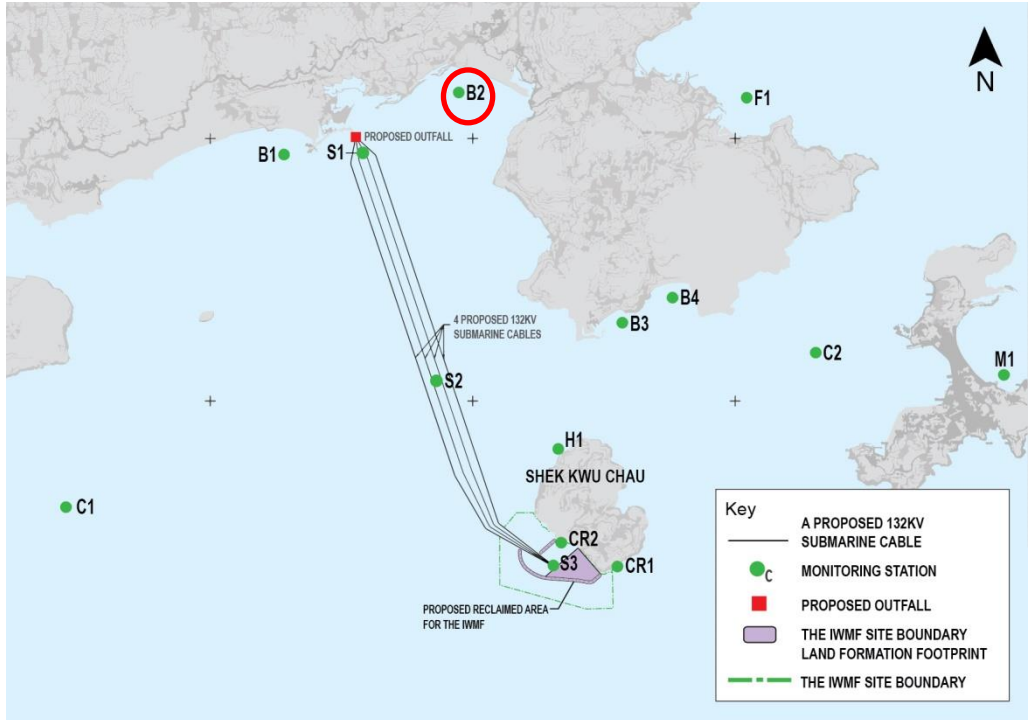
<p>The map shows the Shek Kwu Chau area with various monitoring stations marked with green dots: B1, B2 (circled in red), B3, B4, C1, C2, C3, F1, H1, M1, CR1, CR2, S1, S2, and S3. A red square indicates the proposed outfall. Four lines represent the proposed 132kV submarine cables. A purple shaded area shows the IWMF site boundary and land formation footprint. A green dashed line indicates the IWMF site boundary. A north arrow is present in the top right corner.</p>
