Contract No. EP/SP/66/12
Integrated Waste Management Facilities, Phase 1

Monthly EM&A Report No.5 (Period from 1 November to 30 November 2018)

(Clause 3.3, Further Environmental Permit FEP-01/429/2012/A)

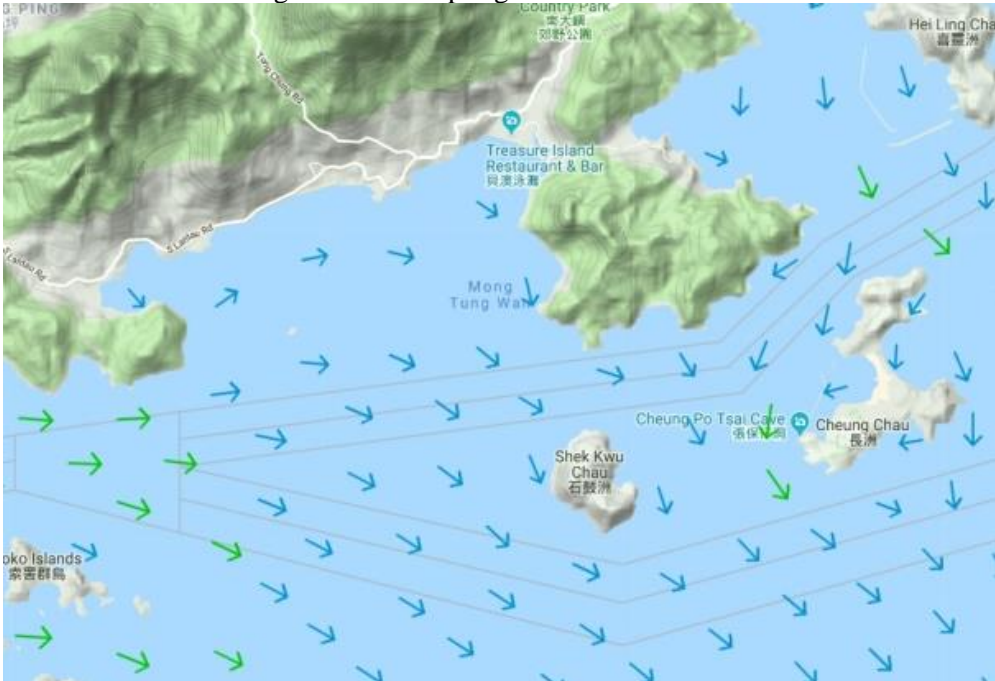
<p>unrelated to the Project.</p> <p>CR2 is located close to the works location within the Project site, while no observation of silt plume was made during the sampling event and absence of major SS source might suggest that SS exceedance at CR2 is deemed to be unrelated to the Project.</p> <p>Site tidiness in the present barges in the Project site were checked during weekly site inspection on 6/11, where no improper site practice that might contribute to the increase in SS level was observed during the inspection.</p>
<p>Actions taken / to be taken</p>	<p>Examination of environmental performance of the Project will be continued during the weekly inspection, and the Contractor is reminded to implement all applicable mitigation measures as per the Updated EM&A Manual.</p>
<p>Remarks</p>	<p>Note: Data with (*) are considered as reference use only since their sampling time were out of predicted tidal period.</p> <p>Current direction during mid-ebb sampling on 3/11:</p>
