Monthly EM&A Report No.5 (Period from 1 November to 30 November 2018)

(Clause 3.3, Further Environmental Permit FEP-01/429/2012/A)

- A1. The Project, Integrated Waste Management Facility (IWMF), is a Designated Project under the Environmental Impact Assessment Ordinance (Cap. 499) (EIAO) and is currently governed by a Further Environmental Permit (FEP No. FEP-01/429/2012/A) for the construction and operation of the Project.
- A2. In accordance with the Updated Environmental Monitoring and Audit (EM&A) Manual for the Project, EM&A works for marine water quality, noise, waste management and ecology should be carried out by Environmental Team (ET), Acuity Sustainability Consulting Limited (ASCL), during the construction phase of the Project.
- A3. This is the 5th Monthly EM&A Report, prepared by ASCL, for the Project summarizing the monitoring results and audit findings of the EM&A programme at and around Shek Kwu Chau (SKC) during the reporting period from 1 November 2018 to 30 November 2018.

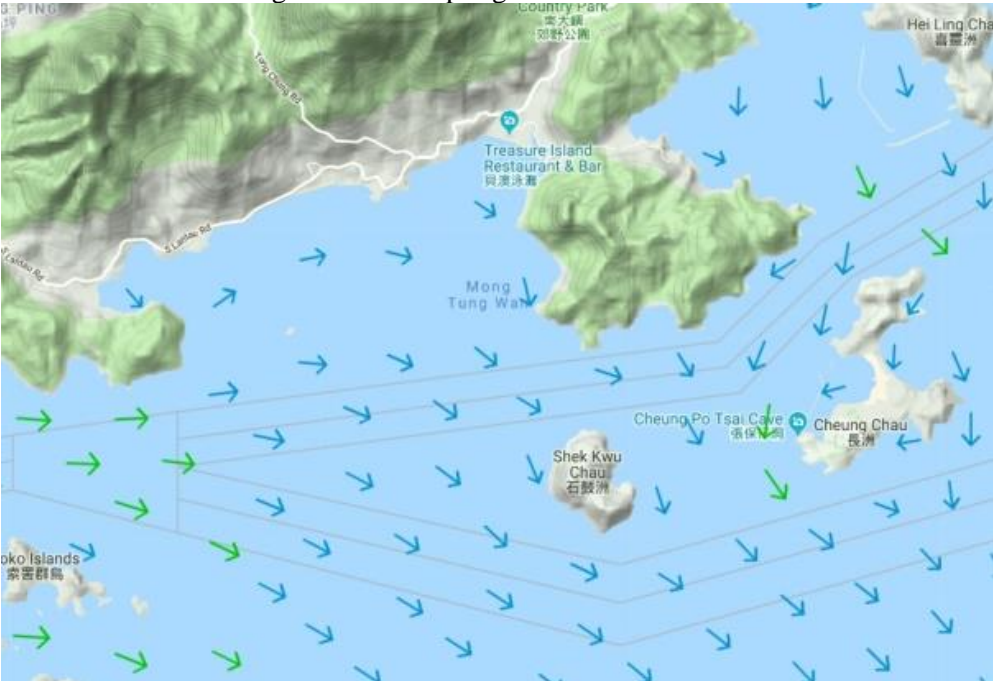
<p>unrelated to the Project.</p> <p>CR2 is located close to the works location within the Project site, while no observation of silt plume was made during the sampling event and absence of major SS source might suggest that SS exceedance at CR2 is deemed to be unrelated to the Project.</p> <p>Site tidiness in the present barges in the Project site were checked during weekly site inspection on 6/11, where no improper site practice that might contribute to the increase in SS level was observed during the inspection.</p>
<p>Actions taken / to be taken</p>	<p>Examination of environmental performance of the Project will be continued during the weekly inspection, and the Contractor is reminded to implement all applicable mitigation measures as per the Updated EM&A Manual.</p>
<p>Remarks</p>	<p>Note: Data with (*) are considered as reference use only since their sampling time were out of predicted tidal period.</p> <p>Current direction during mid-ebb sampling on 3/11:</p>

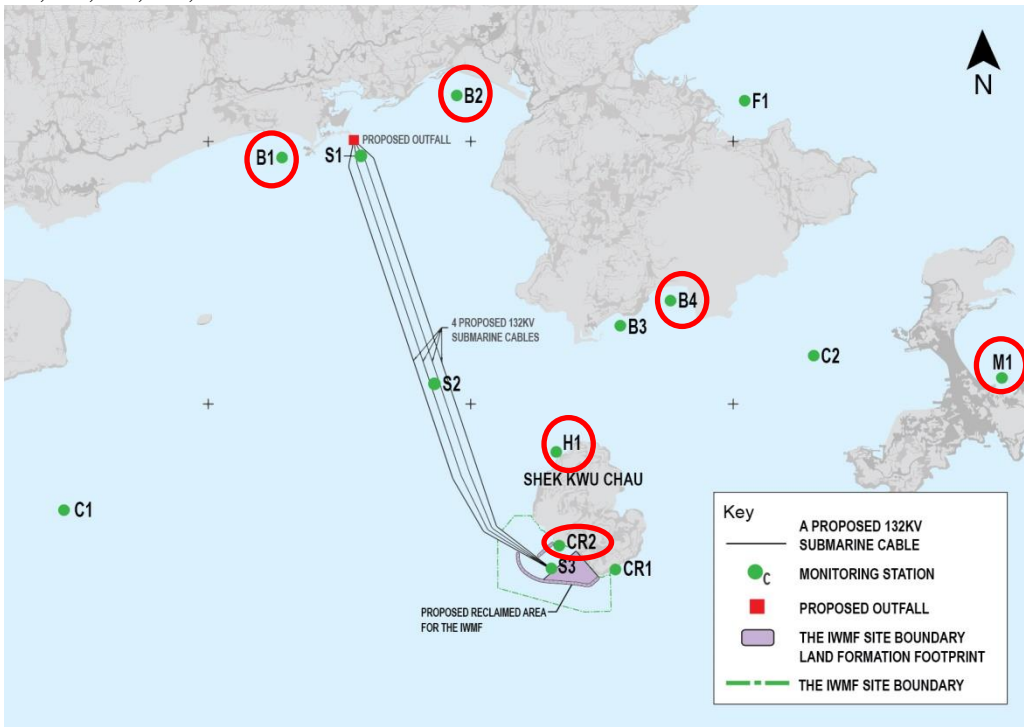
Project	Integrated Waste Management Facilities, Phase 1		
Date	9 November 2018 (Lab result received on 14 November 2018)		
Time	11:48 – 15:40 (Mid-Ebb) 17:09 – 20:54 (Mid-Flood)		
Mid-Ebb			
Monitoring Location	B1, B2, B4, H1, M1 & CR2

Parameter	Suspended Solid (SS)		
Action & Limit Levels	Action Level		Limit Level
	≥ 9.4 mg/L (120% of C1)		≥ 10.2 mg/L (130% of C1)
Measurement Level	Impact Station(s) with Exceedance	Control Stations	Impact Station(s) without Exceedance
