## Monthly EM&A Report No.6 (Period from 1 December to 31 December 2018)

*(Clause 3.3, Further Environmental Permit FEP-01/429/2012/A)*

- A1. The Project, Integrated Waste Management Facility (IWMF), is a Designated Project under the Environmental Impact Assessment Ordinance (Cap. 499) (EIAO) and is currently governed by a Further Environmental Permit (FEP No. FEP-01/429/2012/A) for the construction and operation of the Project.
- A2. In accordance with the Updated Environmental Monitoring and Audit (EM&A) Manual for the Project, EM&A works for marine water quality, noise, waste management and ecology should be carried out by Environmental Team (ET), Acuity Sustainability Consulting Limited (ASCL), during the construction phase of the Project.
- A3. This is the 6<sup>th</sup> Monthly EM&A Report, prepared by ASCL, for the Project summarizing the monitoring results and audit findings of the EM&A programme at and around Shek Kwu Chau (SKC) during the reporting period from 1 December 2018 to 31 December 2018.

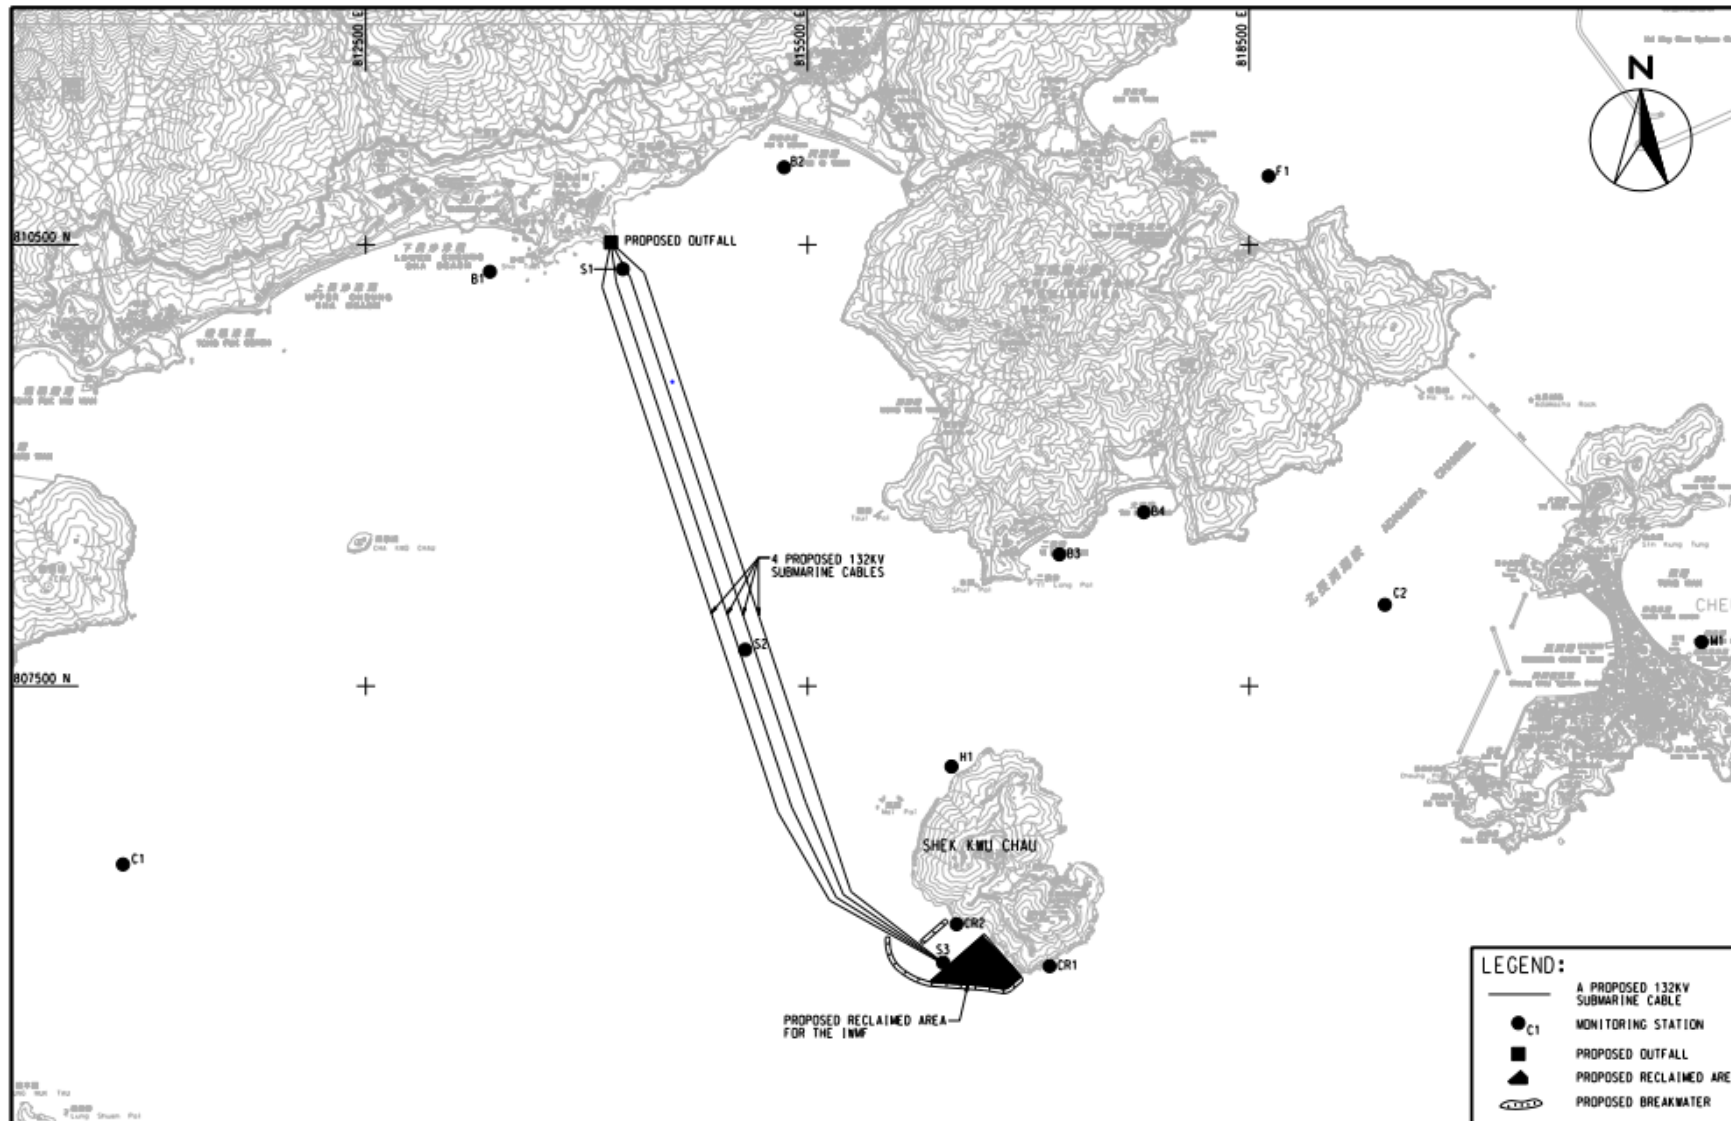
Figure 2.1 Water monitoring locations at Artificial Island near SKC

2.3.1 Impact water quality monitoring was conducted at eleven monitoring locations (B1-B4, H1, C1, C2, F1, CR1, CR2 & M1) during general water quality monitoring and was conducted at fourteen water monitoring locations (B1-B4, H1, C1, C2, F1, S1-S3, CR1, CR2 & M1) during regular DCM monitoring, as shown in **Figure 2.1**.

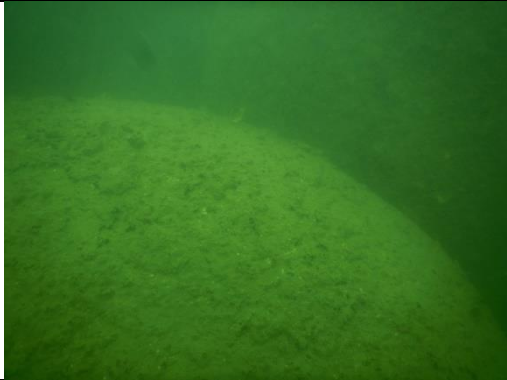
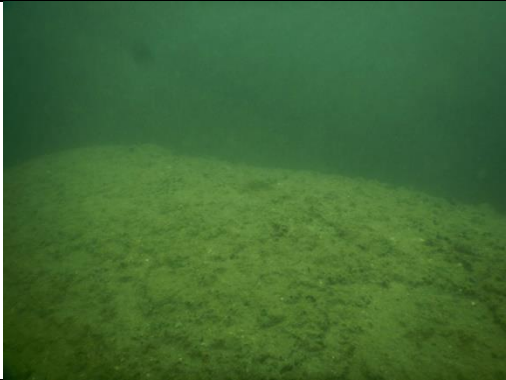
**Photo Plate 5.4 Representative photo records during the REA survey**

- 5.6.8 Since all missing tagged coral colonies was caused by the Super Typhoon Mangkhut, the AL/LL limit level will not be applied at this time.
- 5.6.9 The REA survey was carried out in on 3 December 2018 in the Indirect Impact Site. Only three species of hard coral were recorded during the survey and most of them are in fair condition after the typhoon. Some common coral colonies still appeared in shallow water which are suitable for re-tagging during the construction phase monitoring. All the coral colonies recorded along the transect were all common hard coral species in Hong Kong (**Photo Plate 5.4**).

species of hard coral were recorded. The abundance of hard coral species recorded along the transect was shown in **Table 5.16**. Besides, some invertebrates such as common sea snail: *Thais luteostoma*, Sea urchins: *Anthocidaris crassispina* and common green mussel: *Septifer virgatus* were found at the surface of the boulders.

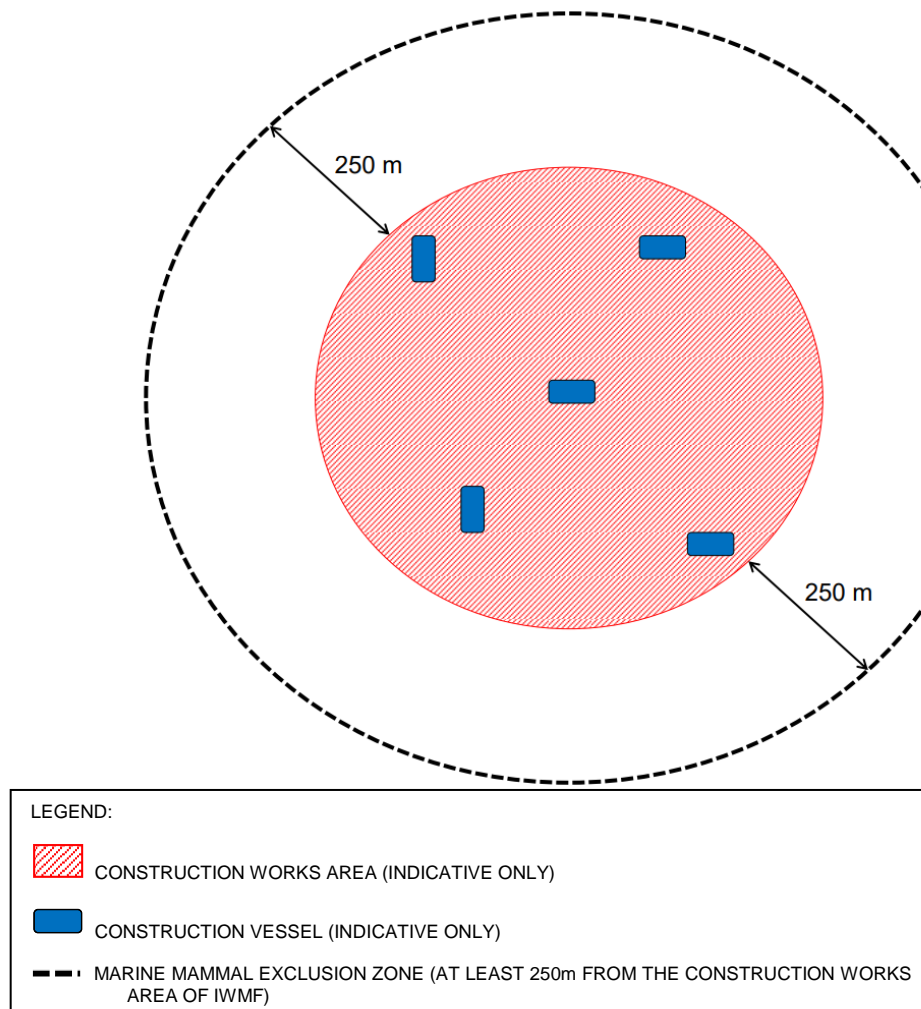
**Figure 6.4 Illustration of Typical MMEZ**

A MMEZ with 250 m distance from the boundary of a work area shall be established during the above situation. A typical MMEZ is indicated in **Figure 6.4** for reference. The MMEZ serves as a monitoring approach to provide appropriate and immediate actions once finless porpoise or Chinese White Dolphin is sighted within the MMEZ. All MMEZ will be monitored by competent Marine Mammal Observers (MMOs) to be provided by the Environmental Team (ET) for the IWMF and trained by the Marine Mammal Monitoring Specialist of the ET who is independent from JV.

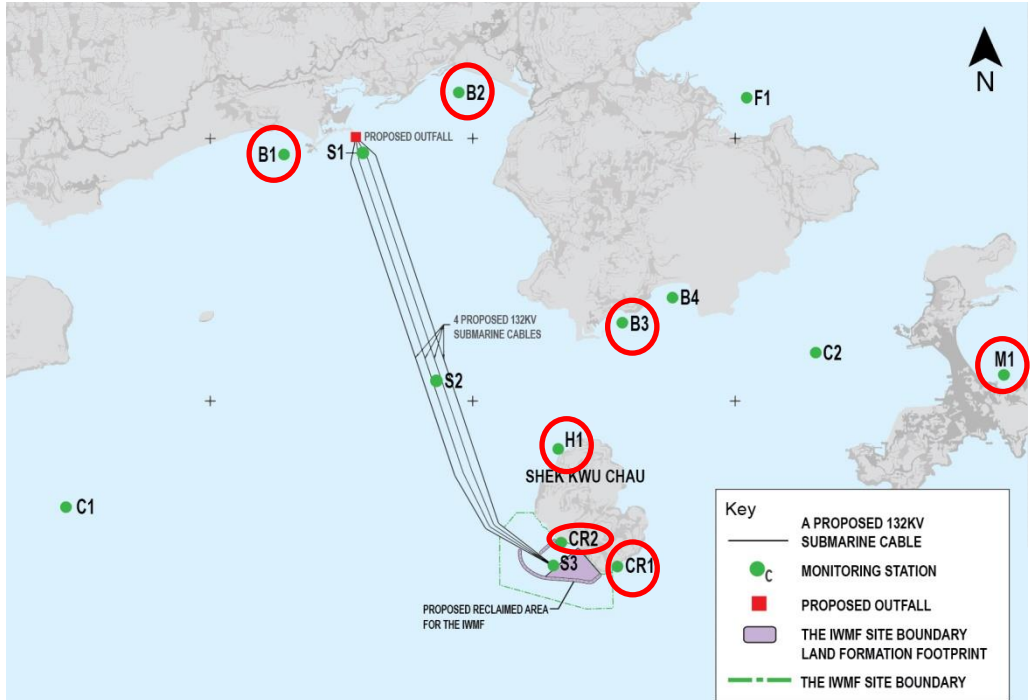
<p>The map shows the Shek Kwu Chau area with various monitoring stations marked. Stations B1, B2, B3, H1, M1, CR1, and CR2 are circled in red. A proposed outfall (S1) and four proposed 132KV submarine cables are shown extending from the land towards the sea. The IWMF site boundary and footprint are also indicated. A key in the bottom right corner defines the symbols used on the map.</p>
