Contract No. EP/SP/66/12

Integrated Waste Management Facilities, Phase 1

Monthly EM&A Report No.6 (Period from 1 December to 31 December 2018)

(Clause 3.3, Further Environmental Permit FEP-01/429/2012/A)

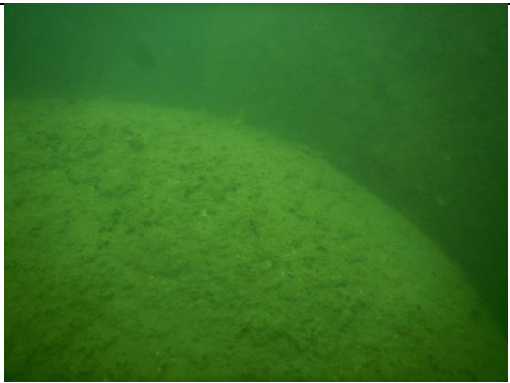
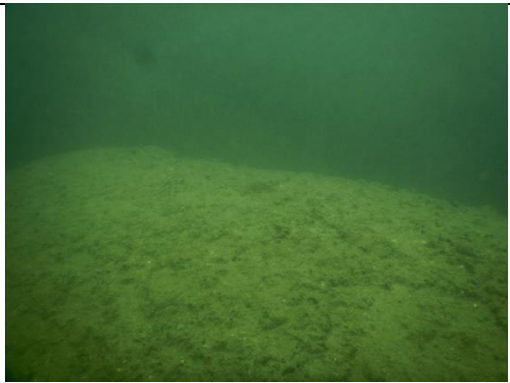
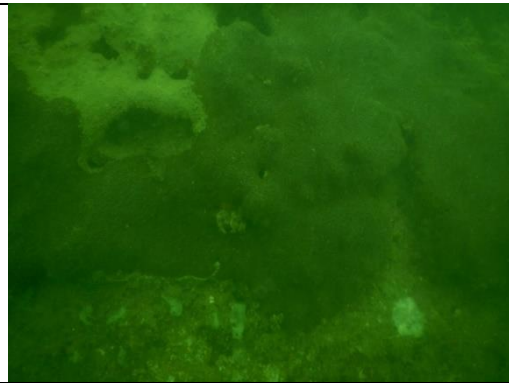
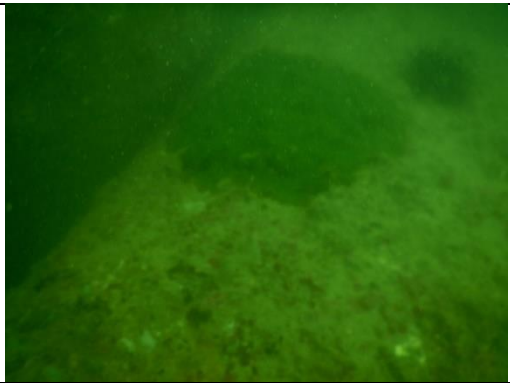
Photo Plate 5.4 Representative photo records during the REA survey

Big Boulders

<i>Anthocidaris crassispina</i>	<i>Septifer virgatus</i>

<i>Psammocora superficialis</i>

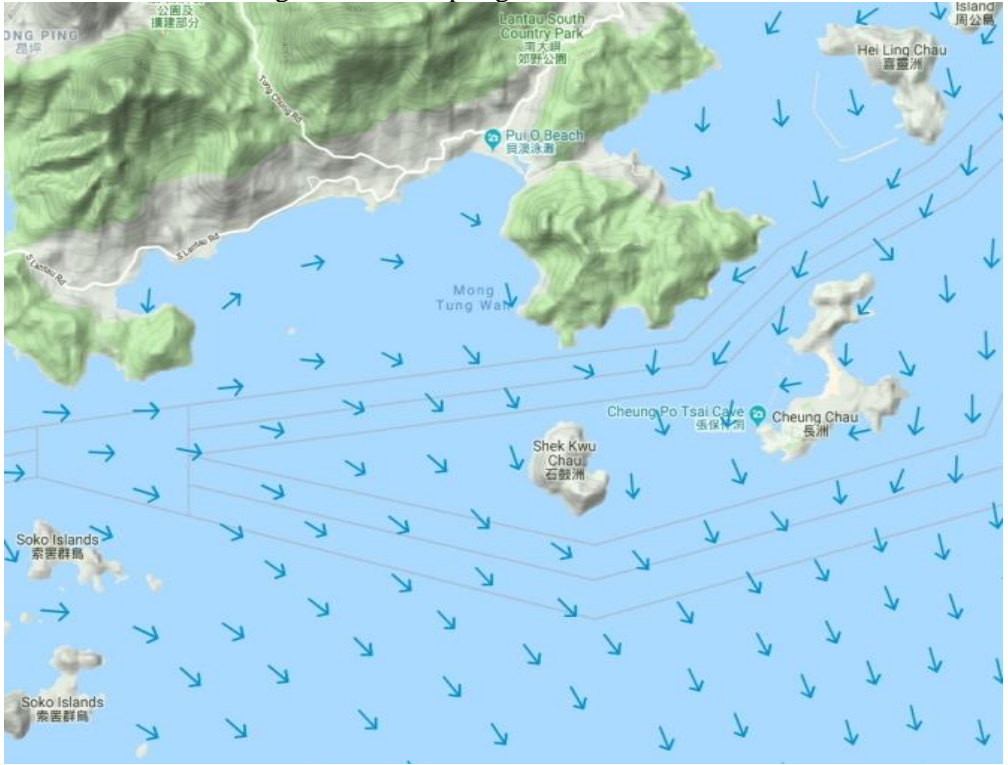
<p>Current direction during mid-flood sampling on 17/12:</p>
