吉寶西格斯 - 振華聯營公司
KEPPEL SEGHERS - ZHEN HUA JOINT VENTURE

Monthly EM&A Report No.7 (Period from 1 January to 31 January 2019)

(Clause 3.3, Further Environmental Permit FEP-01/429/2012/A)

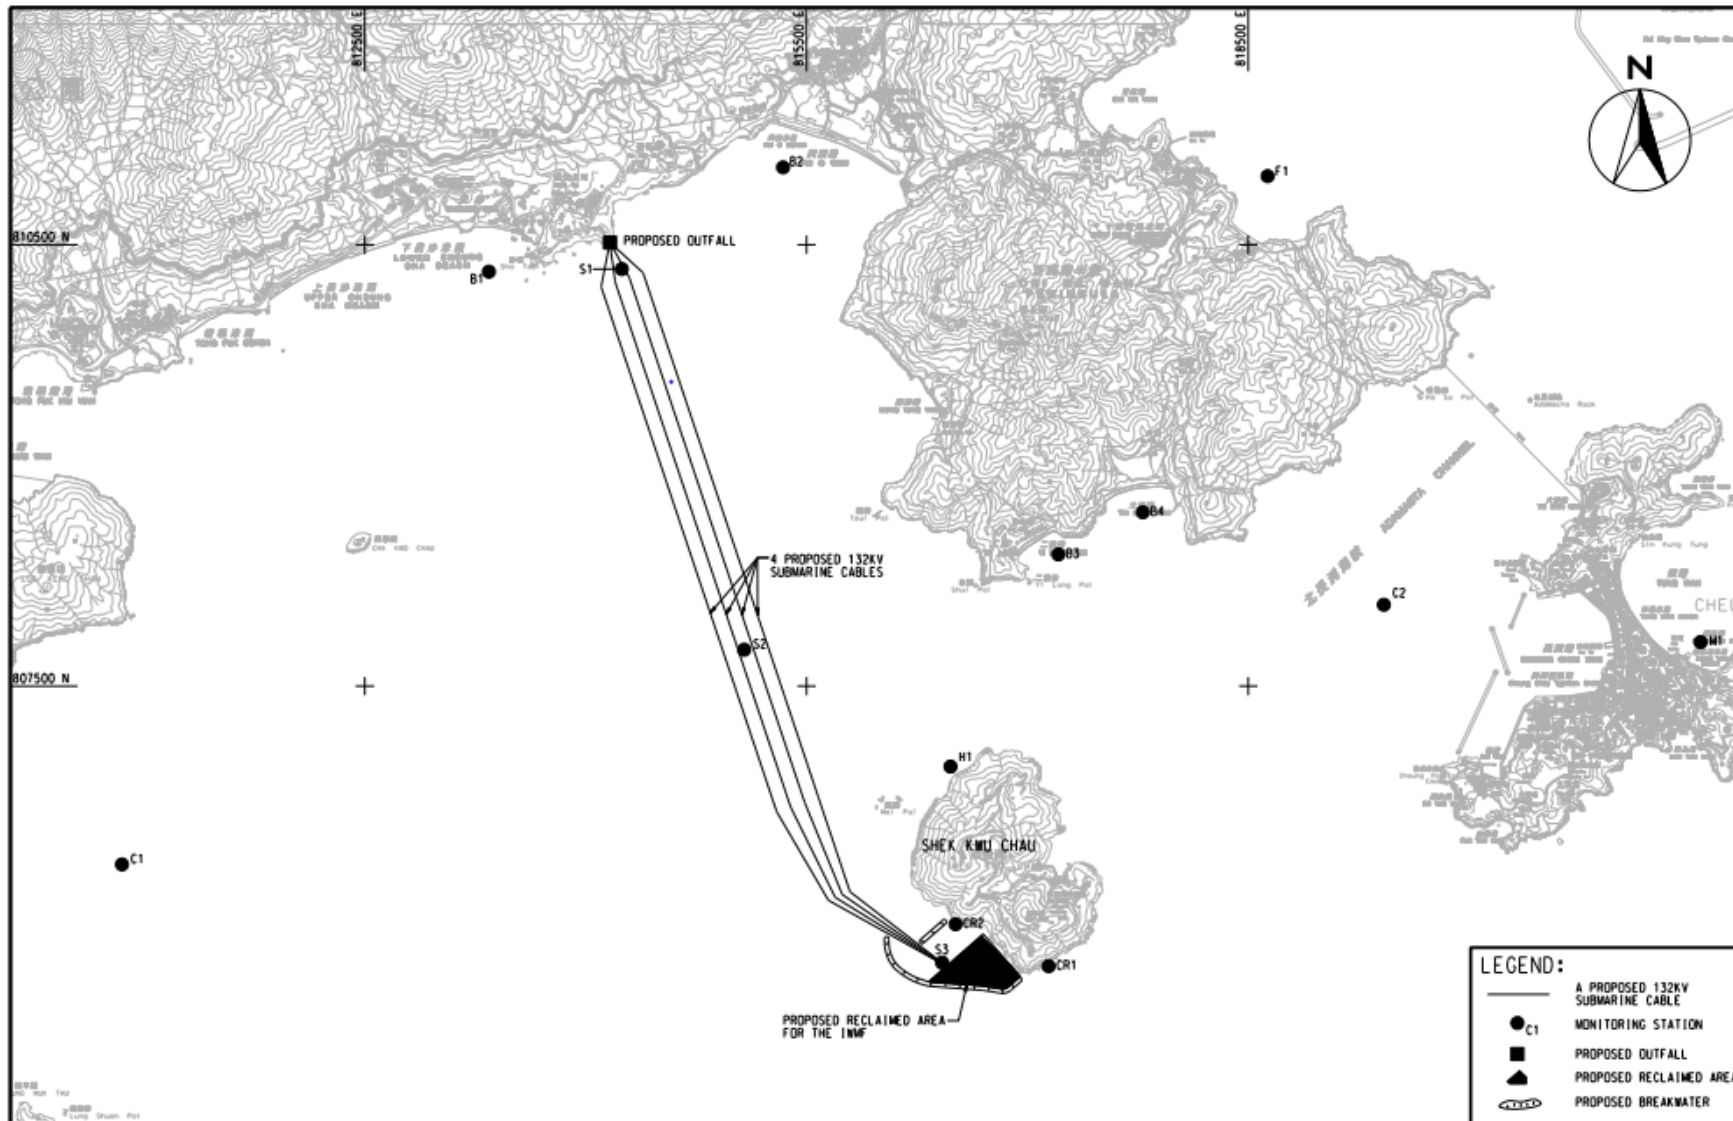
Figure 2.1 Water monitoring locations at Artificial Island near SKC

2.3.1 Impact water quality monitoring was conducted at eleven monitoring locations (B1-B4, H1, C1, C2, F1, CR1, CR2 & M1) during general water quality monitoring and was conducted at fourteen water monitoring locations (B1-B4, H1, C1, C2, F1, S1-S3, CR1, CR2 & M1) during regular DCM monitoring, as shown in **Figure 2.1**.

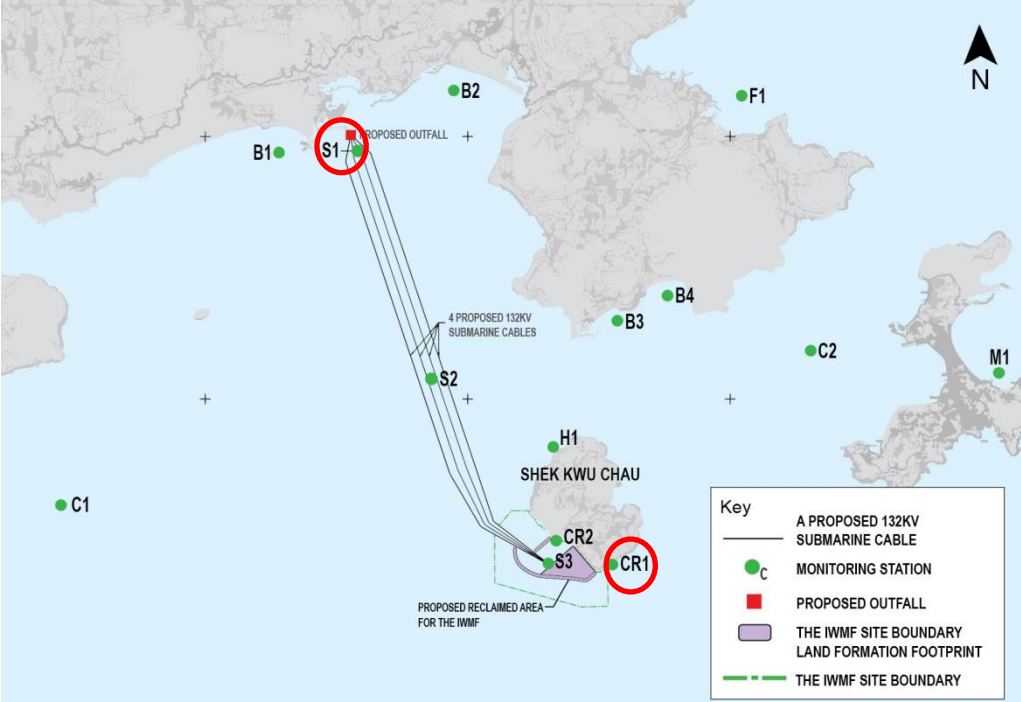
<p>The map shows the Shek Kwu Chau area with various monitoring stations marked with green dots: B1, B2, B3, B4, C1, C2, F1, H1, M1, CR1, CR2, S1, S2, and S3. A red square indicates the proposed outfall. Four lines represent the proposed 132KV submarine cables. A purple shaded area shows the IWMF site boundary, and a green dashed line shows the IWMF site boundary. CR1 and S1 are circled in red. A key in the bottom right corner defines the symbols: A PROPOSED 132KV SUBMARINE CABLE (line), MONITORING STATION (green dot), PROPOSED OUTFALL (red square), THE IWMF SITE BOUNDARY LAND FORMATION FOOTPRINT (purple shaded area), and THE IWMF SITE BOUNDARY (green dashed line). A north arrow is also present.</p>		
<p>Parameter</p>	<p>Suspended Solid (SS)</p>		
<p>Action & Limit Levels</p>	<p>Action Level</p>		<p>Limit Level</p>
	<p>≥ 8.0 mg/L</p>		<p>≥ 10.0 mg/L</p>
