吉寶西格斯 - 振華聯營公司  
KEPPEL SEGHERS - ZHEN HUA JOINT VENTURE

# Quarterly EM&A Report No.1

## (Period from 28 June to 30 September 2018)

(Clause 3.3, Further Environmental Permit FEP-01/429/2012/A)

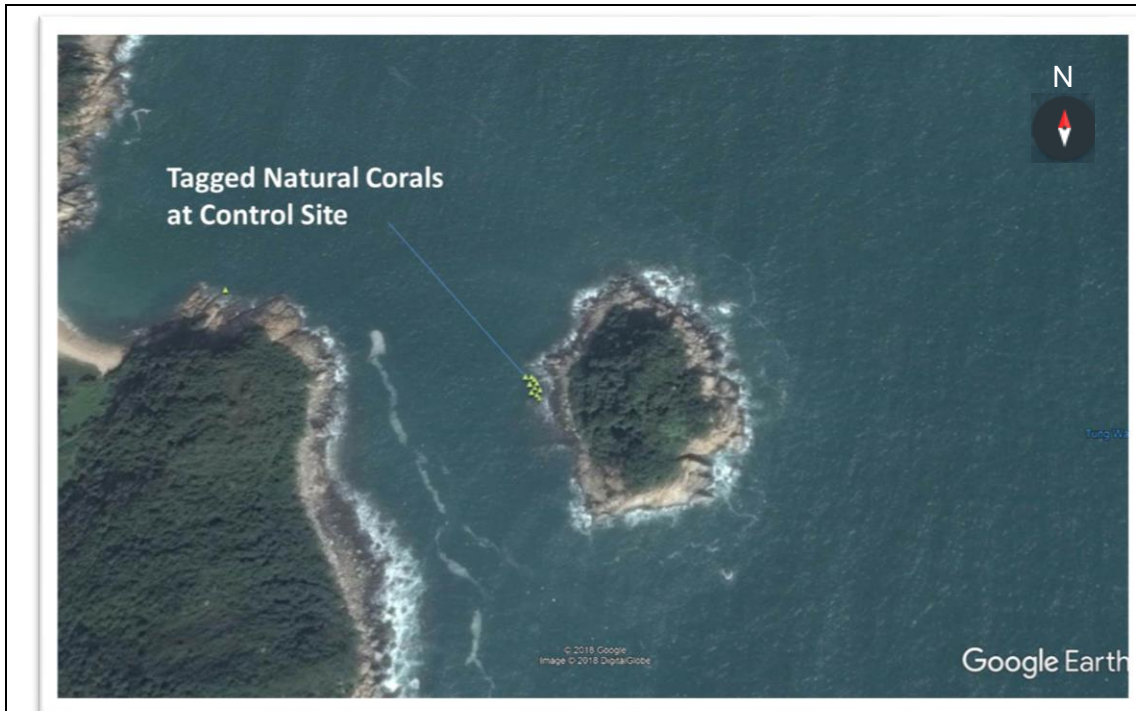
**Figure 5.2 Tagged Natural Corals at Control Site Near Yuen Kong Chau**

Location of the ten tagged coral colonies at each of the proposed indirect impact site, control site and the recipient site R3 are shown in **Figure 5.1**, **Figure 5.2** and **Figure 5.3** respectively:

- 5.4.7 All remaining tagged coral colonies at Control Site still showed either fair or good health condition during the Third Month Construction Phase Monitoring. Tagged coral #1 and #9 showed 5% of increased mortality of the whole colony, while tagged coral #3 and #6 showed increased sediment coverage of 10% and 5% respectively. There was not increased level of mortality, bleaching and sediment of the tagged colonies #4 and #8 when compared with the baseline results.

- 5.4.8 Since all tagged coral colonies at Indirect Impact Site and 4 tagged coral at Control Site were missing during the third month monitoring, it is suggested to re-tag all the missing corals. The re-tagging activity should be done before the next monitoring survey. As the missing tagged coral colonies were caused by the Super Typhoon Mangkhut, the AL/LL will not be applied at this time.

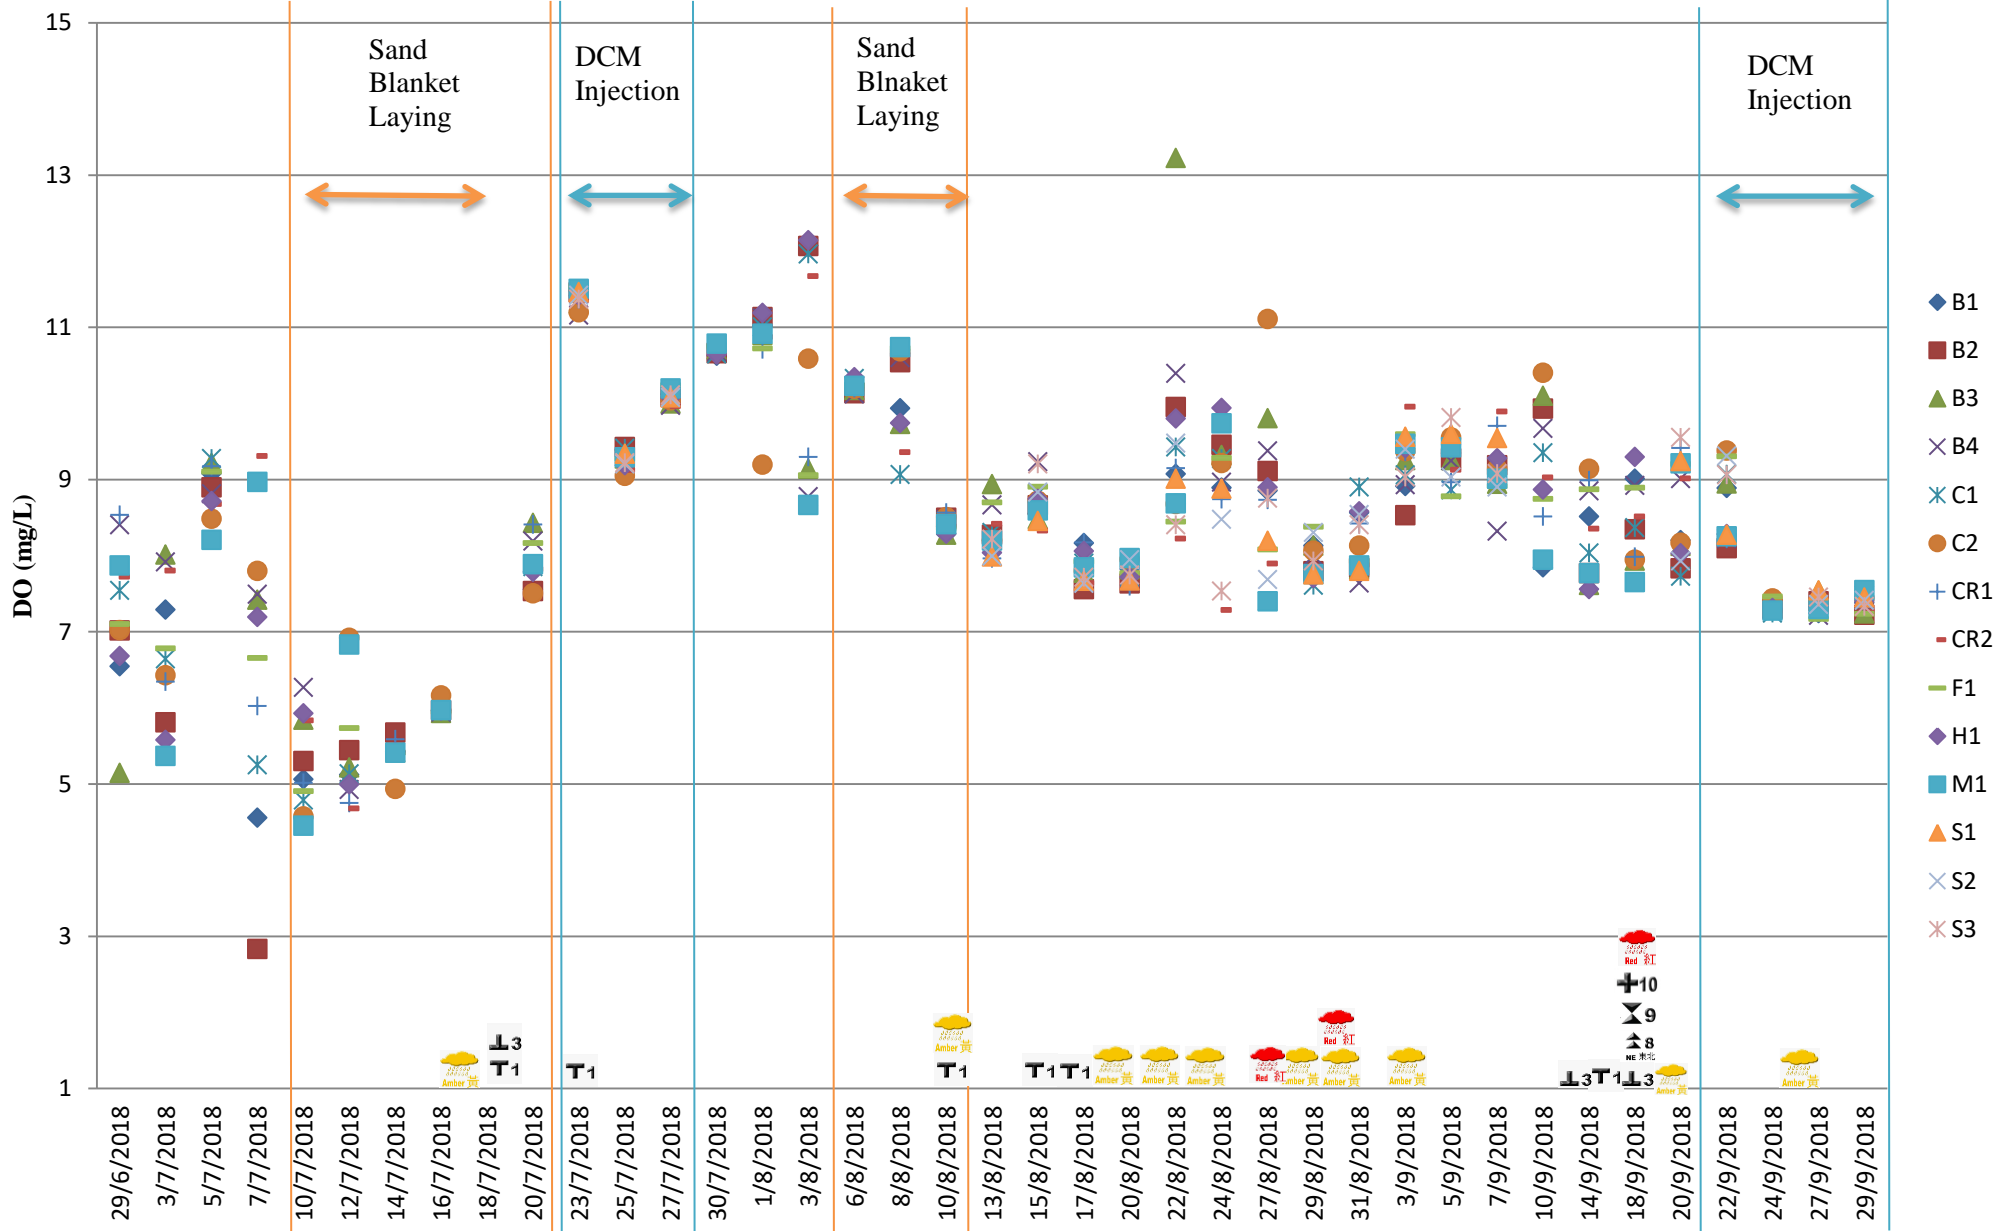
## Dissolved Oxygen (Depth-averaged) during Mid-Flood

Note: The Action and Limit Level of Dissolved Oxygen can be referred to **Table 2.2** of the quarterly EM & A report.
