Contract No. EP/SP/66/12 Integrated Waste Management Facilities, Phase 1 14th Quarterly EM&A Report

Quarterly EM&A Report No.14 (Period from 1 October to 31 December 2021)

(Clause 3.3, Further Environmental Permit FEP-01/429/2012/A)

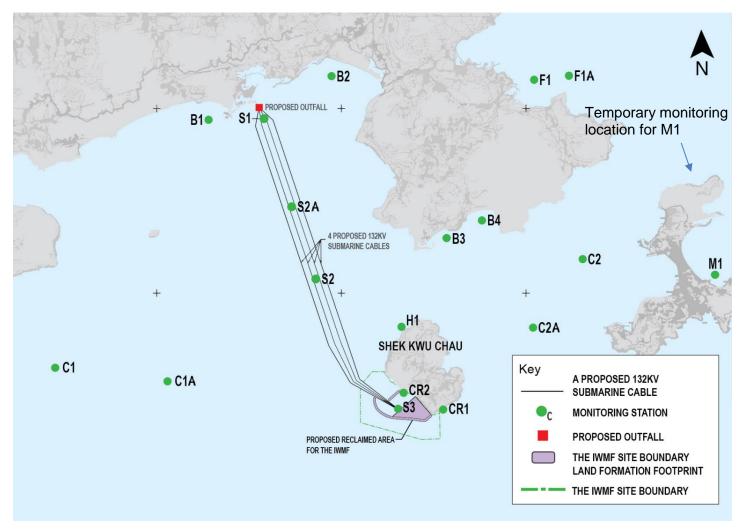
Figure 2.1 Water monitoring locations at Artificial Island near SKC

- 2.2 Water Quality Monitoring Locations
- 2.2.1 Impact water quality monitoring was conducted at eleven monitoring locations (i.e. B1-B4, H1, C1A, C2A, F1A, CR1, CR2 and M1) during general water quality monitoring as shown in **Figure 2.1**.

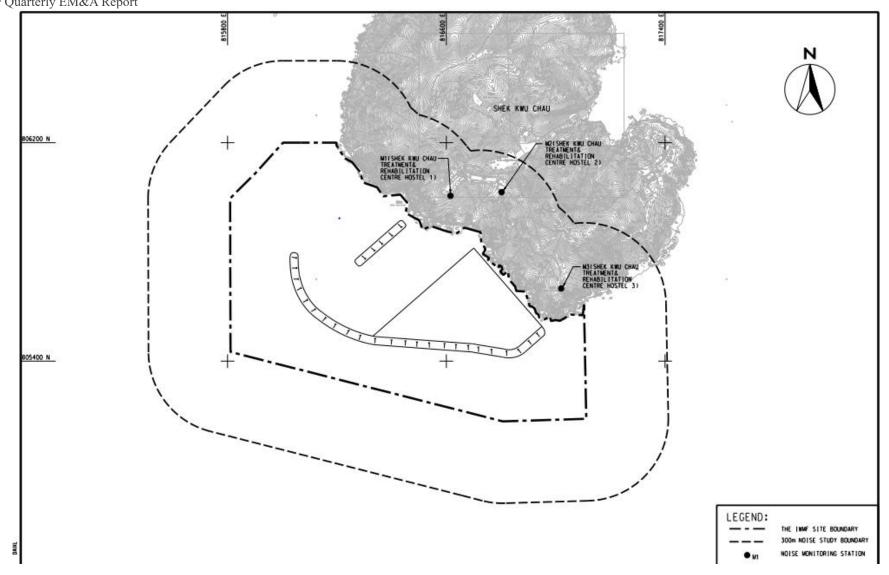
Figure 3.1 Noise monitoring locations at SKC

- 3.2 Noise Monitoring Locations
- 3.2.1 Three noise monitoring locations for impact monitoring and additional impact monitoring at the nearby sensitive receivers are shown in **Figure 3.1**

- 3.2.2 M1, M2 and M3 are Shek Kwu Chau Treatment and Rehabilitation Centre Hostel 1, 2 and 3 respectively of The Society for the Aid and Rehabilitation of Drug Abusers (SARDA) located at southern part of Shek Kwu Chau.

- 3.2.3 Measurements at M1 & M3 were conducted at a point 1m from the exterior of the sensitive receivers building façade and at a position 1.2m above the ground. Measurement setup at M3 has been varying with minor adjustment to minimize the disturbance to the users of Treatment Centre. Measurement at M2 was conducted at a point 1m from building façade of the ceiling of 1st floor level for avoidance of mutual disturbance with users of Treatment Centre. The minor adjustment of monitoring locations, which were in favour to mutual convenience with the users of Treatment Centre, were found with no effect on monitoring result based on on-site observation and experience from the Baseline monitoring of the Project.

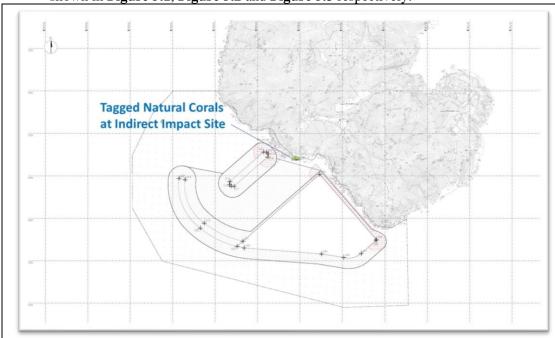
Figure 5.1 Tagged Natural Corals at Indirect Impact Site Near SKC for re-tagging after typhoon Mangkhut

Location of the ten tagged coral colonies at each of the proposed indirect impact site, control site, the recipient site R3 and REA transect at proposed indirect impact site are shown in **Figure 5.1**, **Figure 5.2** and **Figure 5.3** respectively:

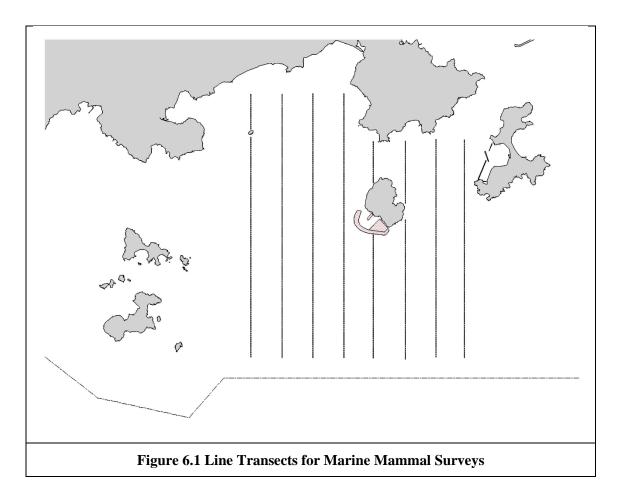
- 6.1 Survey Methods
- 6.1.1 Vessel-based Line-transect Survey
- 6.1.1.1 For the vessel-based marine mammal surveys, the monitoring team adopted the standard line-transect method (Buckland et al. 2001) as same as that adopted during the EIA study and pre-construction phase monitoring to allow fair comparison of marine mammal monitoring results.
- 6.1.1.2 Eight transect lines are set at Southeast Lantau survey area, including Shek Kwu Chau, waters between Shek Kwu Chau and the Soko Islands, inshore waters of Lantau Island (e.g. Pui O Wan) as well as southwest corner of Cheung Chau as shown in **Figure 6.1** below:

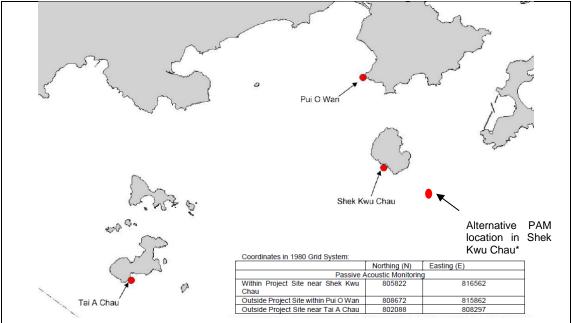
Figure 6.2 Locations of Passive Acoustic Monitoring

Finless Porpoise. During the construction period, the PAM survey will be conducted including placement of two passive porpoise detectors outside the Project Area as control site (i.e. within Pui O Wan and to the south of Tai A Chau) and one porpoise detector within the Project Area (i.e. near Shek Kwu Chau) as shown in **Figure 6.2** below.

Note*: The alternative PAM device adjacent to the Project site was deployed from 5 Mar to 11 Apr 2019, which contained a full 37 days acoustic monitoring data set. After the confirmation of loss of the original PAM within the Project site, this data set was proposed to replace that of the original one, as consulted with AFCD accordingly.

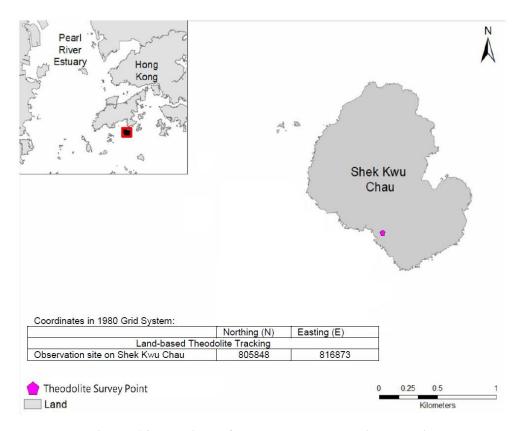
Figure 6.3 Locations of Land-based Theodolite Tracking

6.1.3.1 The Land-based Theodolite Tracking study would use the same station as in the AFCD monitoring study(same as the baseline monitoring location), which is situated at the southwest side of Shek Kwu Chau (GPS position: 22o11.47' N and 113o59.33' E) as shown in below **Figure 6.3**. The station was selected based on its height above sea level (at least 20 metres), close proximity to shore, and relatively unobstructed views of the entire Project Area to the southwest of Shek Kwu Chau. The height of the Shek Kwu Chau Station established by the HKCRP team is 74.6 m high at mean low water, and only a few hundred metres to the IWMF reclamation site, which is ideal for the purpose for the present behavioural and movement monitoring of finless porpoises as well during construction phase considering there as an un-obstructed vantage point at a height above the Project Site.

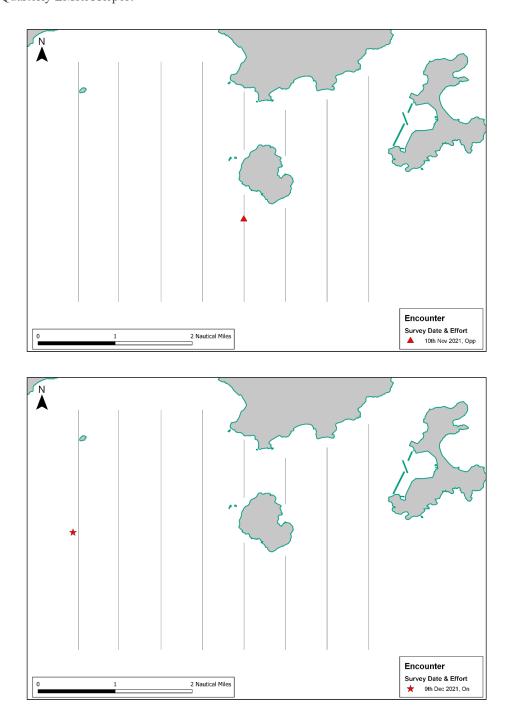
Figure 6.4 Location of sightings recorded during October to December 2021 Vesselbased Line-transect Survey

Date	Species	Sighting No.	Time	Group Size	PSD	Behaviour	Lat.	Long.	Area	Effort	Season
10 Nov 2021	Finless Porpoise	99	12:22	1	N/A	Travelling	22.18479	113.9835	SEL	On	AUTUMN
9 Dec 2021	Finless Porpoise	100	10:40	1	14	Unknown	22.1929	113.9437	SEL	On	WINTER

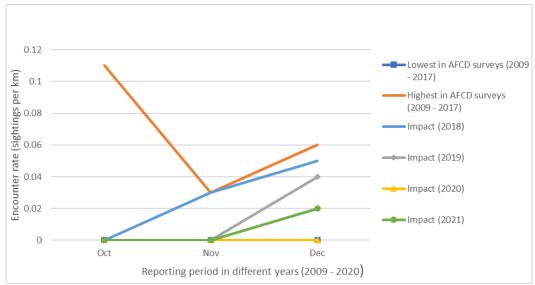
Figure 6.5 Plot of encounter rate during October to December in 2009 – 2021 from different surveys

- 6.3.1.4 A review of all the porpoise sightings in the survey area for October to December between 2009 2021 indicates that there is no sighting usually recorded in October to December. Given the similar survey conditions and the encounter rate recorded for porpoise in the project area during the reporting period, the encounter rate for October to December 2021 were between 0.00km⁻¹ and 0.02km⁻¹ (see Figure 6.5), it is noted that the encounter rate of impact survey is low when compared to other years. It is noted that the reporting period was covering between both non-peak and peak season and that construction not related to IWMF is ongoing on the southern boundary of the study site, both which may impact encounter rates. It is also noted that the impact survey focuses on a relatively small populations of highly mobile individuals and the survey area conducted for this monitoring is very small. For October to December 2021, the number of recorded sightings was similar to the case in 2019 impact monitoring conducted by ET.

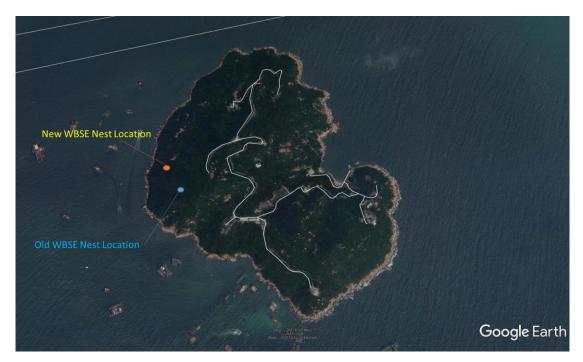
Figure 7.1 Location of WBSE Nest on SKC

- 7.2.2 Two adult WBSEs were recorded near Shek Kwu Chau area. It was found that the WBSEs moved to new nest for incubation since the early December 2021. No abnormal behavior of the recorded adults during the December 2021 construction phase monitoring. All marine works during the monitoring period did not show any impact to the WBSE.
- 7.2.3 No disturbances from anthropogenic activities on the island were recorded during the monitoring survey. No invasion of other fauna species was recorded as well.
