Contract No. EP/SP/66/12
Integrated Waste Management Facilities, Phase 1
15th Quarterly EM&A Report

Quarterly EM&A Report No.15 (Period from 1 January to 31 March 2022)

(Clause 3.3, Further Environmental Permit FEP-01/429/2012/A)

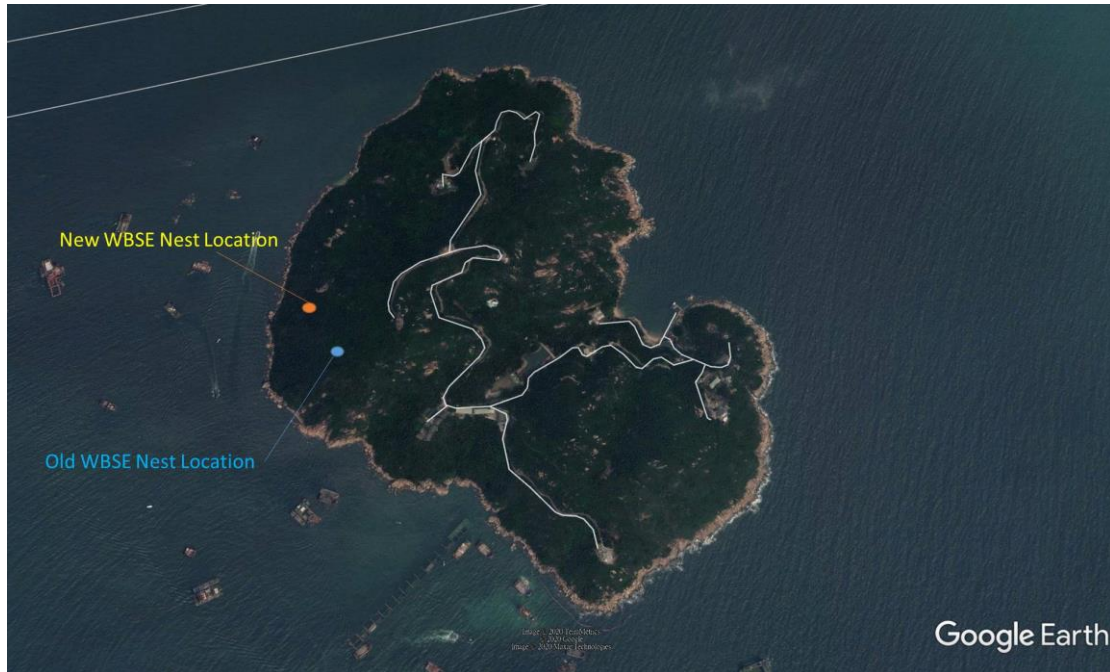
Figure 7.1 Location of WBSE Nest on SKC

- 7.2.3 No disturbances from anthropogenic activities on the island were recorded during the monitoring survey. No invasion of other fauna species was recorded as well.
