Quarterly EM&A Report No.2 (Period from 1 October to 31 December 2018)

(Clause 3.3, Further Environmental Permit FEP-01/429/2012/A)

- A3. This is the 2nd Quarterly EM&A Report, prepared by ASCL, for the Project summarizing and concluding the monitoring results and audit findings of the EM&A programme at and around Shek Kwu Chau (SKC) during the reporting period from 1 October 2018 to 31 December 2018.

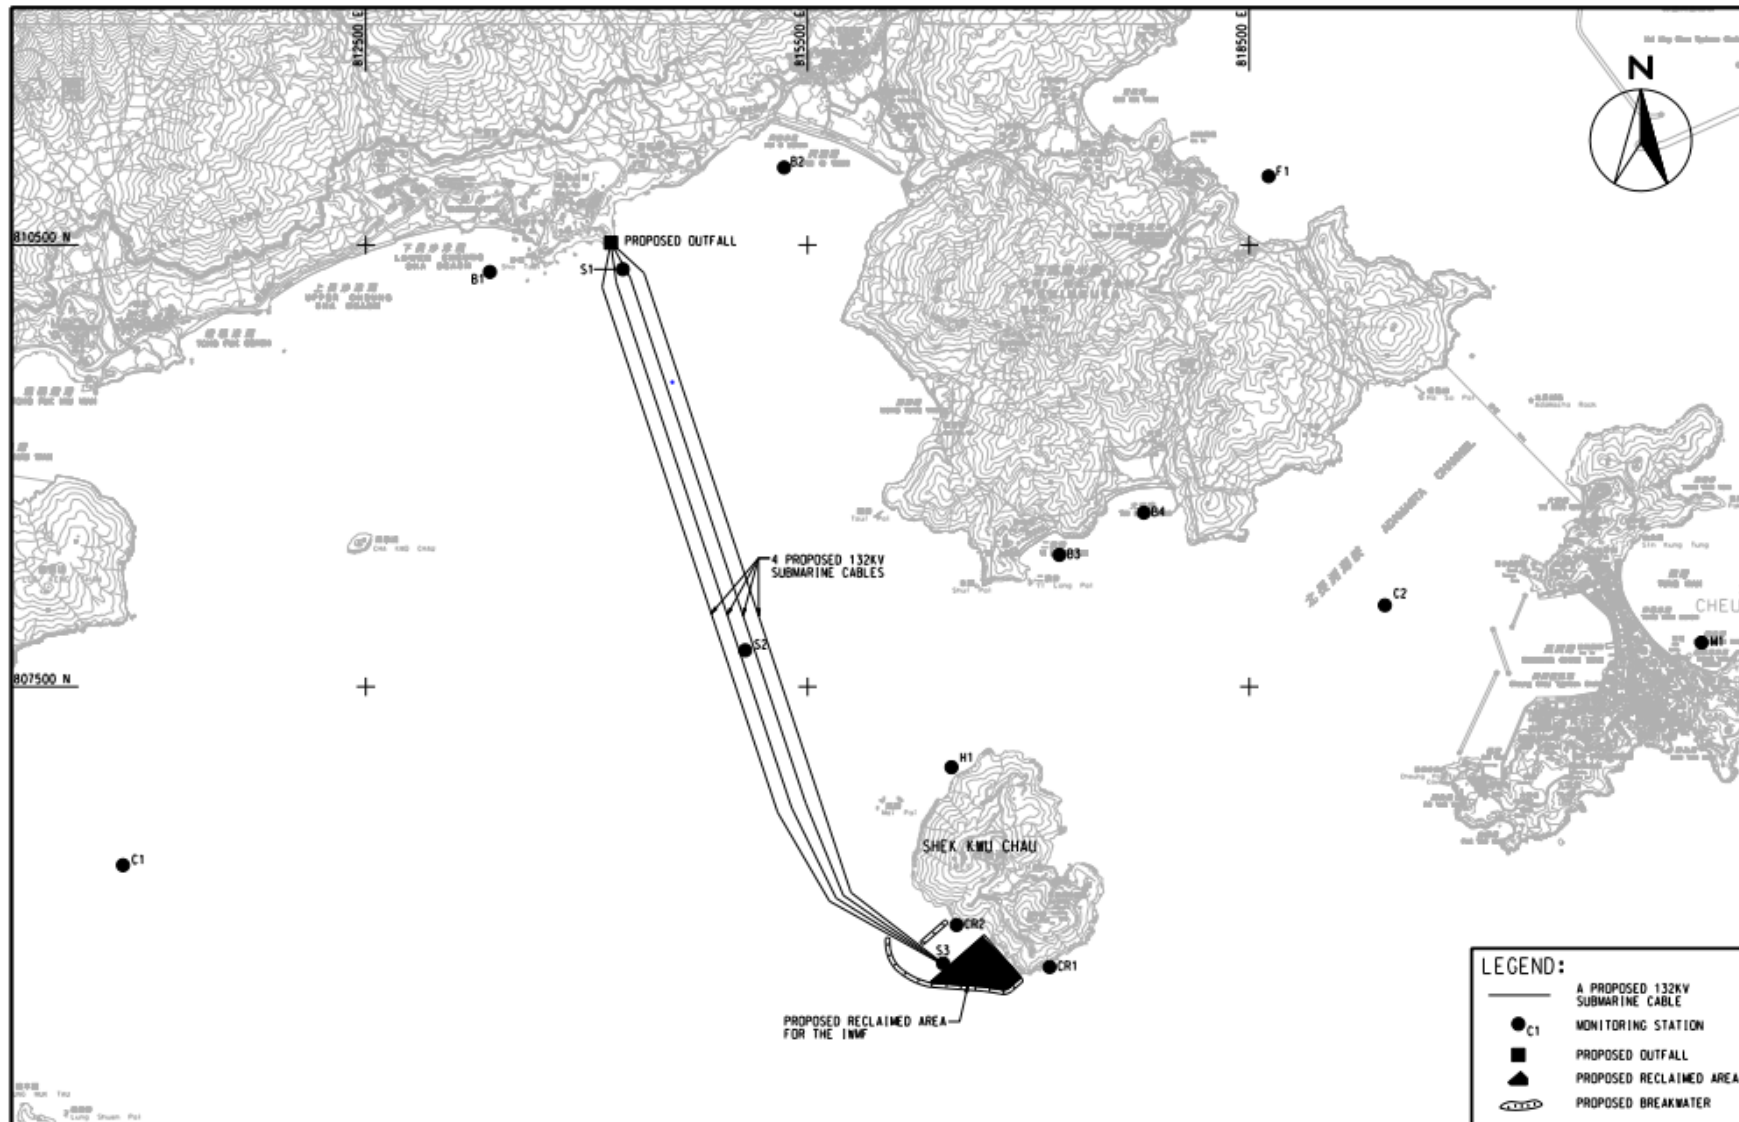
Figure 2.1 Water monitoring locations at Artificial Island near SKC

- 2.2.1 Impact water quality monitoring was conducted at eleven monitoring locations during general water quality monitoring and fourteen water monitoring locations during regular DCM monitoring, as shown in **Figure 2.1**.

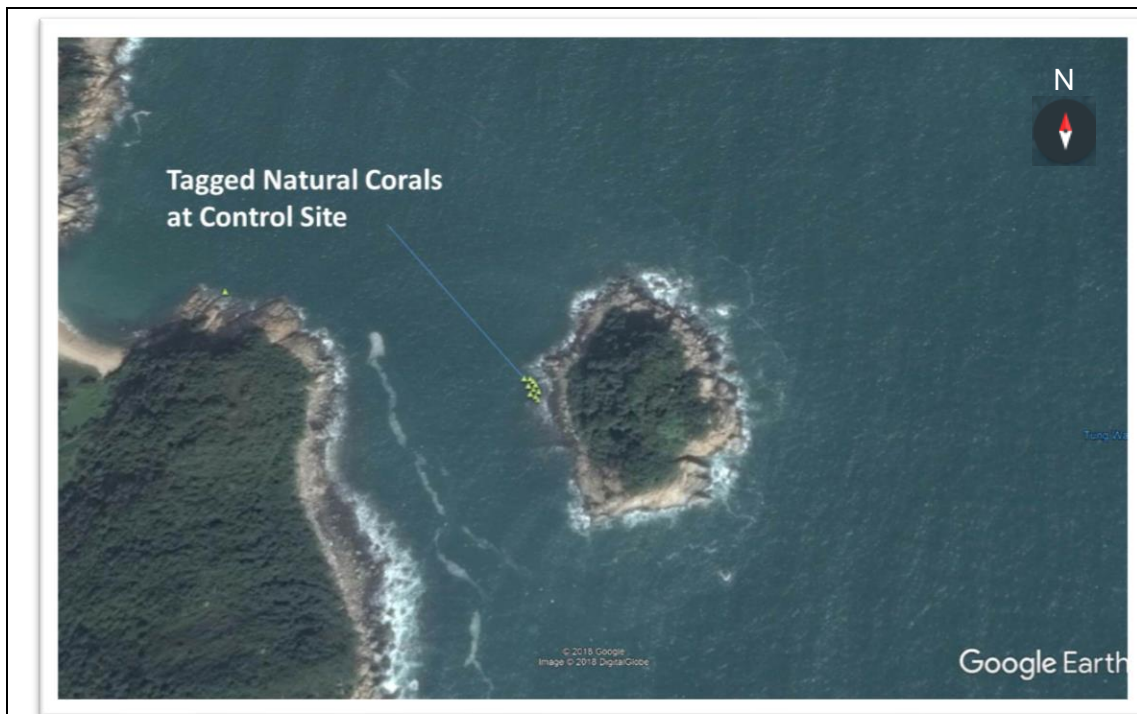
Figure 5.2 Tagged Natural Corals at Control Site Near Yuen Kong Chau for re-tagging after typhoon Mangkhut

5.4.1 After strong hitting of the super typhoon Mangkhut in mid-September 2018, the whole bottom at the Indirect Impact Site were covered with 1m thick of sand and mud in which all ten tagged hard coral colonies were all missing. For the control site of Soko Island, most of the rocks at the bottom were turned over by the super typhoon Mangkhut in mid-September 2018, however, only 4 tagged coral colonies were missing. Since there was a suspension order on diving activities due to the fatal accident on 15 October 2018, the coral re-tagging event planned on late-October at both Indirect Impact Site and Control Site were cancelled and postponed to November and December 2018 due to adverse weather. During the reporting period, the re-tagging activity at Indirect Impact Site was conducted on 23 November 2018 while the re-tagging activity at Control Site was conducted on 3 December 2018 (**Figure 5.1** and **5.2** respectively); and the weather conditions were summarized in **Table 5.6**.

5.4.2 Four (4) and ten (10) re-tagged hard coral colonies were re-tagged at each site of Control and Indirect Impact sites respectively during 4th to 6th months construction phase monitoring as suggested in the Coral Monitoring Plan. After the retagging at both sites are finished, one additional monthly monitoring survey will be conducted in January 2019 and those monitoring results will be reported in 3rd Quarterly and 7th Monthly EM&A report. The general health conditions (size, condition, mortality,

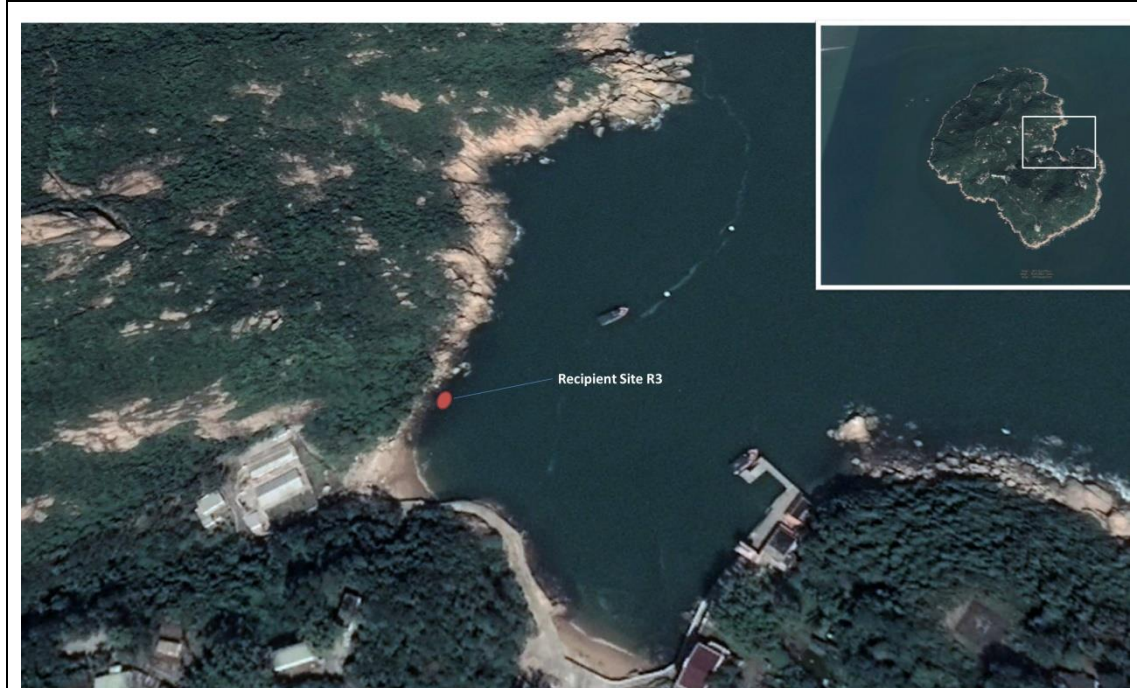
Figure 5.3 Tagged Translocation Corals at Recipient Site R3 near SKC

- 5.4.3 The third Post-translocation Monitoring was performed on 3 December 2018 for the Recipient Site R3 (**Figure 5.3**) and the weather conditions were summarized in **Table 5.7**.

- 5.4.9 The third post-translocation coral monitoring was carried out on 3 December 2018. Sixteen (16) movable hard coral colonies were monitored at the recipient site R3. However, 9 translocated coral colonies were missing during the second monitoring survey and only 7 left (**Table 5.11**). The remaining translocated coral colonies also showed an increased mortality from 5% to 15% (**Table 5.11**). The missing colonies probably were swept away by the strong wave action caused by the Super Typhoon Mangkhut hitting Hong Kong on 15th and 16th September 2018.

- 5.4.11 Since all missing tagged coral colonies at the Recipient Site R3 were caused by the Super Typhoon Mangkhut, the AL/LL will not be applied at this time. Post-translocation monitoring survey will be continued to monitor the remaining tagged coral colonies for both translocated coral and natural coral colonies.

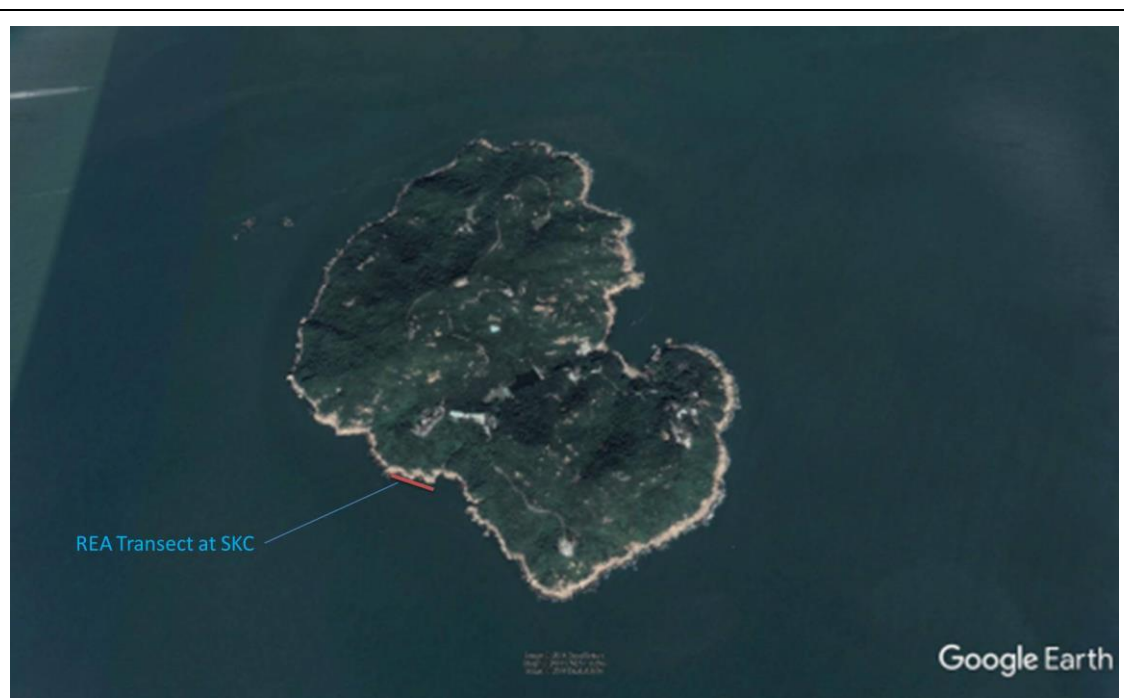
Figure 5.4 REA Transect at Indirect Impact Site near SKC

- 5.4.4 An additional 100m REA survey was carried out on 3 December in the proposed Indirect Impact site (**Figure 5.4**) to further assess the seabed condition after super typhoon Mangkhut. GPS coordinates of the REA transect starting and ending points, maximum depth and bottom substrate of the site were summarized in **Table 5.8**. The findings of ecological & substratum attributes and taxon abundance along the REA transect survey were summarized in **Table 5.13** and **5.14** respectively.

- 5.4.12 The REA survey was carried out on 3 December 2018 in the Indirect Impact Site. Only three species of hard coral were recorded during the survey and most of them are in fair condition after the typhoon. Some common coral colonies still appeared in shallow water which are suitable for re-tagging during the construction phase monitoring. All the coral colonies recorded along the transect were all common hard coral species in Hong Kong (**Appendix F**).

- 5.4.13 From the REA survey, the monitoring site was mainly composed of natural bedrock and big boulders down to 3.5 meters water depth along the surveyed route (**Table 5.13**). Scattered hard coral colonies were recorded along the REA transect and only 3 species of hard coral were recorded. The abundance of hard coral species recorded along the transect was shown in **Table 5.14**. Besides, some invertebrates such as common sea snail: *Thais luteostoma*, Sea urchins: *Anthodiaris crassispina* and common green mussel: *Septifer virgatus* were found at the surface of the boulders.

- 5.4.14 This site supported a sparse and patchy cover (<1%) of hard corals. All the recorded coral colonies grew on the big boulders and bedrock surfaces. All hard coral colonies recorded along the transect were common hard coral species in Hong Kong water and in fair health condition.

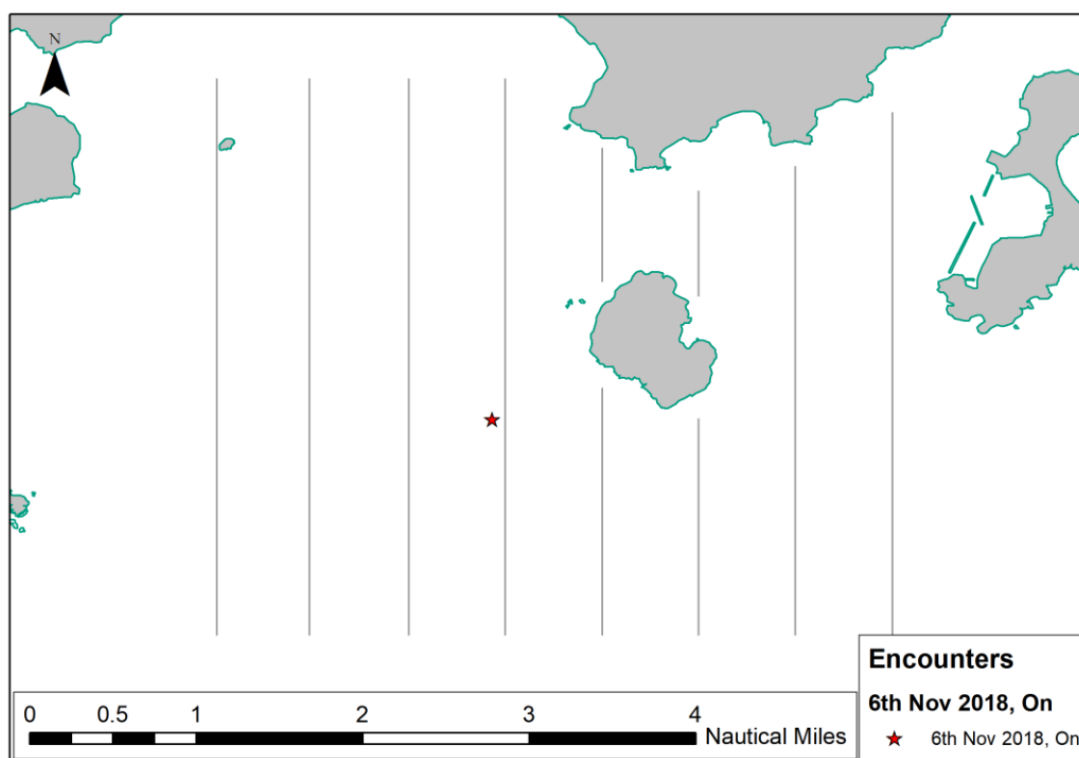
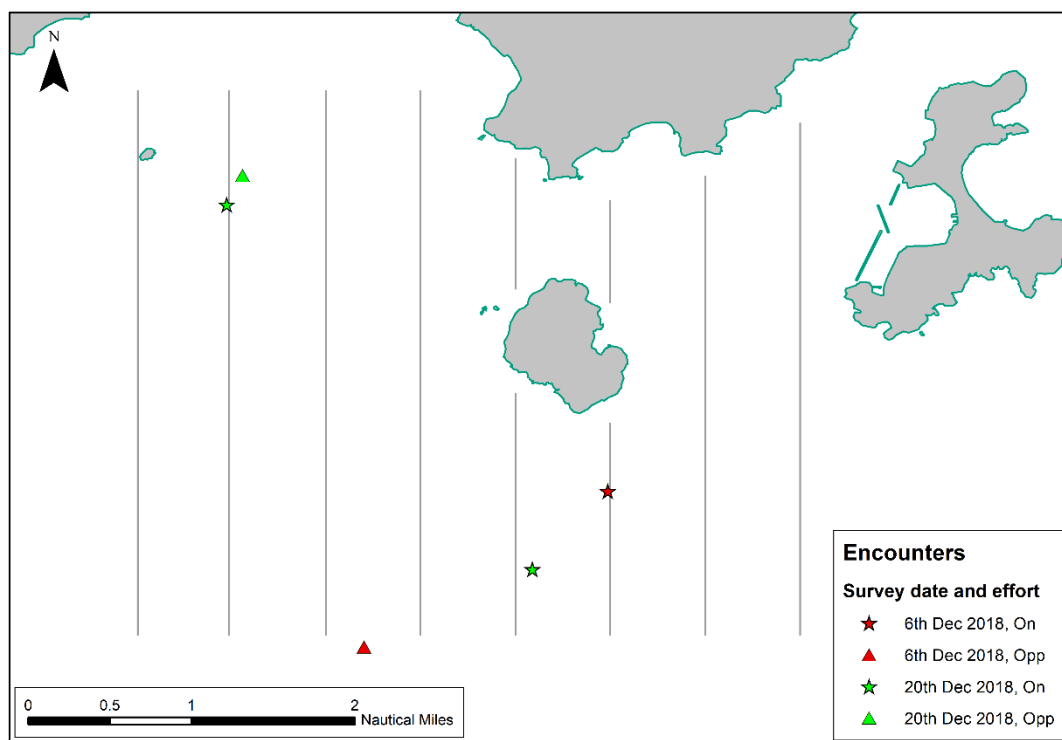
**Figure 6.2 Location of sightings recorded during November and December 2018
Vessel-based Line-transect Survey**

A review of all the porpoise sightings in the survey area for October to December between 2009-2017 indicates that there are fluctuations between the number of sightings usually recorded in October to December. Given the similar survey conditions and the low encounter rate recorded for porpoise in the project area during the reporting period, an increase in sightings within this area in October to December 2018 is in agreement with the detailed in AFCD long term monitoring data.

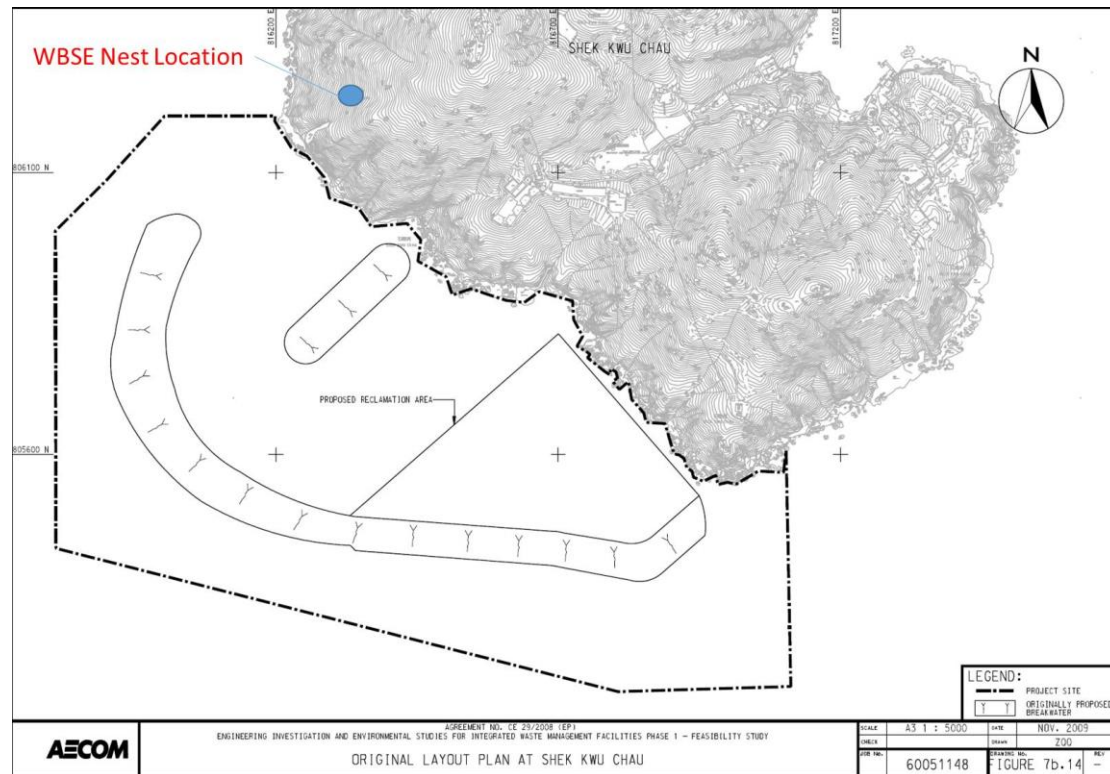
Figure 7.1 Location of WBSE Nest on SKC

- 7.2.2 Two WBSE adults were recorded during each survey and appeared flying over SKC Island, standing on the tree top on SKC Island during the survey in October to December 2018. In the October 2018 monitoring survey, the newly built nest was observed and both WBSE were recorded. The new WBSE nest was being built at the same location as the old one, which is located at the western part of SKC Island (**Figure 7.1**) quite away from the Shek Kwu Chau Treatment and Rehabilitation Centre.
- 7.2.3 Any disturbances from anthropogenic activities on the island were not recorded during the monitoring survey. However, fishing boats moving close to the shore were recorded. Since the nest is about 160m away from the shore and it is not accessible, fishing boat activities didn't show any direct disturbance to the WBSE nest.

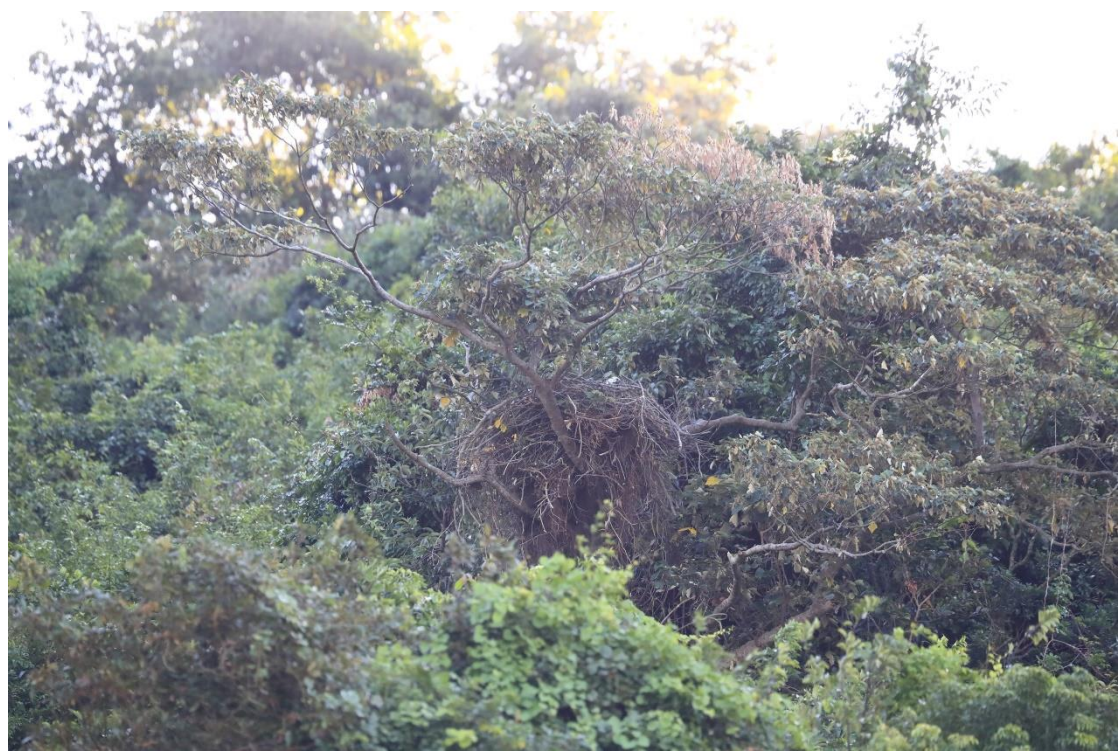
New nest of WBSE

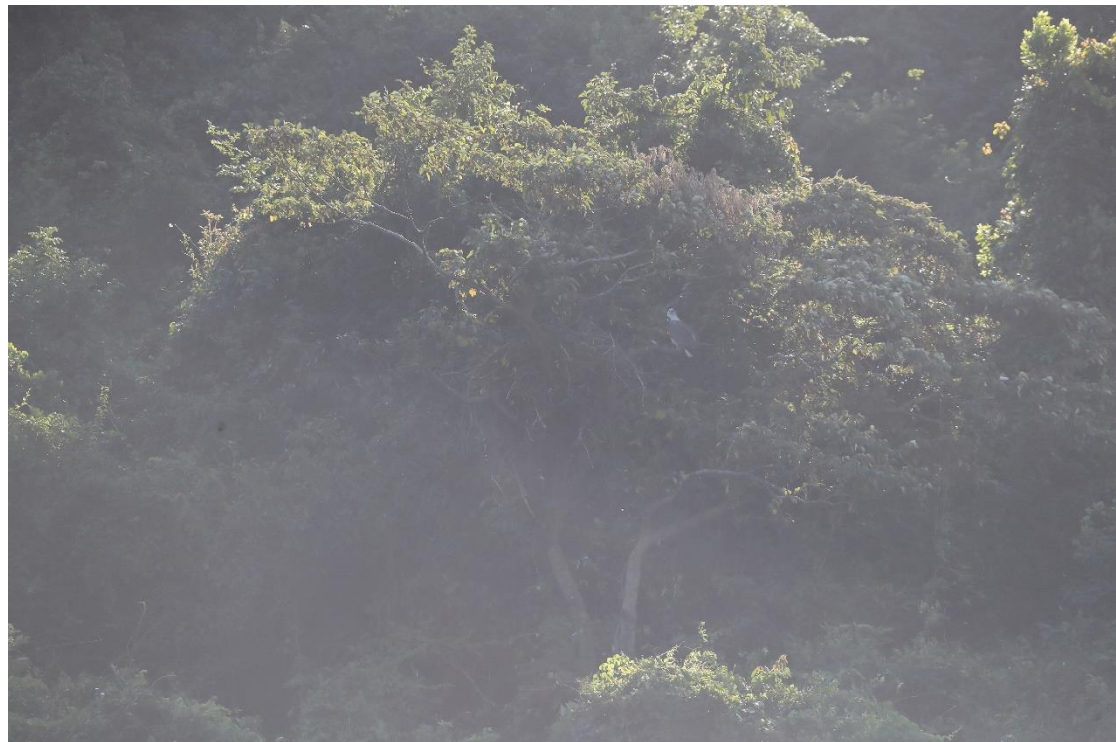
WBSE standing next to the new nest
