Contract No. EP/SP/66/12
Integrated Waste Management Facilities, Phase 1
Quarterly EM&A Report No.3

Quarterly EM&A Report No.3 (Period from 1 January to 31 March 2019)

(Clause 3.3, Further Environmental Permit FEP-01/429/2012/A)

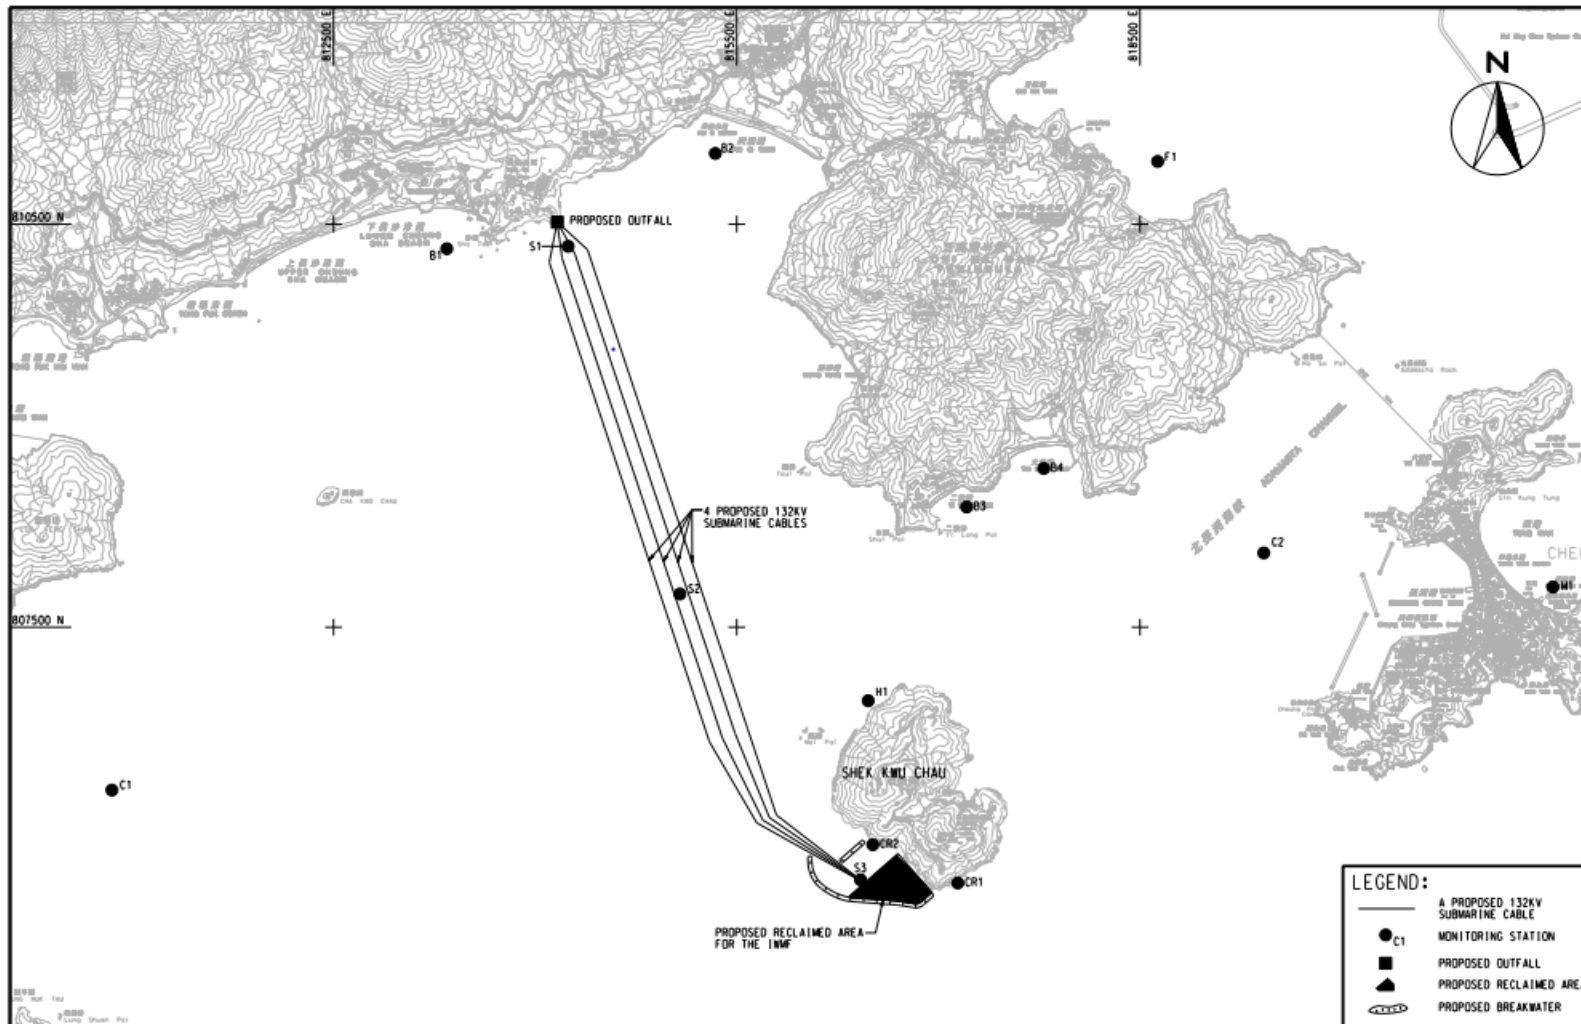
Figure 2.1 Water monitoring locations at Artificial Island near SKC

- 2.2.1 Impact water quality monitoring was conducted at eleven monitoring locations during general water quality monitoring and fourteen water monitoring locations during regular DCM monitoring, as shown in **Figure 2.1**.
