Contract No. EP/SP/66/12
Integrated Waste Management Facilities, Phase 1
5th Quarterly EM&A Report

Quarterly EM&A Report No.5

(Period from 1 July to 30 September 2019)

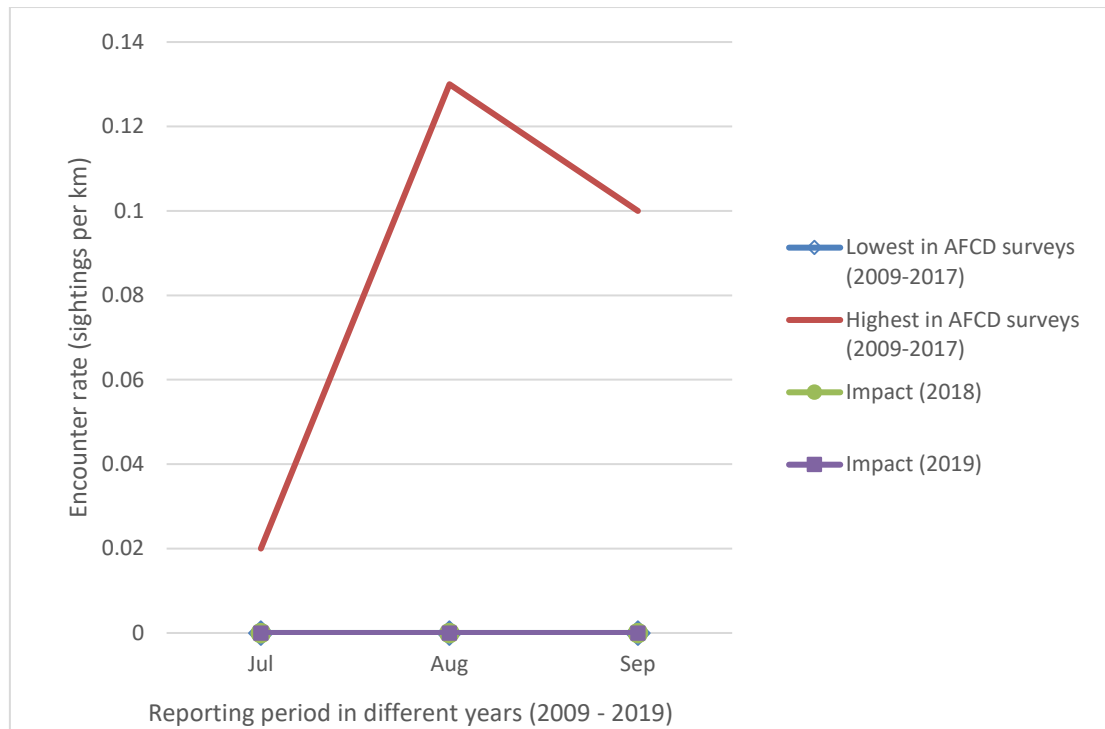
Figure 6.4 Plot of encounter rate during July to September in 2009 – 2019 from different surveys

- 6.3.1.2 A review of the long term AFCD marine mammal monitoring programme, the EIA and the pre-construction baseline monitoring report for this project was conducted. Both the EIA and the pre-construction baseline monitoring were conducted during the peak porpoise months Dec 2008 to May 2009 and Feb to April 2018, respectively. The AFCD long term monitoring data and impact monitoring in 2018 should be compared directly to Impact Survey results of the reporting periods.

- 6.3.1.4 A review of all the porpoise sightings in the survey area for July to September between 2009-2018 indicates that there is no sighting usually recorded in July to September. Given the similar survey conditions and the encounter rate recorded for porpoise in the project area during the reporting period, the encounter rate for July to September 2019 was 0 km⁻¹ respectively (see **Figure 6.2**), it is noted that the encounter rate of impact survey is low when compared to other years. It is noted that the non-peak season of finless porpoise is coming to start and that works at IWMF are increasing, both which may impact encounter rates. It is also noted that the impact survey focuses on a relatively small populations of highly mobile individuals and the survey area conducted for this monitoring is very small. For July to September 2019, there were no recorded sightings, as was the case in 2018 impact monitoring conducted by ET and some of long-term monitoring data conducted by AFCD.
