Contract No. EP/SP/66/12  
Integrated Waste Management Facilities, Phase 1  
5<sup>th</sup> Quarterly EM&A Report

## Quarterly EM&A Report No.5 (Period from 1 July to 30 September 2019)

(Clause 3.3, Further Environmental Permit FEP-01/429/2012/A)

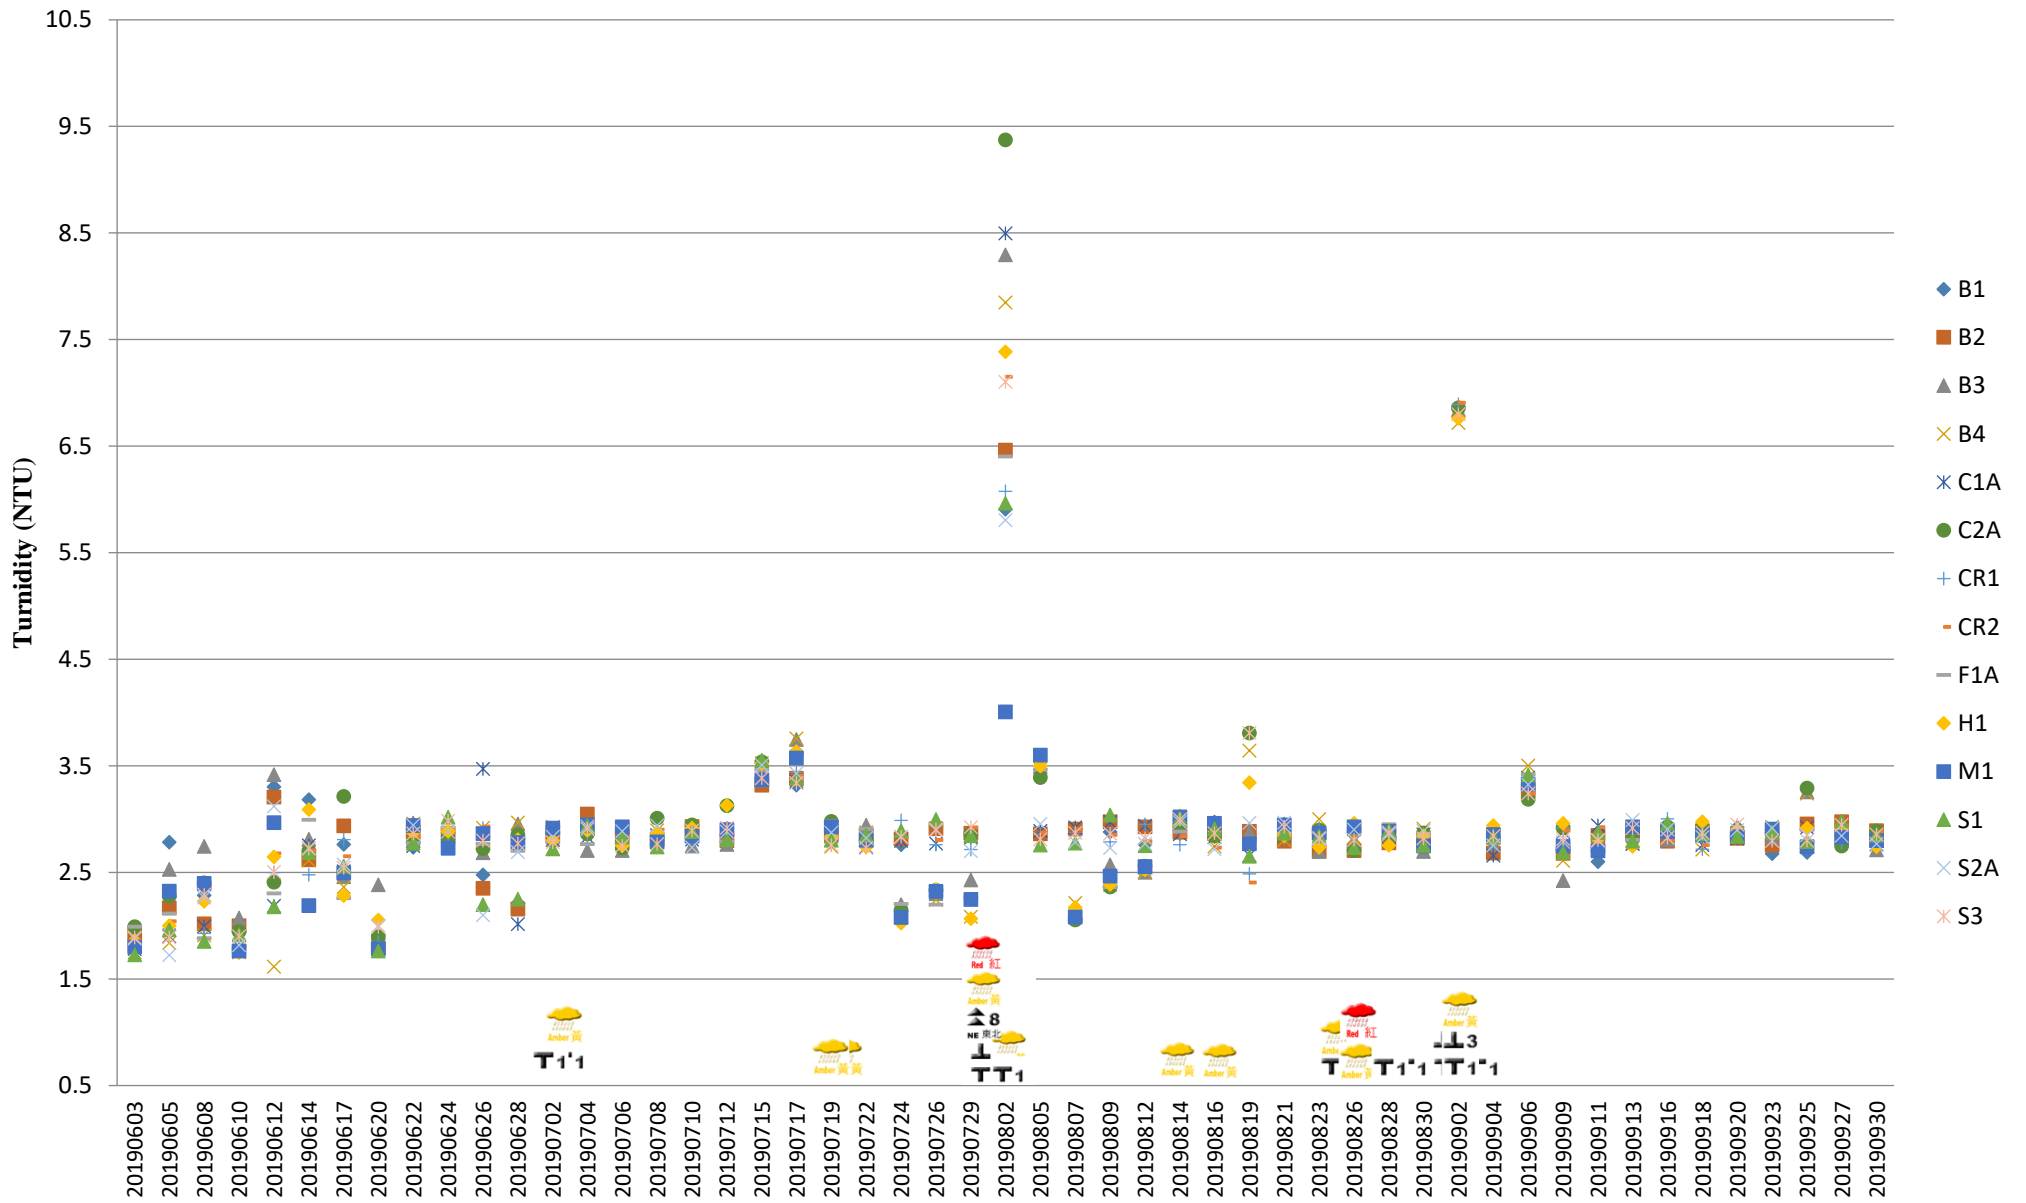
## Turbidity (Depth-averaged) during MID-EBB

Note: The Action and Limit Level of turbidity can be referred to **Table 2.3** of the quarterly EM&A report.
