Contract No. EP/SP/66/12
Integrated Waste Management Facilities, Phase 1
6th Quarterly EM&A Report

Quarterly EM&A Report No.6

(Period from 1 October to 31 December 2019)

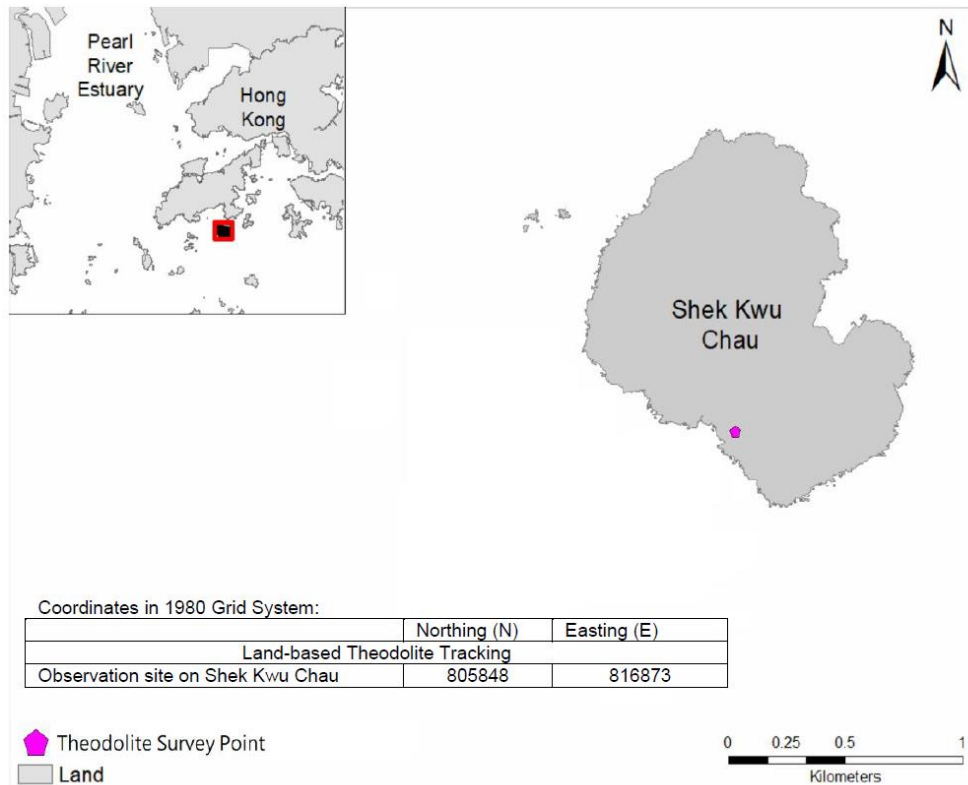
Figure 6.3 Locations of Land-based Theodolite Tracking

at the southwest side of Shek Kwu Chau (GPS position: 22°11.47' N and 113°59.33' E) as shown in below **Figure 6.3**. The station was selected based on its height above sea level (at least 20 metres), close proximity to shore, and relatively unobstructed views of the entire Project Area to the southwest of Shek Kwu Chau. The height of the Shek Kwu Chau Station established by the HKCRP team is 74.6 m high at mean low water, and only a few hundred metres to the IWMF reclamation site, which is ideal for the purpose for the present behavioural and movement monitoring of finless porpoises as well during construction phase considering there as an un-obstructed vantage point at a height above the Project Site.

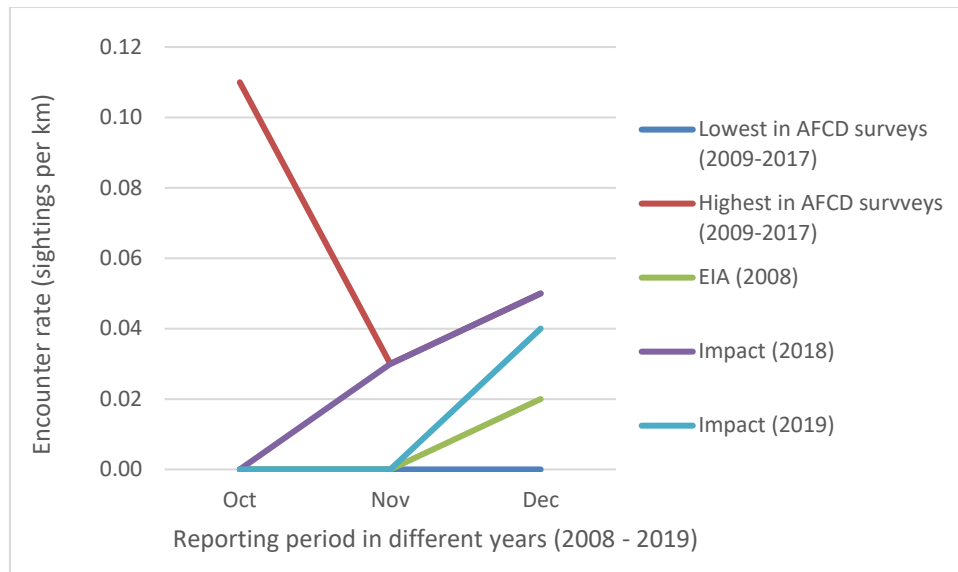
Figure 6.4 Plot of encounter rate during October to December in 2008 – 2019 from different surveys

6.3.1.2 A review of the long term AFCD marine mammal monitoring programme, the EIA and the pre-construction baseline monitoring report for this project was conducted. Both the EIA and the pre-construction baseline monitoring were conducted during the peak porpoise months Dec 2008 to May 2009 and Feb to April 2018, respectively. The AFCD long term monitoring data and impact monitoring in 2018 should be compared directly to Impact Survey results of the reporting periods.

6.3.1.3 A review of the Beaufort Sea state survey conditions between 2009 and 2018 (only data available from AFCD at time of writing; (AFCD 2018; 2017; 2016; 2015; 2014; 2013; 2012; 2011; 2010)) shows that survey conditions in October to December 2019 were within the % limits of previous AFCD surveys, similar to impact monitoring surveys conducted in 2018.

6.3.1.4 A review of all the porpoise sightings in the survey area for October to December between 2009-2018 indicates that there is few sightings usually recorded in October to December. Given the similar survey conditions and the encounter rate recorded for porpoise in the project area during the reporting period, the encounter rate for October to December 2019 was 0, 0, 0.04 km⁻¹ respectively (see **Figure 6.2**), it is noted that the encounter rate of impact survey is low when compared to other years. It is noted that the reporting period was covering between both non-peak and peak season and that works at IWMF are increasing, both which may impact encounter rates. It is also noted that the impact survey focuses on a relatively small populations of highly mobile individuals and the survey area conducted for this monitoring is very small. For October to December 2019, there was only recorded sightings in December 2019, as was similar to the case in 2018 impact monitoring conducted by ET and some of long-term monitoring data conducted by AFCD.

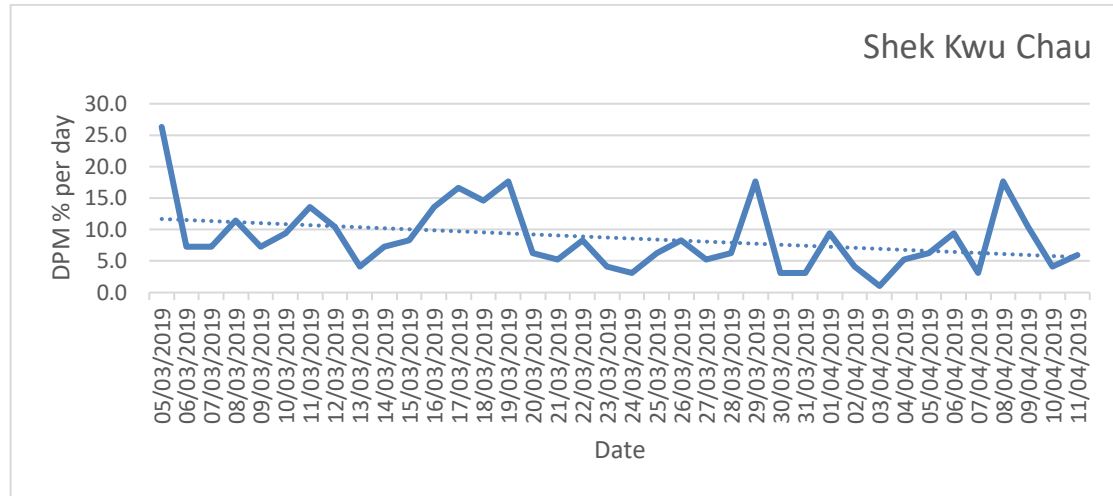
Figure 3 The Daily Rate of Detection Positive Minutes (DPM) for Finless Porpoise (*Neophocaena phocaenoides*) at Shek Kwu Chau, 5th March - 11th April 2019

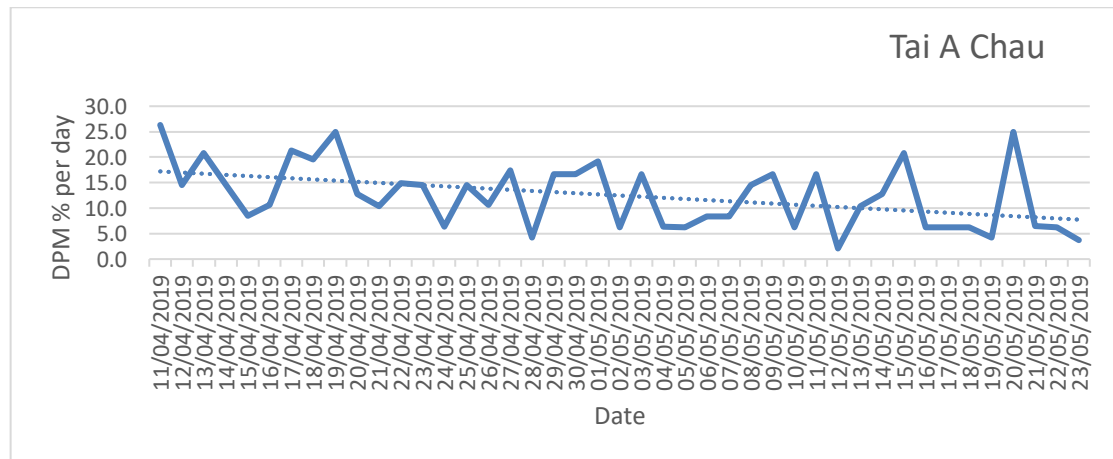
Figure 4 The Daily Rate of Detection Positive Minutes (DPM) for Finless Porpoise (*Neophocaena phocaenoides*) at Tai A Chau, 11th April – 23rd May 2019

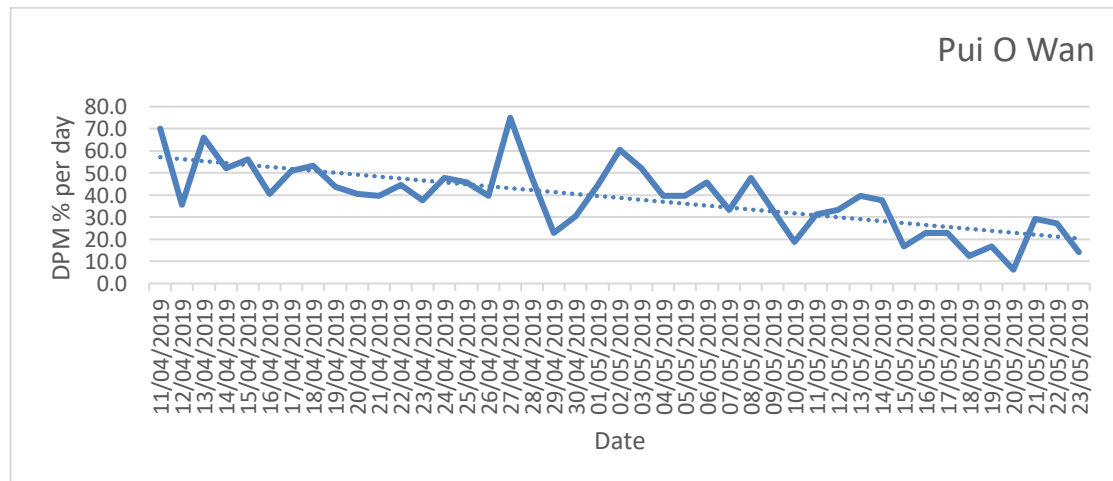
Figure 5 The Daily Rate of Detection Positive Minutes (DPM) for Finless Porpoise (*Neophocaena phocaenoides*) at Pui O Wan, 11th April - 23rd May 2019

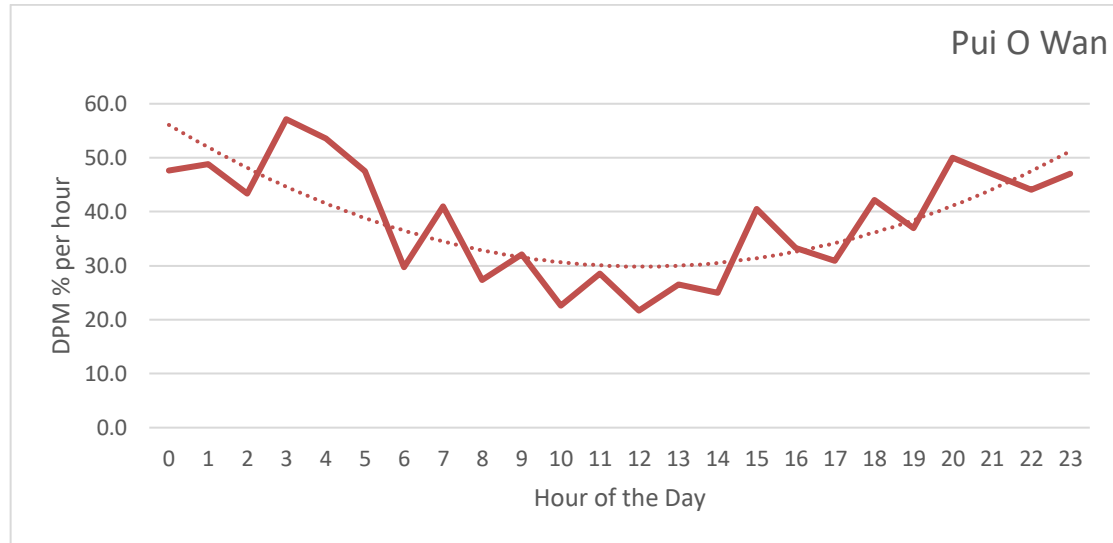
Figure 6 Finless Porpoise (*Neophocaena phocaenoides*) Diurnal Detection Patterns at Pui O Wan, 11th April - 23rd May 2019

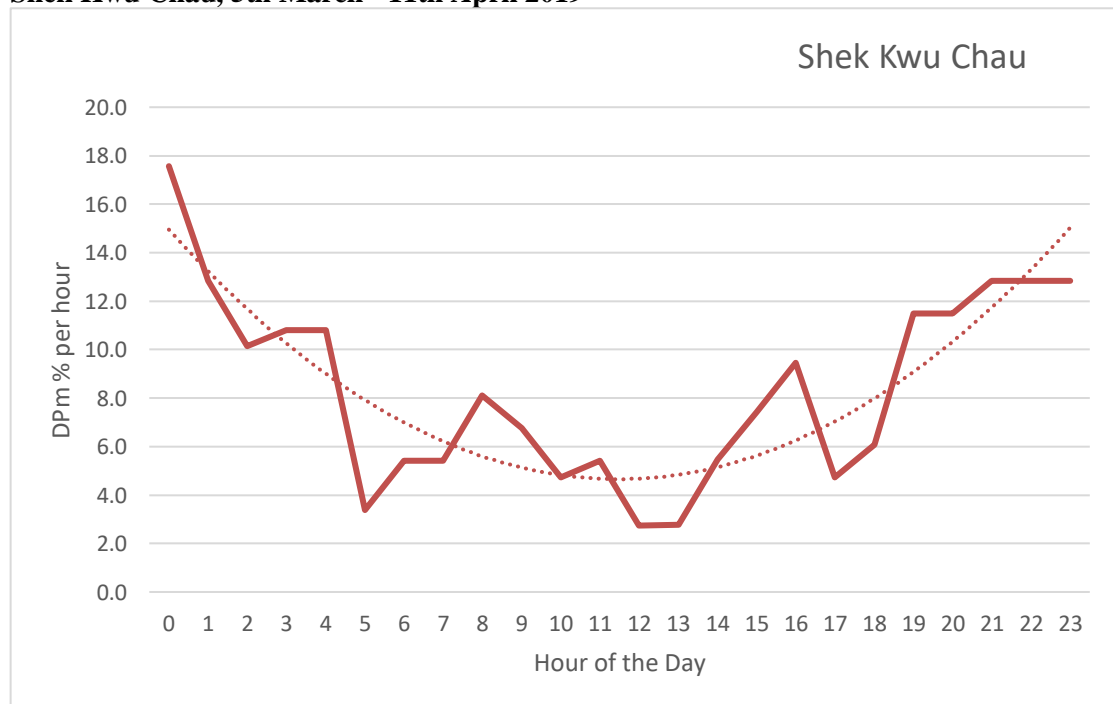
Figure 7 Finless Porpoise (*Neophocaena phocaenoides*) Diurnal Detection Patterns at Shek Kwu Chau, 5th March - 11th April 2019

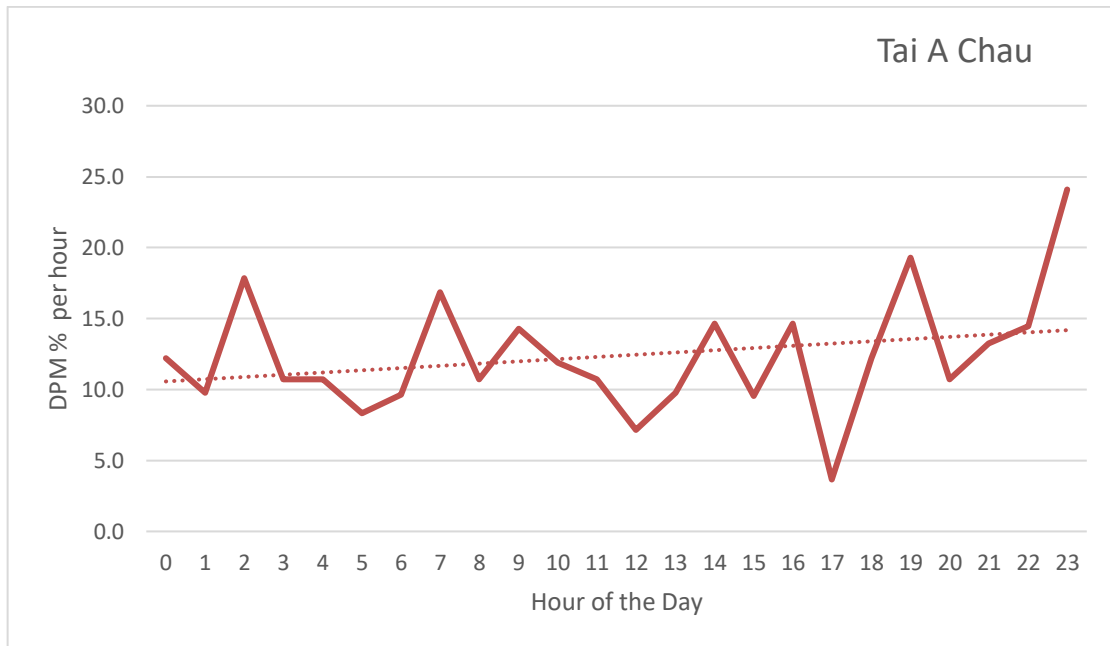
Figure 8 Finless Porpoise (*Neophocaena phocaenoides*) Diurnal Detection Patterns at Tai A Chau, 11th April - 23rd May 2019
