Contract No. EP/SP/66/12
Integrated Waste Management Facilities, Phase 1
7th Quarterly EM&A Report

Quarterly EM&A Report No.7

(Period from 1 January to 31 March 2020)

(Clause 3.3, Further Environmental Permit FEP-01/429/2012/A)

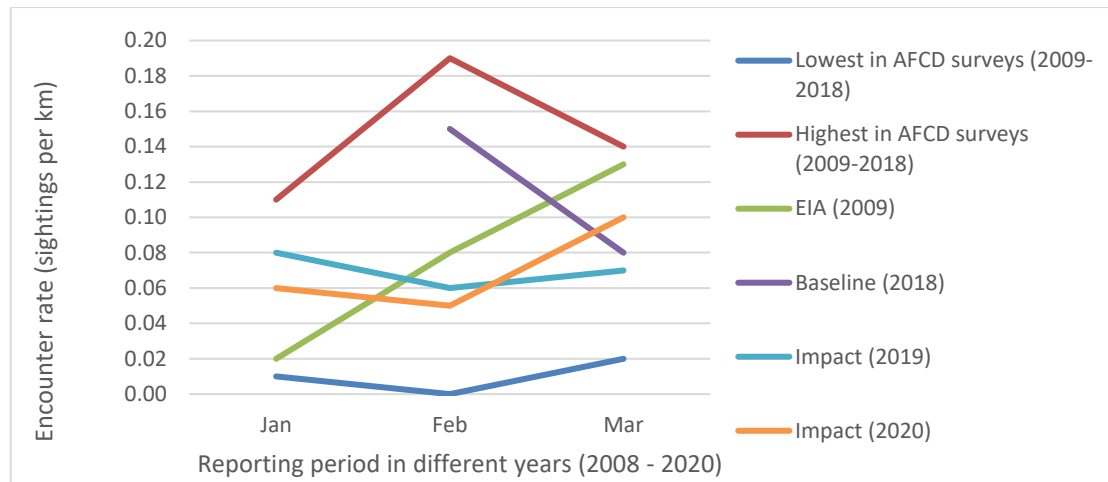
Figure 6.4 Plot of encounter rate during January to March in 2008 – 2020 from different surveys

6.3.1.4 A review of all the porpoise sightings in the survey area for January to March between 2009-2018 indicates that there is more sightings usually recorded in January to March. Given the similar survey conditions and the encounter rate recorded for porpoise in the project area during the reporting period, the encounter rate for January to March 2020 was 0.06, 0.05, 0.10 km⁻¹ respectively (see **Figure 6.4**), it is noted that the encounter rate of impact survey is similar when compared to other years. It is noted that the reporting period was covering peak season and that works at IWMF are increasing, both which may impact encounter rates. It is also noted that the impact survey focuses on a relatively small populations of highly mobile individuals and the survey area conducted for this monitoring is very small. For January to March 2020, as was similar to the case in 2019 impact monitoring conducted by ET and the encounter rates of impact surveys were lying within the range of encounter rate in AFCD surveys.
