**JOB No.: TCS00881/18**

**CEDD CONTRACT CV/2016/10  
SITE FORMATION AND ASSOCIATED INFRASTRUCTURAL  
WORKS FOR DEVELOPMENT OF COLUMBARIUM AT  
SANDY RIDGE CEMETERY**

**MONTHLY ENVIRONMENTAL MONITORING AND AUDIT  
REPORT (NO.2) – SEPTEMBER 2018**

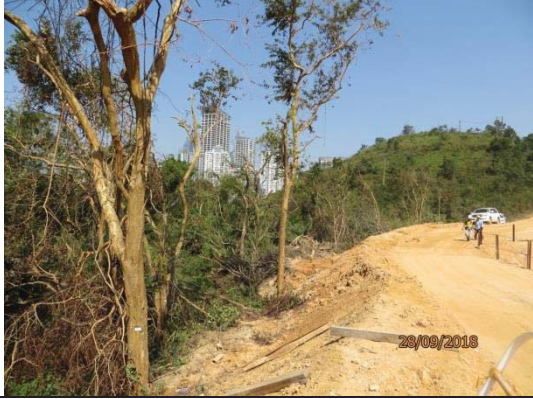
<b>Fig A.</b>	<b>Fig B.</b>

<p>No hoarding or barrier was provided</p>	<p>No proper TPZ was provided for some of the retained trees</p>

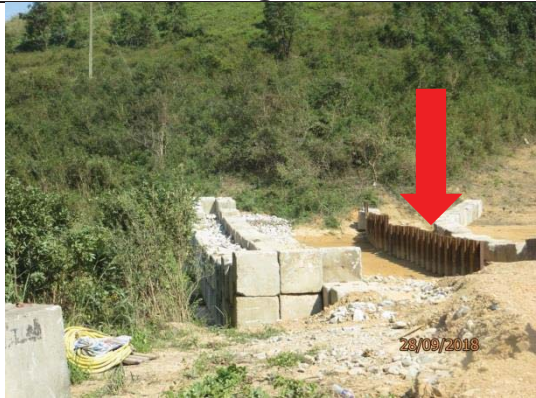
Fig C.	Fig D.

<p>Trench Steel Sheet Piles were inserted in the earth bund</p>	<p>Raised soil level to prevent muddy water enters the wet wood land</p>
<p><b>Fig E.</b></p>

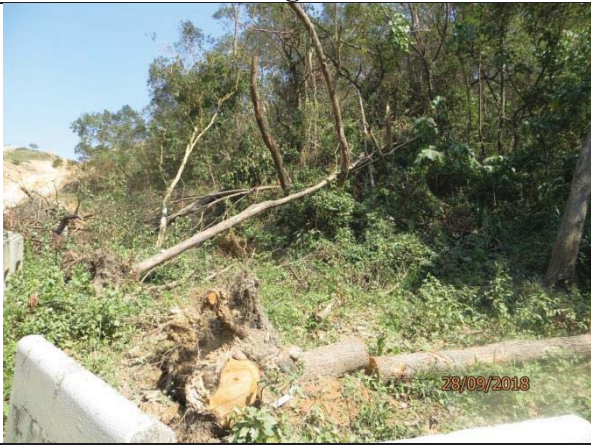
<p>Retain trees affected by typhoon Mangkhut</p>
