翠谷工程有限公司  
Green Valley Landfill, Limited

## South East New Territories (SENT) Landfill Extension

Monthly Environmental Monitoring & Audit Report No.5  
for May 2019

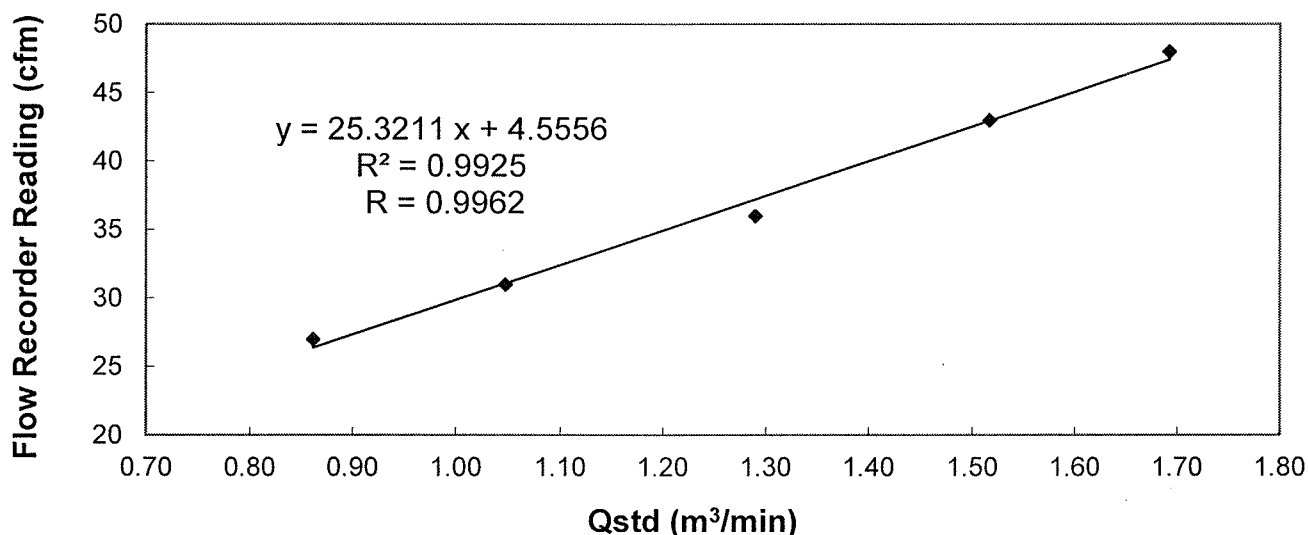
Results	Flow recorder reading (cfm)	48	43	36	31	27
	Qstd (Actual flow rate, m <sup>3</sup> /min)	1.69	1.52	1.29	1.05	0.86
	Pressure : 762.06 mm Hg	Temp. : 296 K

**Sampler 9795 Calibration Curve**  
Site: Tseung Kwan O 137 (TKO-A1)

Acceptance Criteria : Correlation coefficient (r) of the calibration curve greater than 0.990 after a 5-point calibration

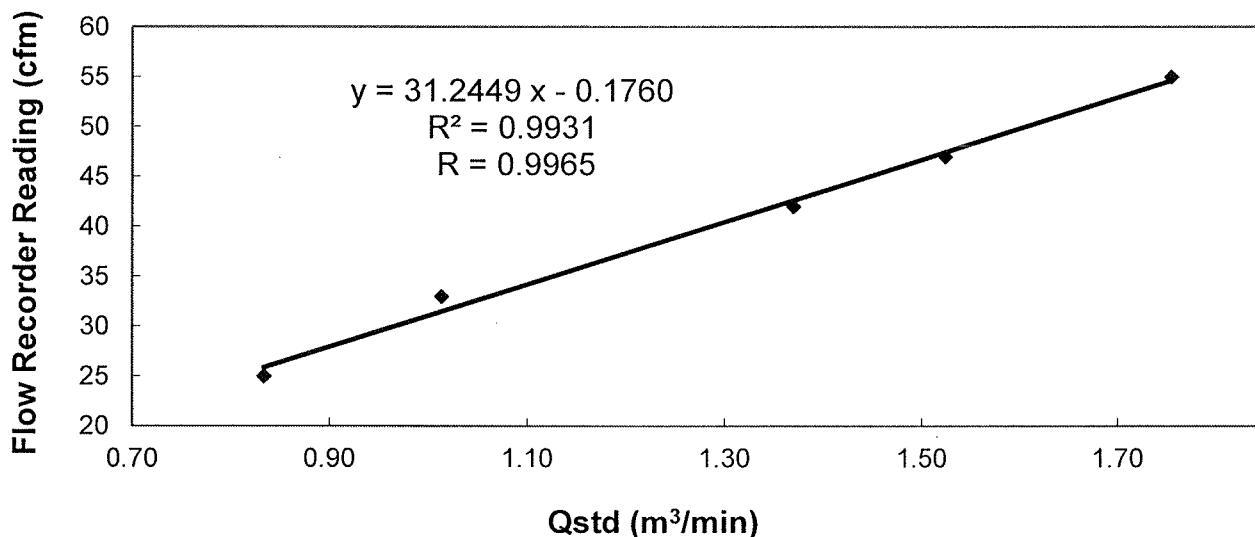
Results	Flow recorder reading (cfm)	55	47	42	33	25
	Qstd (Actual flow rate, m <sup>3</sup> /min)	1.75	1.52	1.37	1.01	0.83
	Pressure :	762.06 mm Hg			Temp. :	296 K

**Sampler 1176 Calibration Curve**  
Site: Tseung Kwan O 137 (TKO-A2a)

Acceptance Criteria : Correlation coefficient (r) of the calibration curve greater than 0.990 after a 5-point calibration

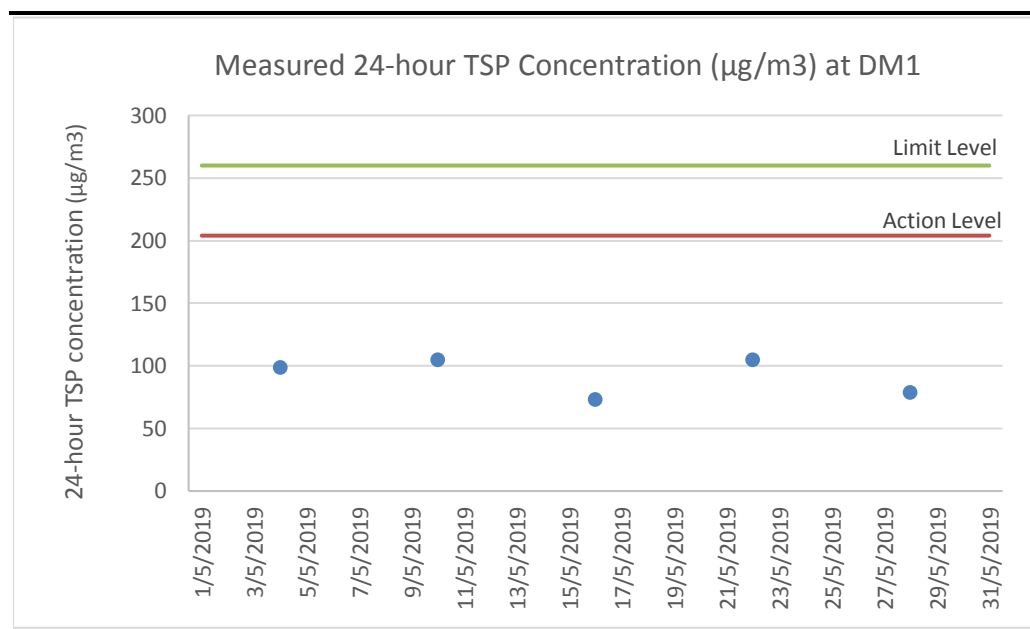
**Note:**  
DM1 corresponds to the existing TSP monitoring station TKO-A1 currently operating by CEDD.

**Figure D2.1 Graphical Presentation for 24-hr TSP Monitoring at DM1**

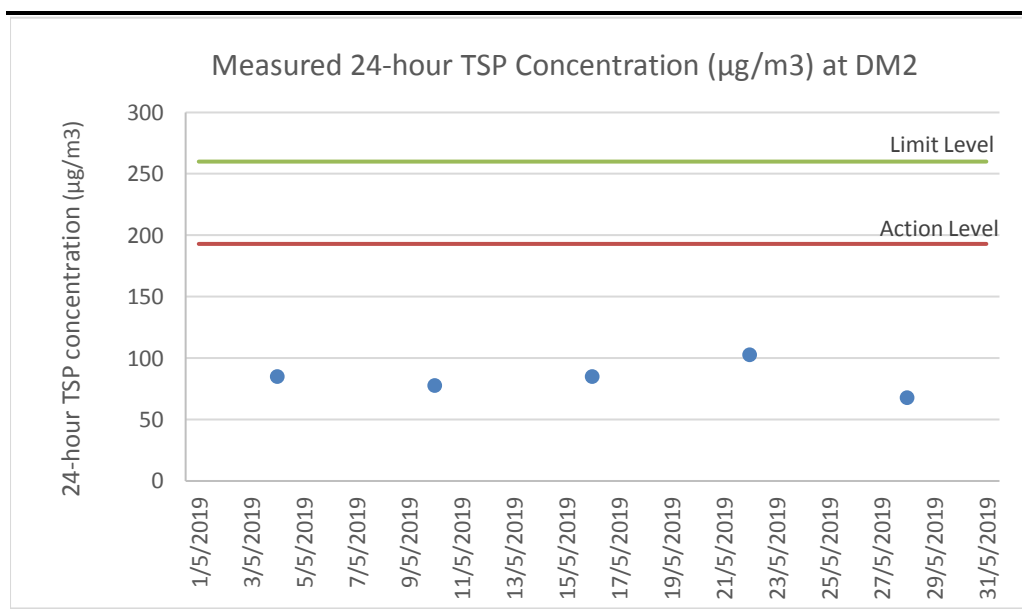
DM2 corresponds to the existing TSP monitoring station TKO-A2a currently operating by CEDD.

**Figure D2.2 Graphical Presentation for 24-hr TSP Monitoring at DM2**

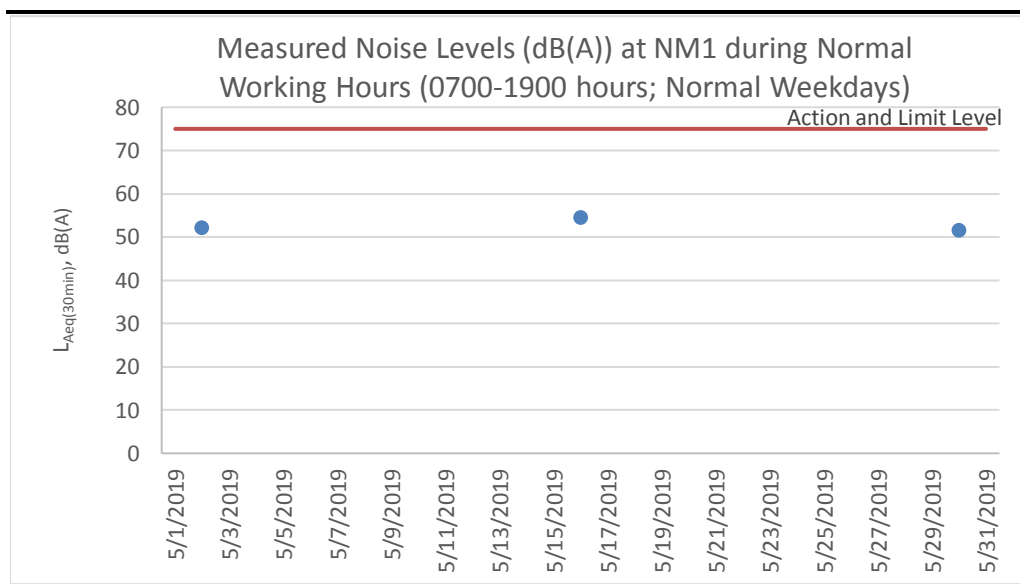
Correction of +3 dB(A) was made for free field measurements.

**Figure E2.1 Graphical Presentation for Noise Monitoring at NM1**

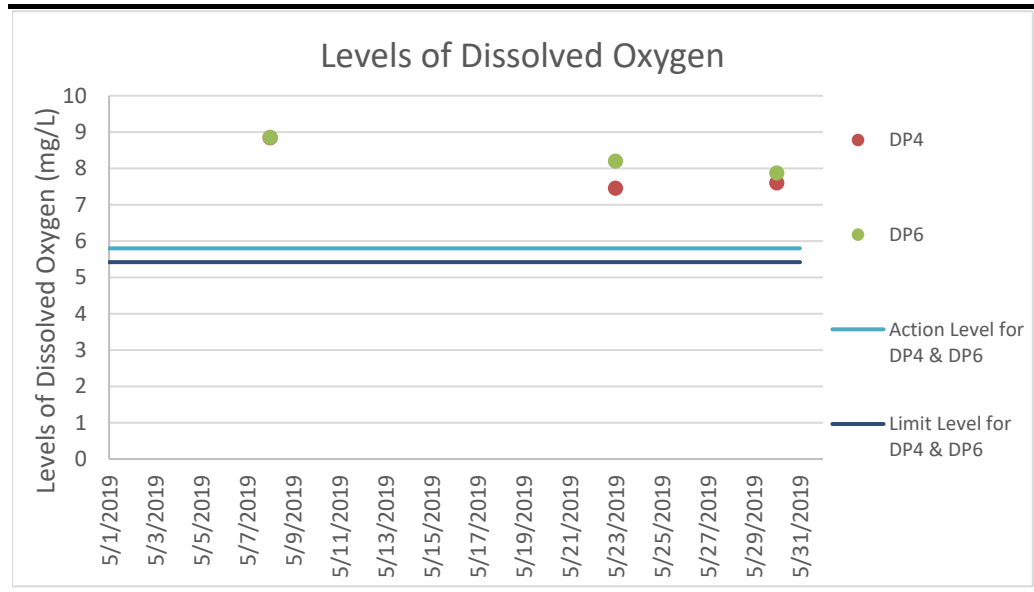
**Figure F2.1 Graphical Presentation for Surface Water Quality Monitoring (DO)**

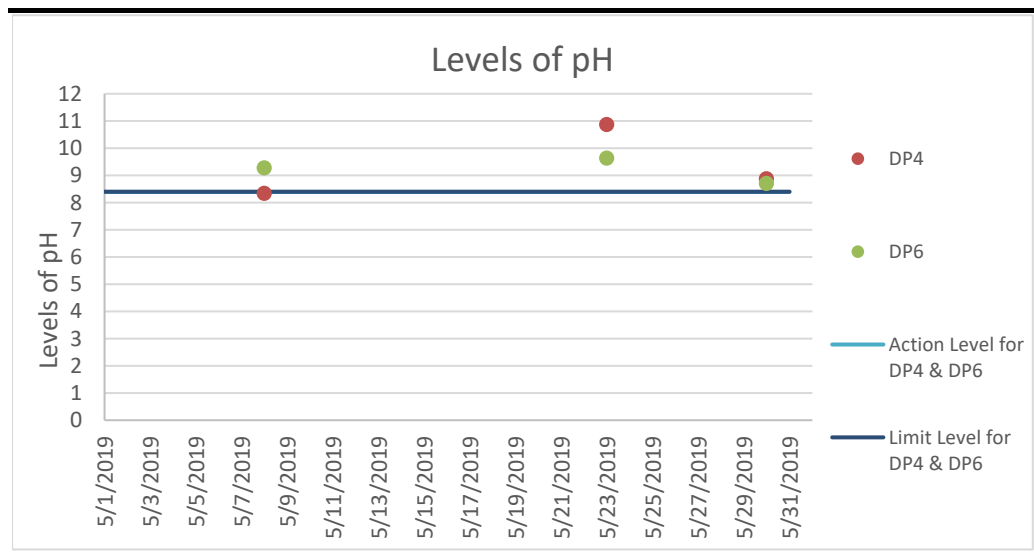
**Figure F2.2 Graphical Presentation for Surface Water Quality Monitoring (pH)**

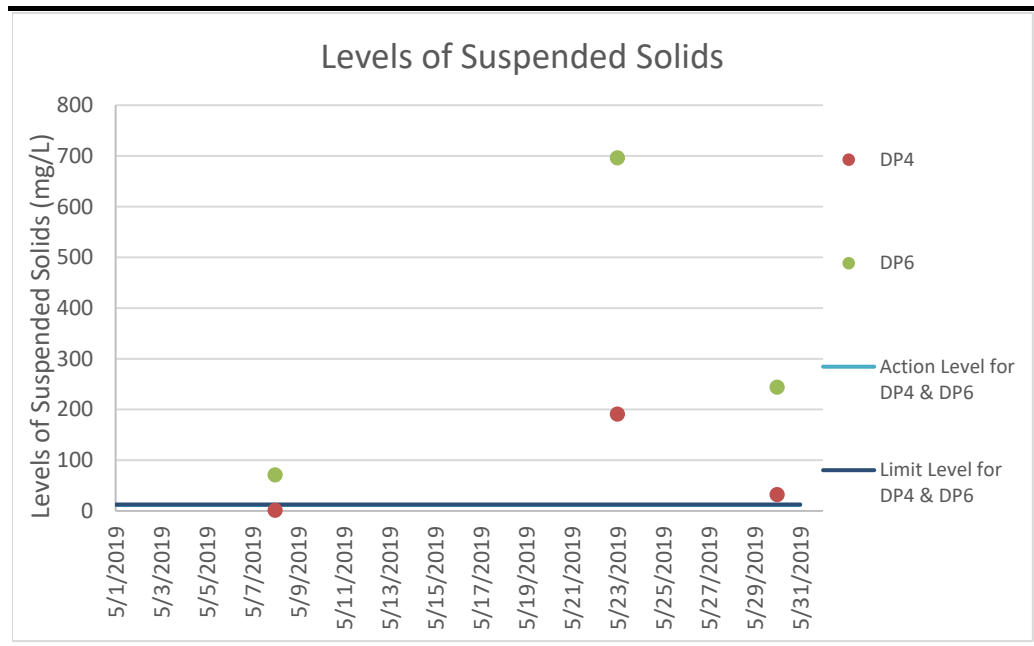
Figure F2.3 Graphical Presentation for Surface Water Quality Monitoring (SS)

Based on the investigation conducted for each of the monitoring event with potential Action and Limit Levels exceedances with the Contractor, and the IEC, the pH and SS exceedances at DP6 on 8 May 2019, pH exceedance at DP6 on 23 May 2019 and pH and SS exceedances at DP4 (Future, temporary) and DP6 on 30 May 2019 were considered not Project-related. However, upon further investigation, the pH and SS exceedances at DP4 (Future, temporary) and SS exceedance at DP6 on 23 May 2019 were found deemed to Project-related activities. The Contractor was reminded to implement all relevant mitigation measures for the construction works and maintain good site practice. The ET will keep track on the monitoring data and ensure Contractor’s compliance of the environmental requirements.
