## **South East New Territories (SENT) Landfill Extension**

Monthly Environmental Monitoring & Audit Report No.23 for November 2020

January 2021

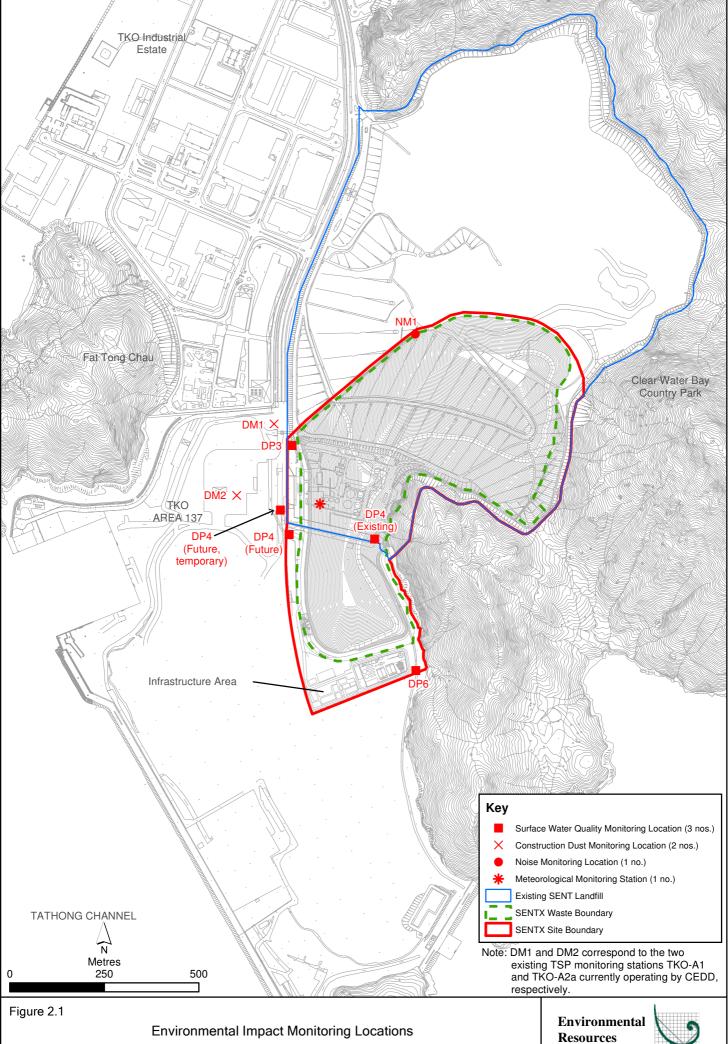
The equipment used in the impact air quality monitoring programme and monitoring locations are summarised in *Table 2.2* and illustrated in *Figure 2.1* respectively. Copies of the calibration certificates for the equipment are presented in *Annex D1*.

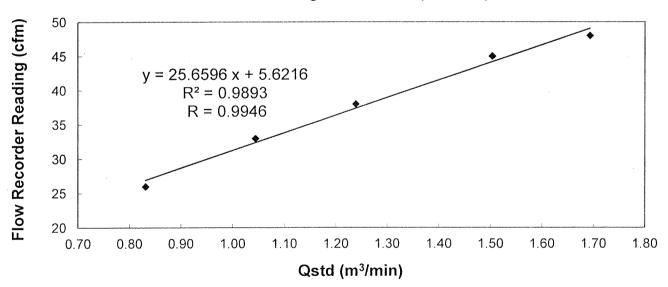
#### Sampler 9795 Calibration Curve Site: Tseung Kwan O 137 (TKO-A1)

Flow recorder rea	48	45	38	33	26	
Qstd (Actual flow	1.69	1.50	1.24	1.04	0.83	
Pressure :	758.31 mm Hg		Temp. :	301	K

Acceptance Criteria: Correlation coefficient (r) of the calibration curve greater than 0.990 after a 5-point calibration

The high volume sampler complies\* / does not comply\* with the specified requirements and is deemed acceptable\*/ unacceptable\* for use.

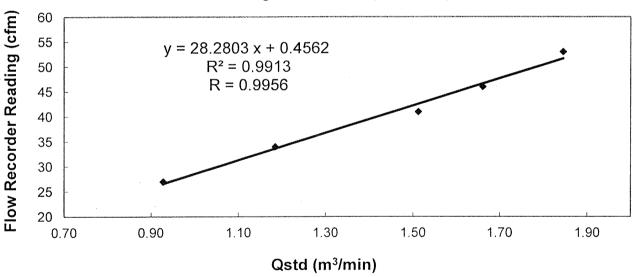
#### Sampler 1176 Calibration Curve Site: Tseung Kwan O 137 (TKO-A2a)

Flow recorder read	53	46	41	34	27	
Qstd (Actual flow	1.84	1.66	1.51	1.18	0.93	
Pressure :	758.31 mm Hg		Temp.:	301	K

Acceptance Criteria: Correlation coefficient (r) of the calibration curve greater than 0.990 after a 5-point calibration

The high volume sampler complies\* / does not comply\* with the specified requirements and is deemed acceptable\* / unacceptable \* for use.

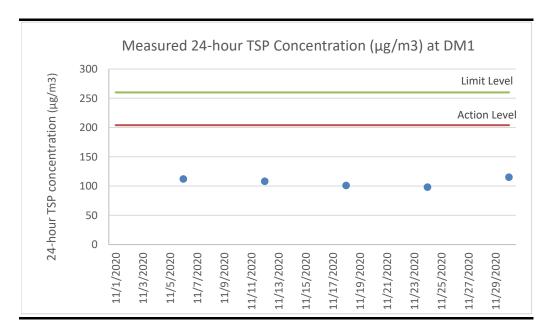
Figure D2.1 Graphical Presentation for 24-hr TSP Monitoring at DM1

$\,$  DM1 corresponds to the existing TSP monitoring station TKO-A1 currently operating by CEDD.

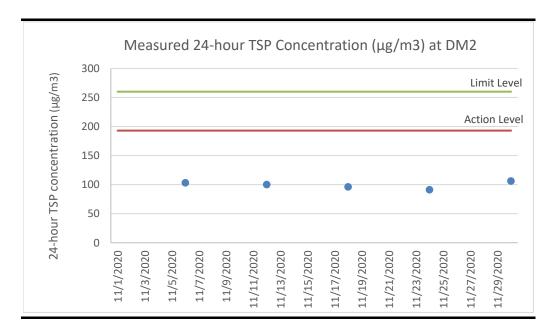
Figure D2.2 Graphical Presentation for 24-hr TSP Monitoring at DM2

Start Date	Start Time	Finish Date	Finish Time	Weather	24-hour TSP (μg/m3)
6 Nov 20	13:05	7 Nov 20	13:05	Cloudy	103
12 Nov 20	8:00	13 Nov 20	8:00	Fine	100
18 Nov 20	13:25	19 Nov 20	13:25	Cloudy	96
24 Nov 20	8:00	25 Nov 20	8:00	Cloudy	91
30 Nov 20	9:40	1 Dec 20	9:40	Cloudy	106
				Average	99
				Min	91
				Max	106

DM2 corresponds to the existing TSP monitoring station TKO-A2a currently operating by CEDD.

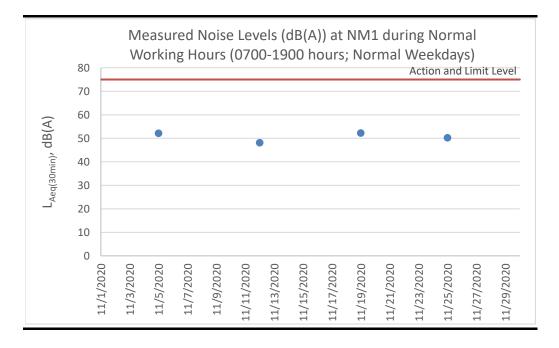
Figure E2.1 Graphical Presentation for Noise Monitoring at NM1

Correction of +3 dB(A) was made for free field measurements.
