South East New Territories (SENT) Landfill Extension

Quarterly Environmental Monitoring & Audit Report No.11

October 2021

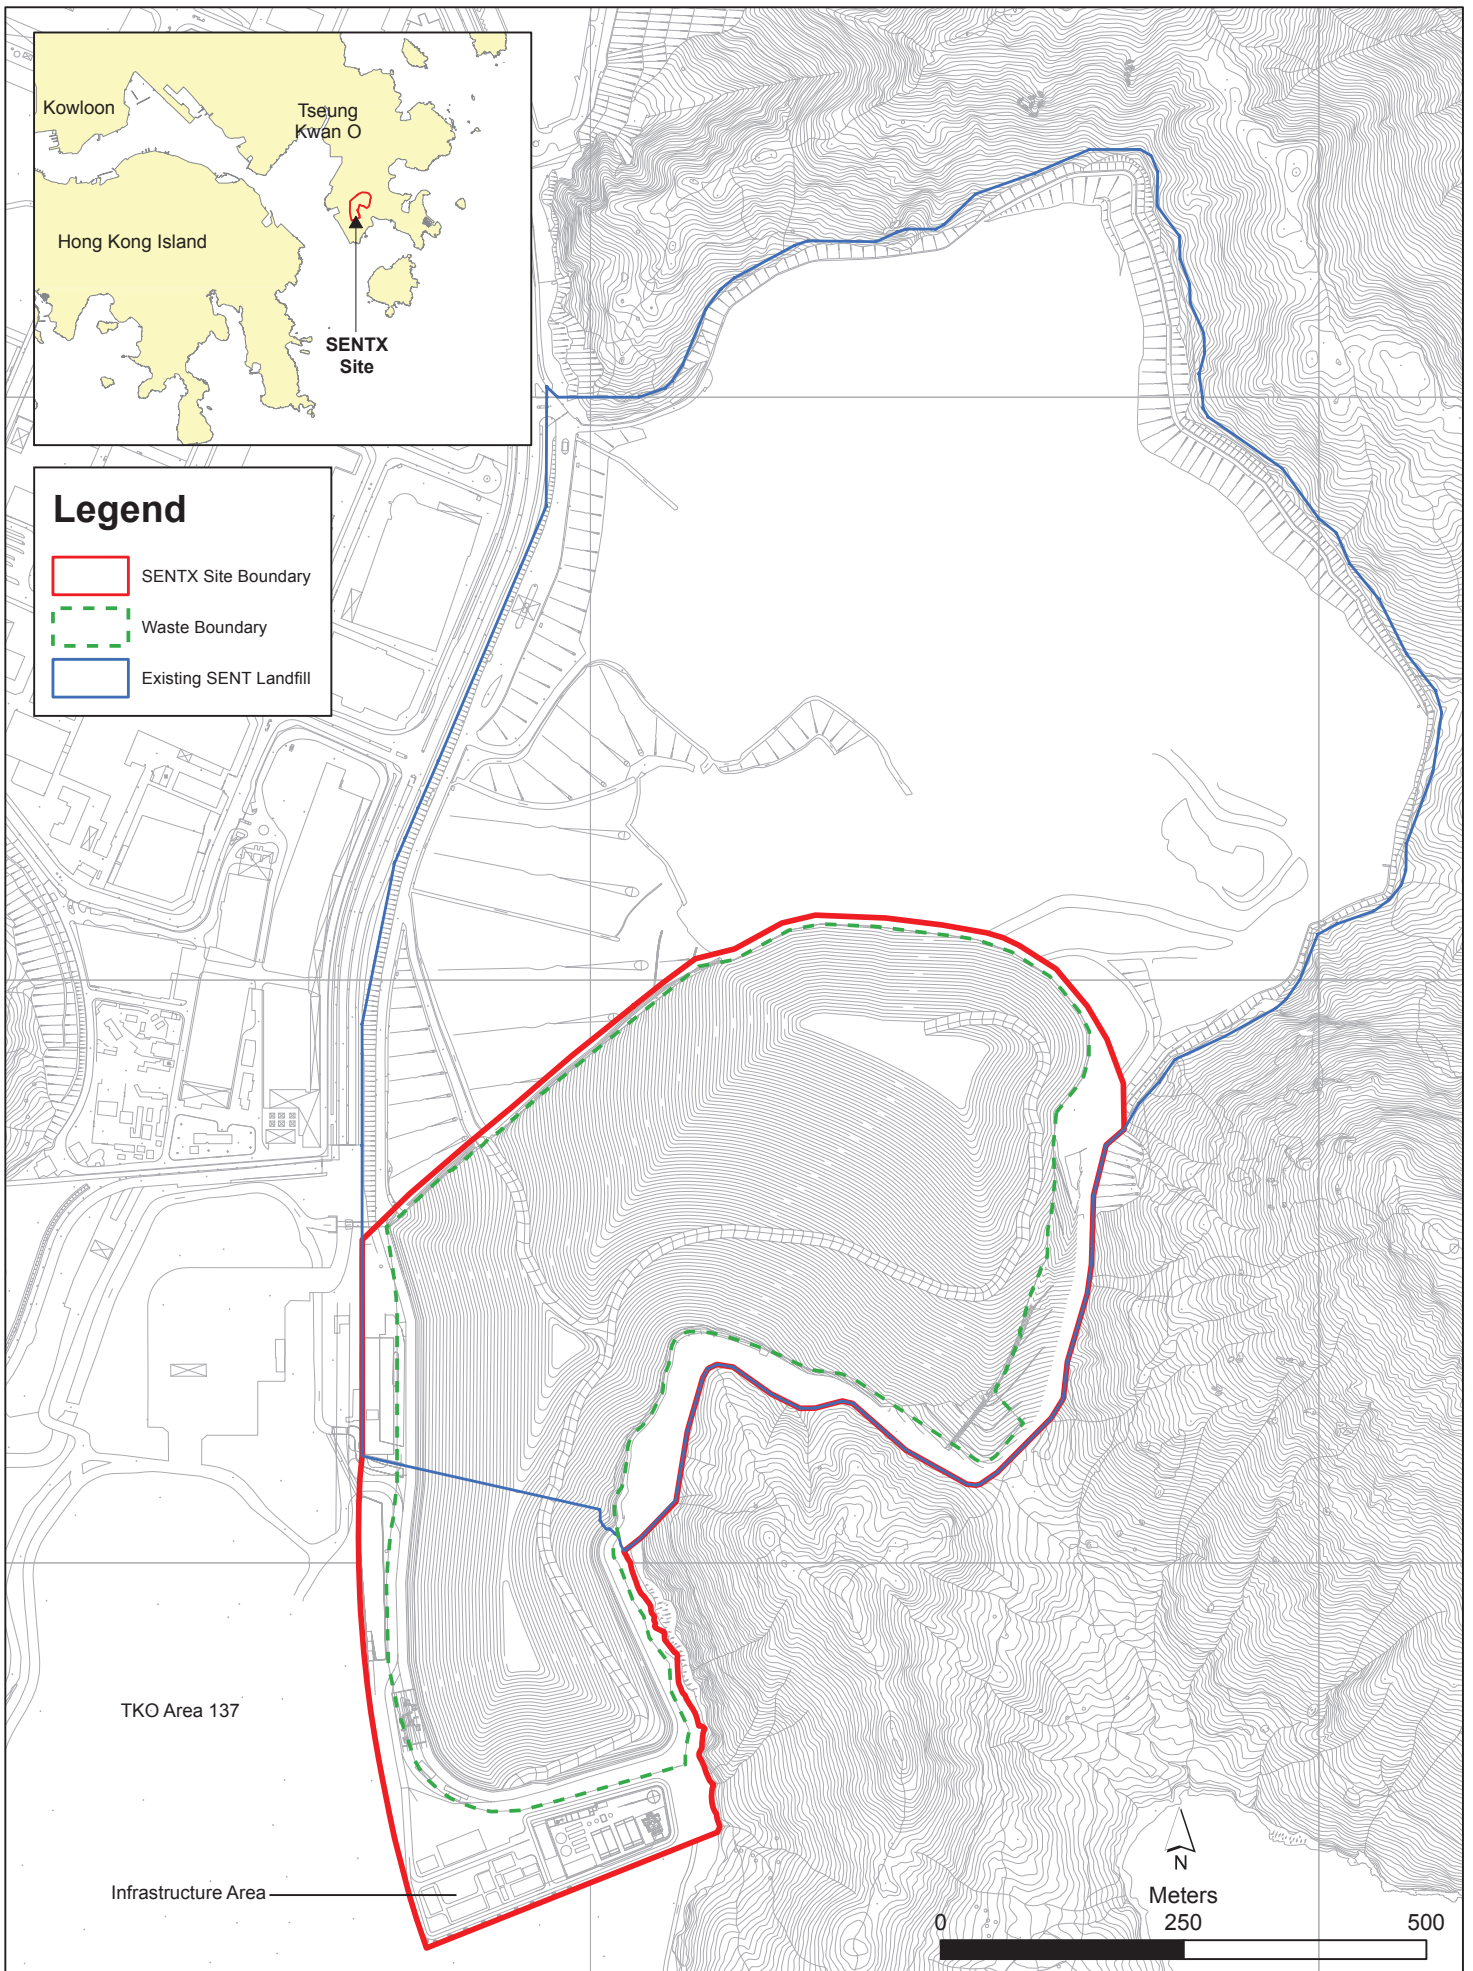
Figure 1.1

Layout Plan of SENTX

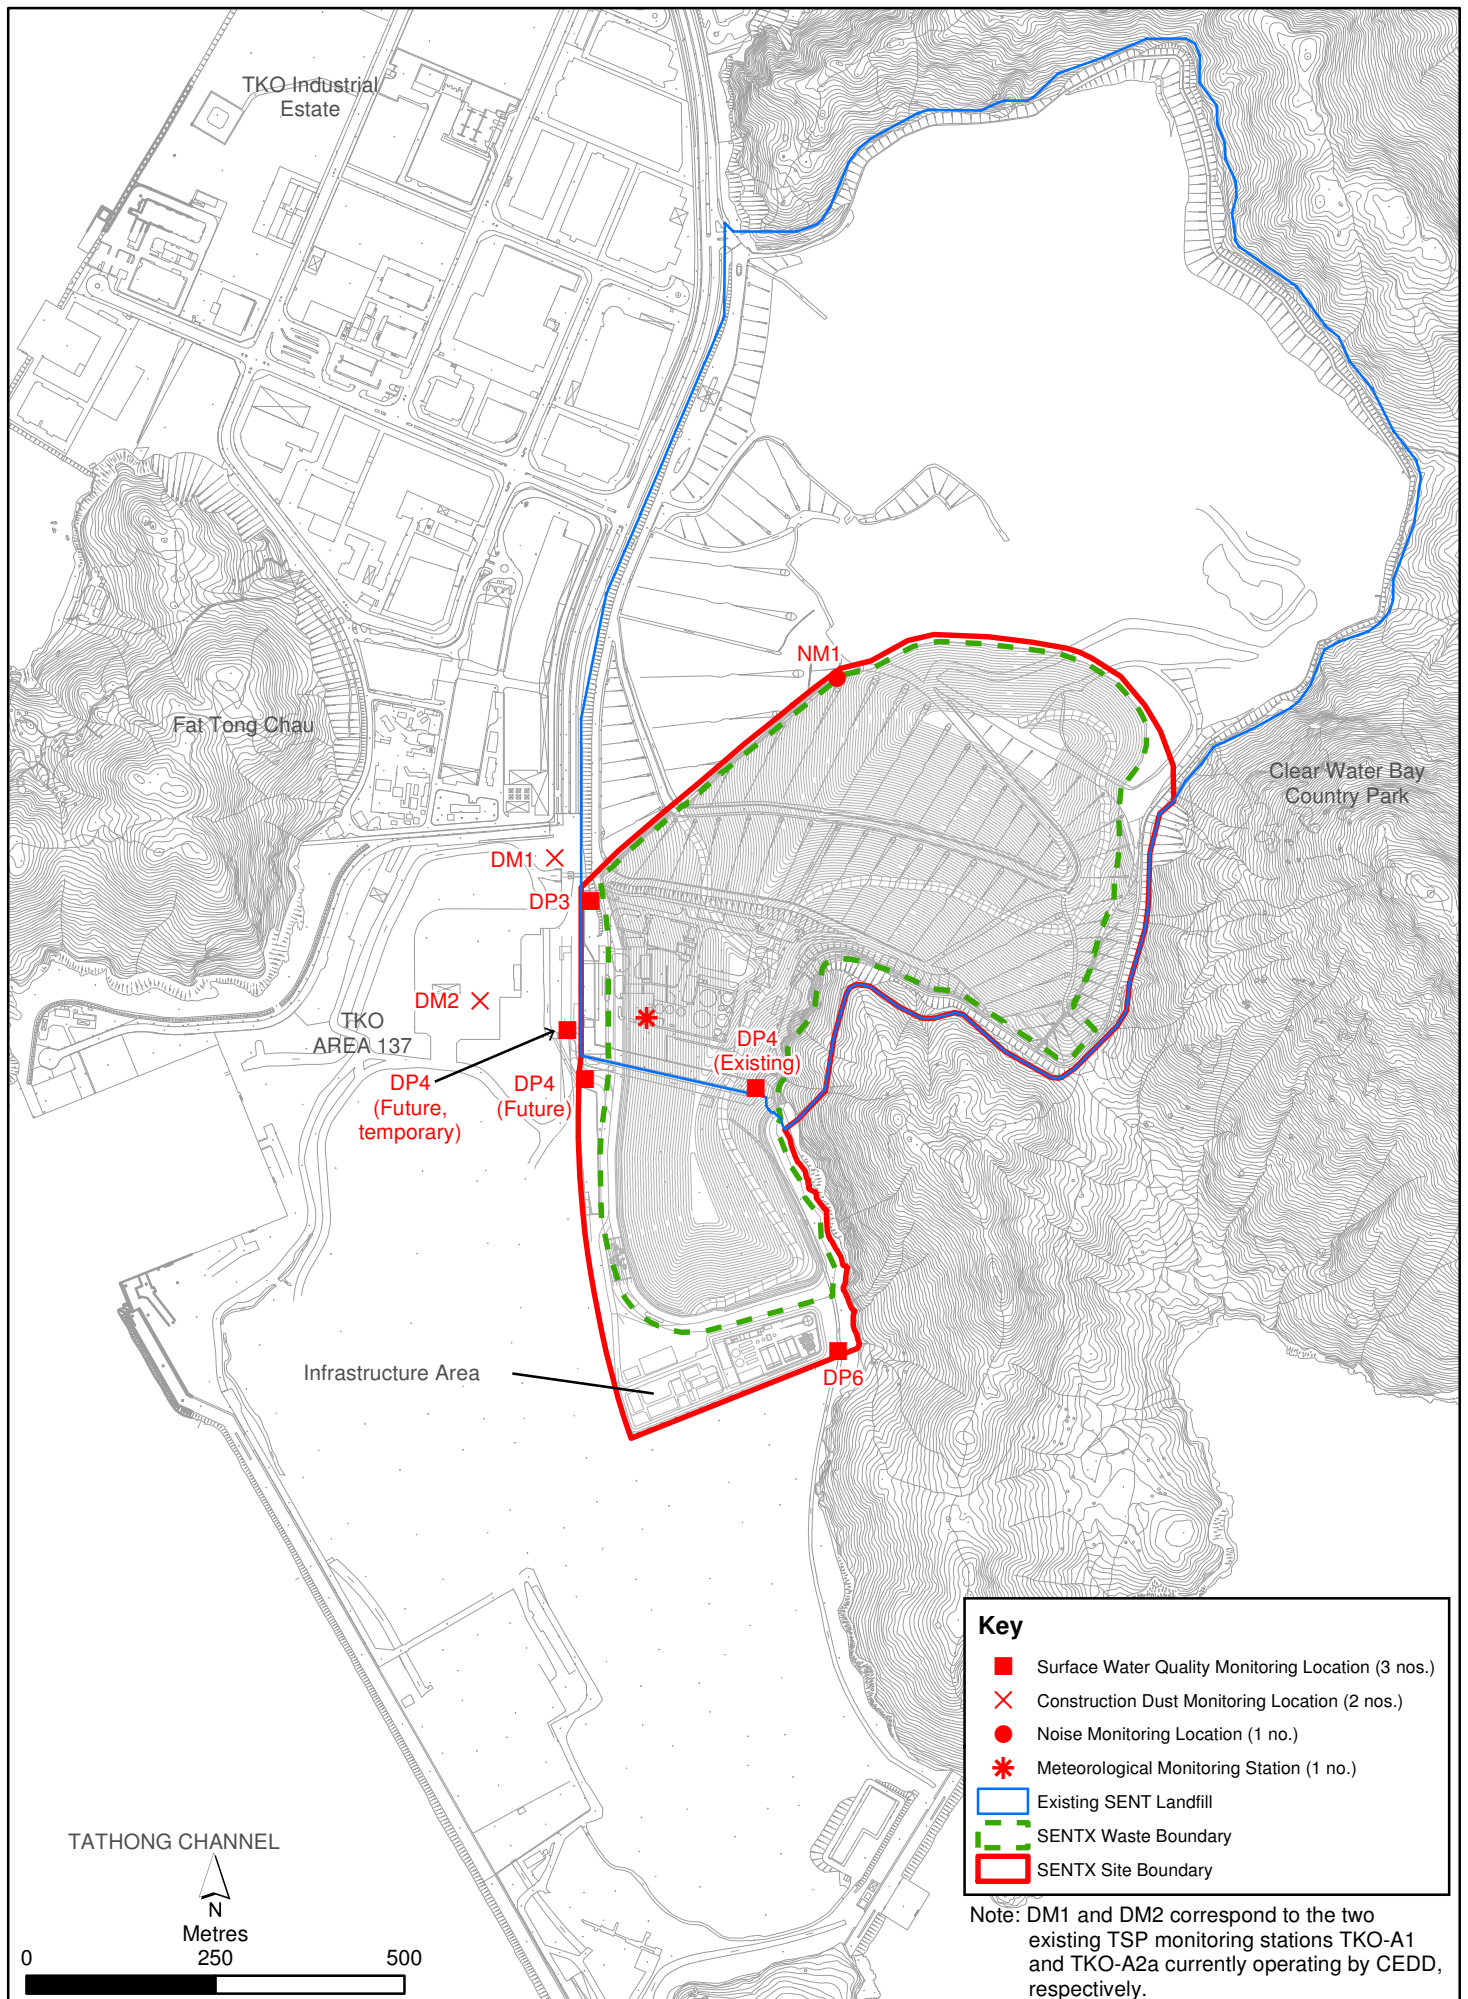
Figure 2.1

Environmental Impact Monitoring Locations

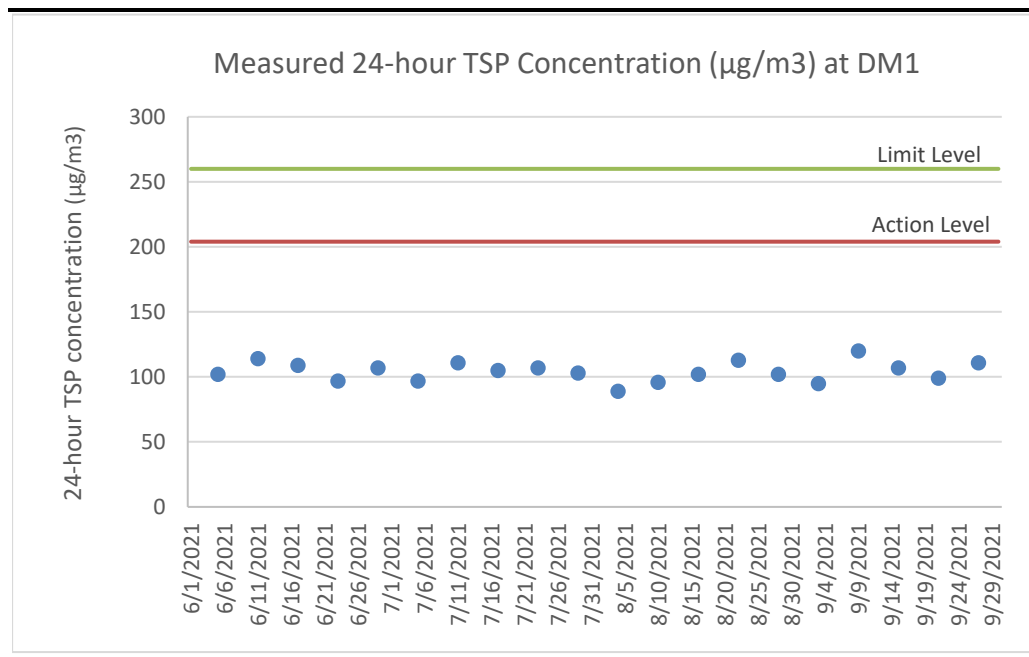
DM1 corresponds to the existing TSP monitoring station TKO-A1 currently operating by CEDD.

Figure D1.1 Graphical Presentation for 24-hr TSP Monitoring at DM1

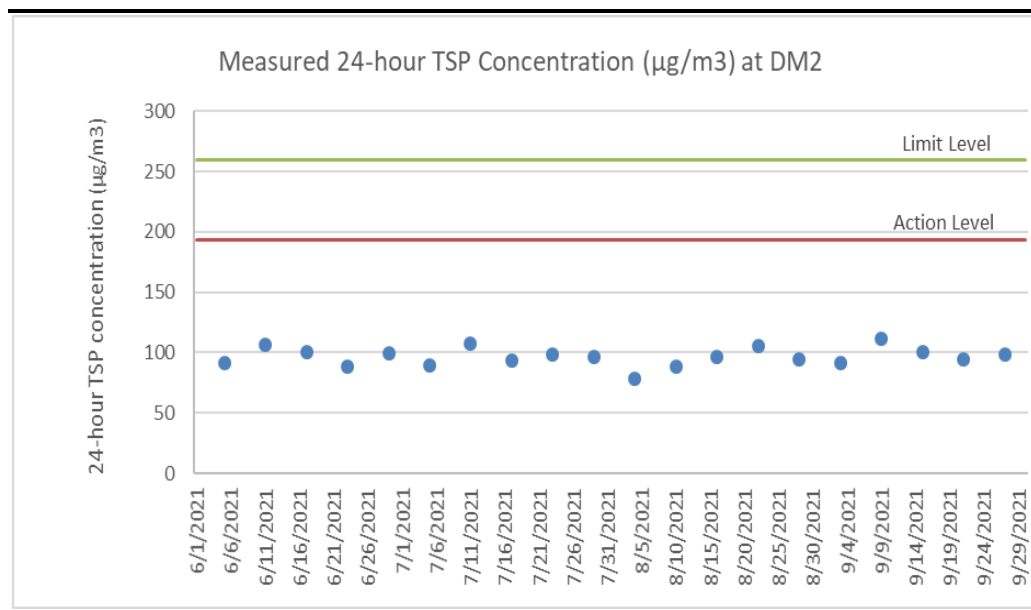
DM2 corresponds to the existing TSP monitoring station TKO-A2a currently operating by CEDD.

Figure D1.2 Graphical Presentation for 24-hr TSP Monitoring at DM2

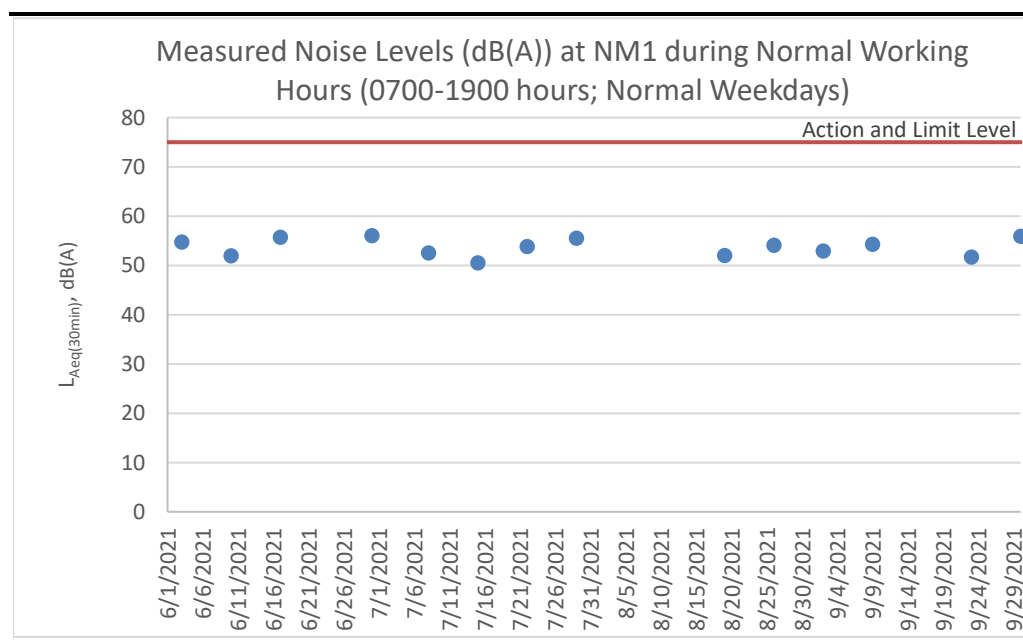
Correction of +3 dB(A) was made for free field measurements.

Figure E1.1 Graphical Presentation for Noise Monitoring at NM1

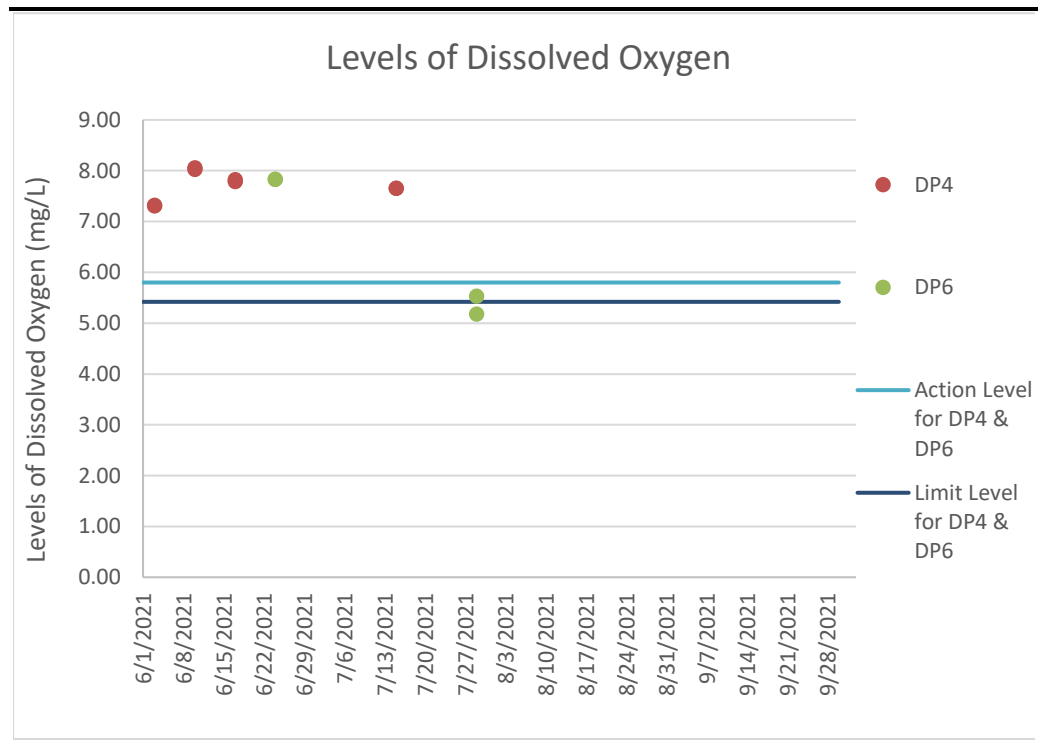
Figure F1.1 Graphical Presentation for Surface Water Quality Monitoring (DO)

One exceedance of the Limit Level for DO, one exceedance of the Limit Level for pH and one exceedance of the Limit Level for suspended solids (SS) were recorded for surface water quality impact monitoring in the reporting period. The DO, pH and SS exceedances were found deemed to Project-related activities.

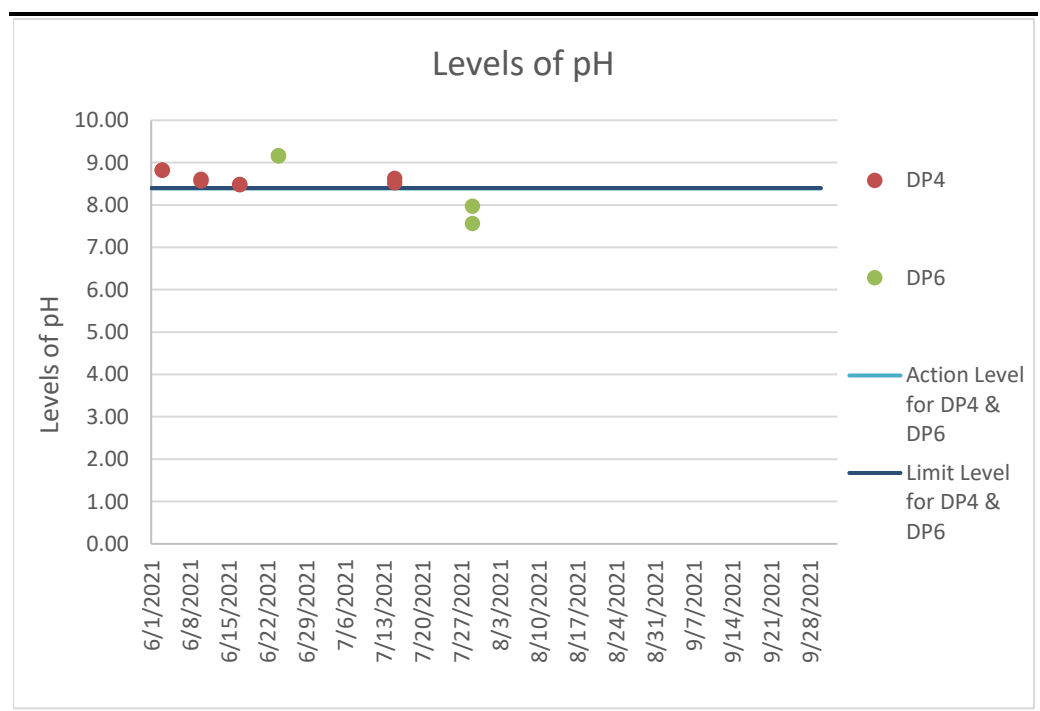
Figure F1.2 Graphical Presentation for Surface Water Quality Monitoring (pH)

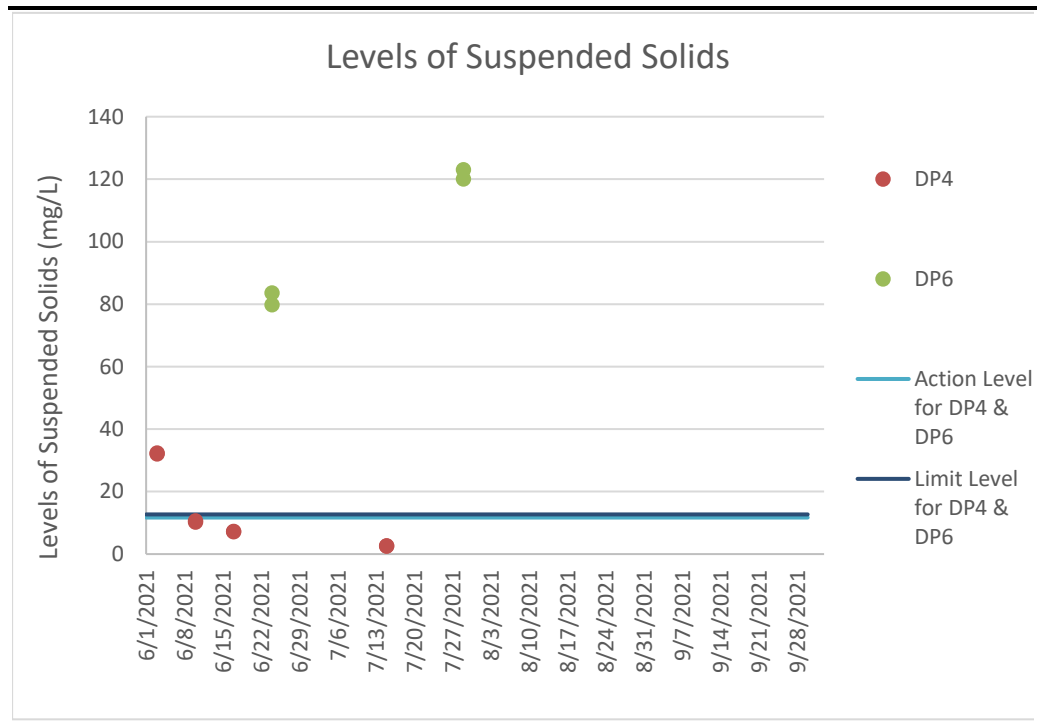
Figure F1.3 Graphical Presentation for Surface Water Quality Monitoring (SS)
