Contract No. 13/WSD/17

**Design, Build and Operate First Stage of Tseung Kwan O
Desalination Plant**

**Quarterly EM&A Report No.14
(Period from 1 June 2023 to 31 August 2023)**

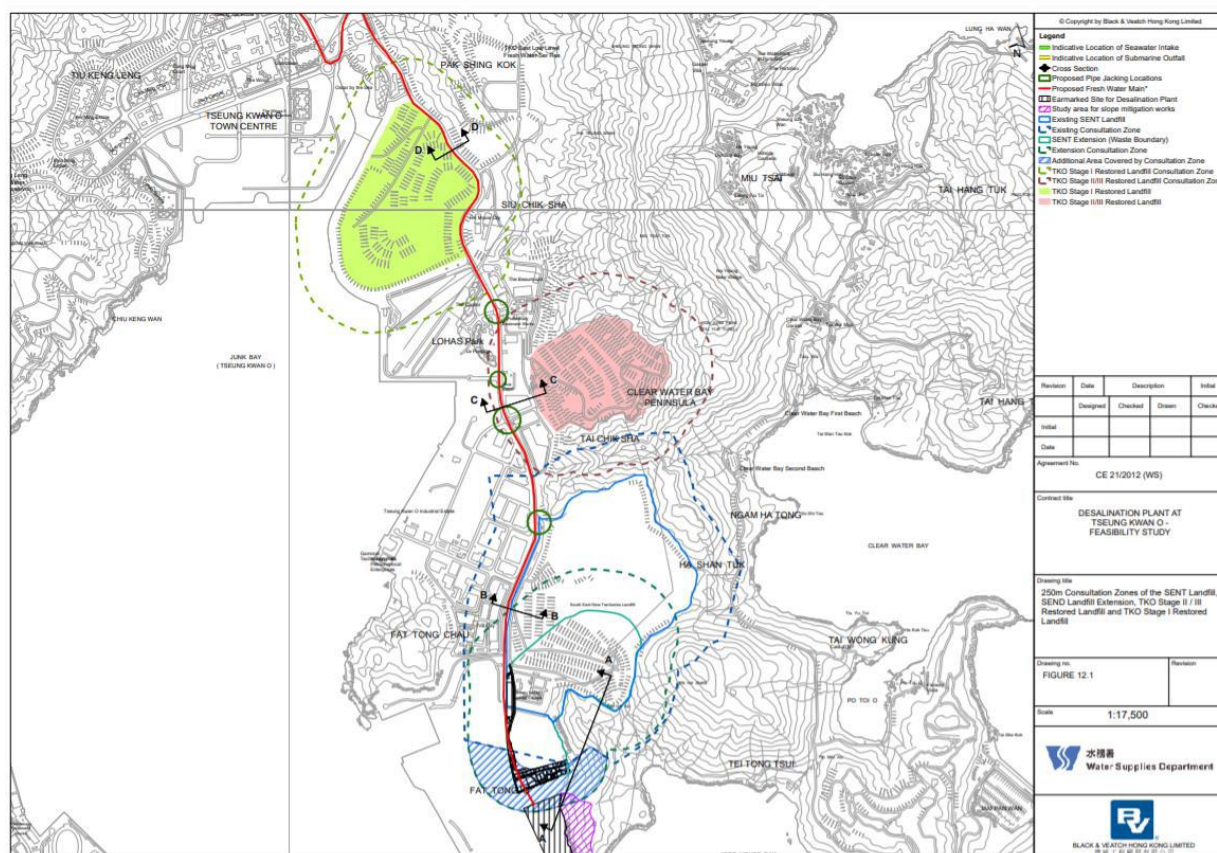
Figure 5.1 Overview of the SENT Extension Consultation Zone and the Project Site Area

The area required to be monitored for landfill gas in the reporting period is shown in **Figure 5.1**.
