**JOB No.: TCS01216/21**

**Reclaimed Water Supply to Sheung Shui and Fanling**

**MONTHLY ENVIRONMENTAL MONITORING & AUDIT  
REPORT (No.11) – OCTOBER 2022**

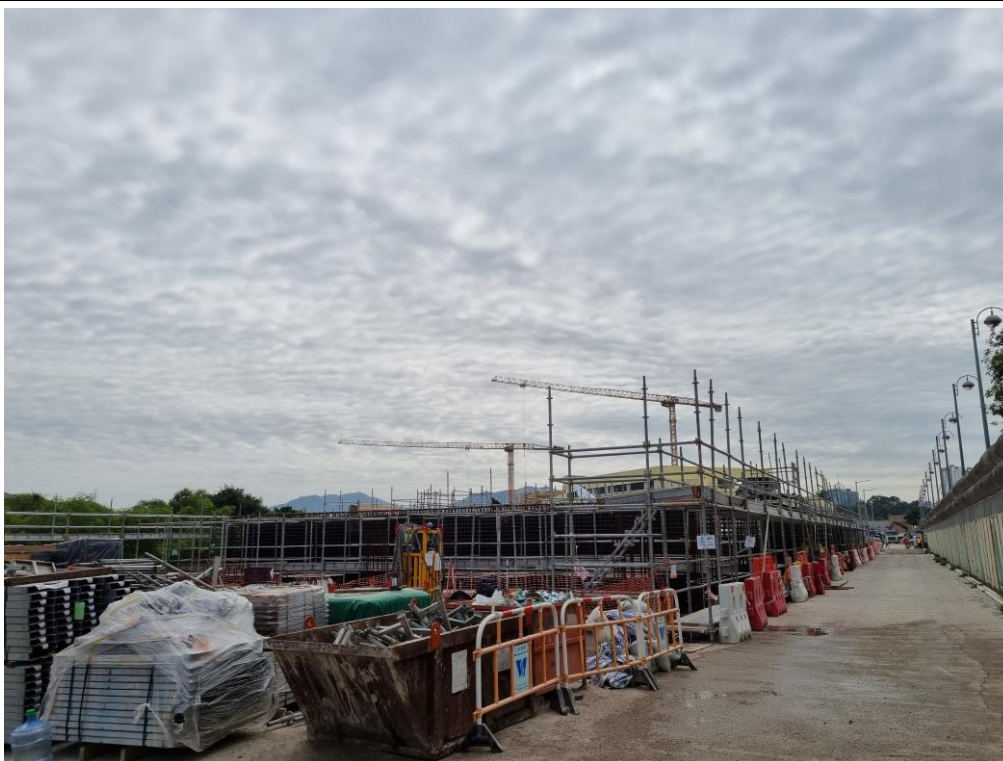
Formwork erection and scaffolding work at HCF

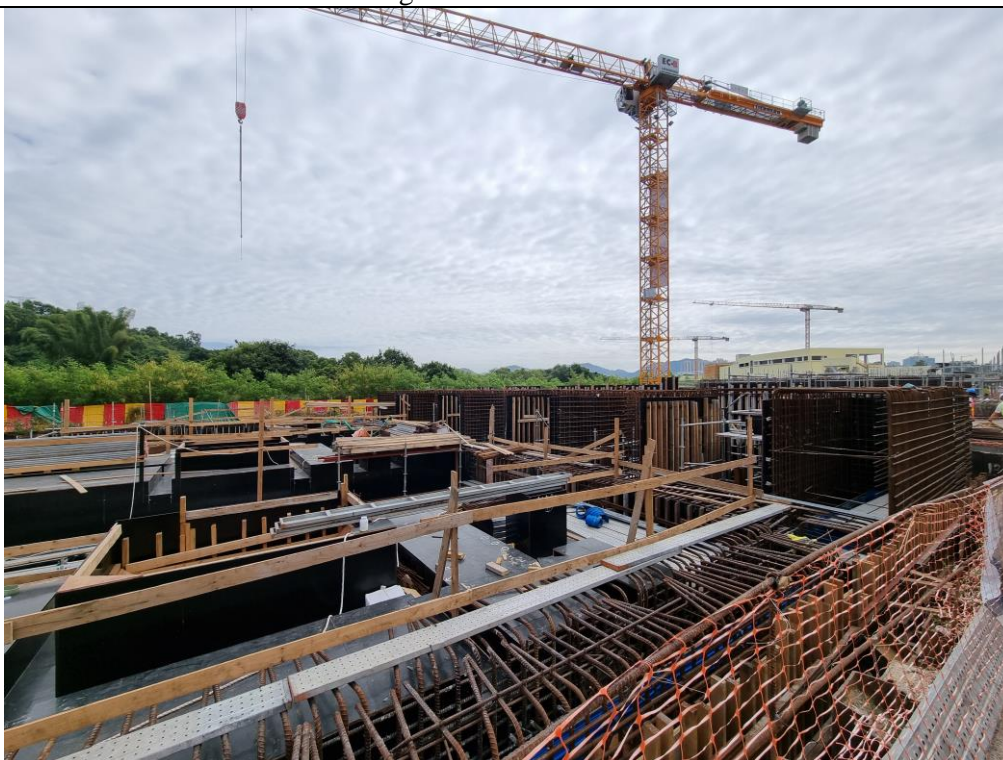
Formwork erection and scaffolding work at ReWSP
