ENVIRONMENTAL MONITORING AND AUDIT REPORT

CONTRACT No. CV/2002/13

FILL BANK AT TUEN MUN AREA 38

JANUARY 2005

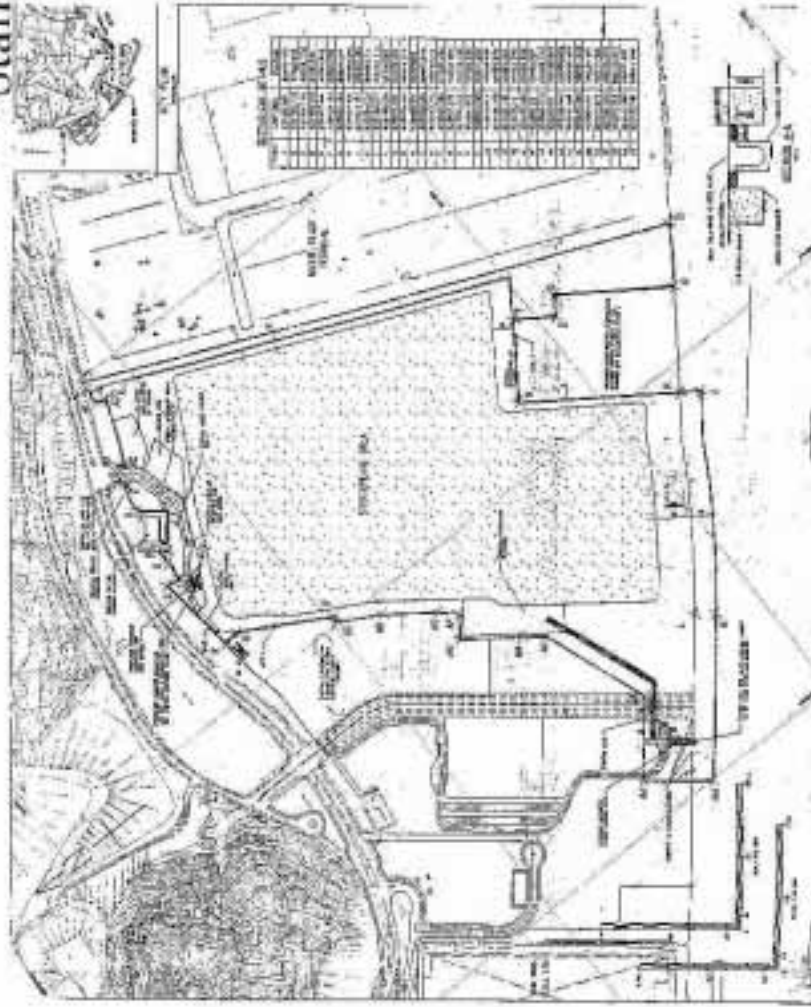
Figure 2.1 - The Site Layout Plan

The site layout plan is shown in Figure 2.1.

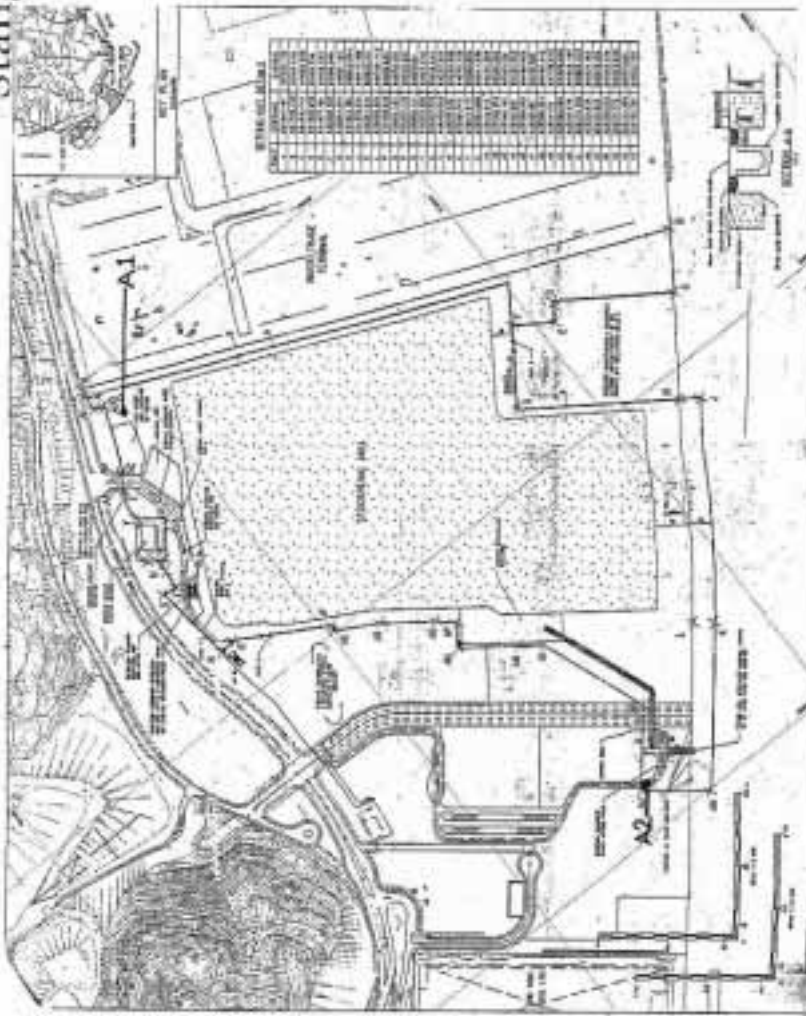
Figure 4.1 – Air Quality Monitoring Stations

Two stations (A1 and A2) have been identified as the locations for the monitoring of 24-hour and 1-hour Total Suspended Particulates (TSP). In this reporting period, the monitoring of 24-hour TSP was carried out on five occasions at A1 and A2. Monitoring of 1-hour TSP was carried out on fifteen occasions at A1 and A2. There was no exceedance to the set action or limit levels for both parameters at both stations.

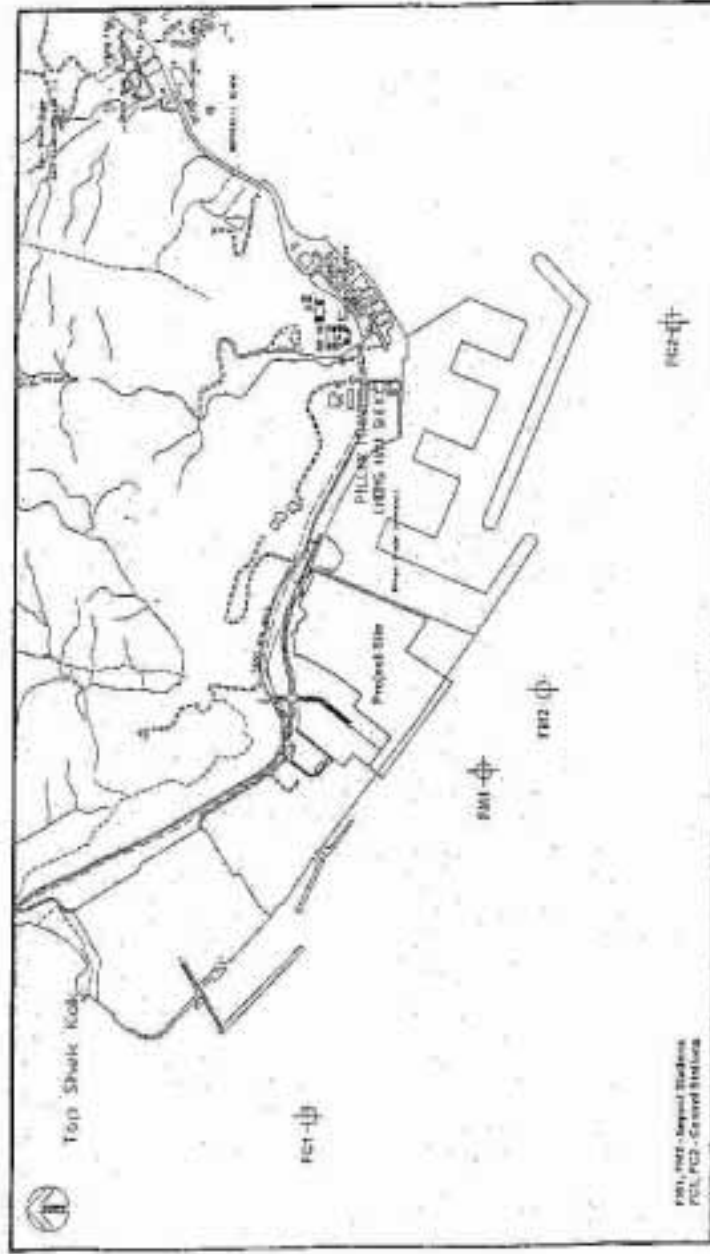
Figure 4.2 – Water Quality Monitoring Stations

Water quality in terms of turbidity, dissolved oxygen, suspended solids, temperature, and salinity, was carried out on twelve occasions during flood tide and eleven occasion during ebb tide at FM1, FM2, FC1 and FC2 in this reporting period. There was no exceedance to the set action or limit level for all parameters at all stations.
