**Proposed Extension of Public Golf Course  
at Kau Sai Chau Island, Sai Kung**

**Monthly Environmental Monitoring & Audit (EM&A) Report  
for February 2006**

**(Report No. 382210/002)**

**March 2006**

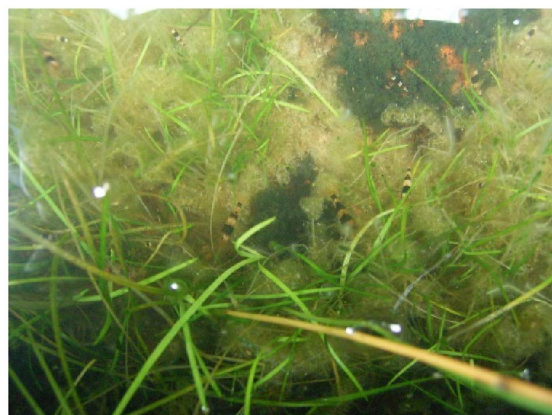
- 5.3.10 Aquatic fauna communities were checked during the monitoring survey. Atyid shrimp *Caridina trifasciata* were found in Stream B, Stream C & Stream D during the present monitoring survey (**Annex E - Photo Plate 5.3-1**). Abundance was low in all streams but slightly higher in Stream B. Stream C had been of higher shrimp abundance in the January 2006 survey, but became much dryer in the present survey and thus the shrimp abundance had dropped. Two juvenile individuals of the endemic freshwater crab *Nanhaipotamon hongkongense*, which had been recorded in Streams C and D during the EIA study but not recovered in the January 2006 survey, was found inside burrows on the dry channel bed of Stream C during the present monitoring survey (**Annex E - Photo Plate 5.3-2**).

*Caridina trifasciata* in Stream C

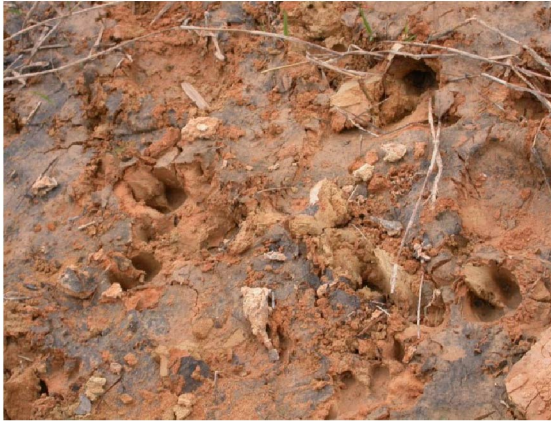
- 5.3.11 Other aquatic fauna and flora encountered during the monitoring included Freshwater snail *Brotia hainanensis*, which is usually found in streams with good water quality, found at B2 tributary of Stream B, and Long-armed Palemond shrimp *Macrobrachia hainanensis* in the isolated shallow pools in Stream C, and Sundew. Some wild boar footprints were also found at the stream bed of Stream A (**Annex E - Photo Plate 5.3-1**).

Wild boar footprints at Stream A

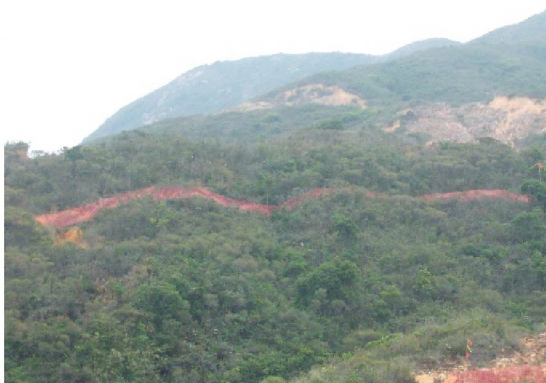
- 5.3.12 The demarcation of the stream buffer zone had been partially established at Stream A main stream and Tributary B2 of Stream B at the time of the monitoring survey (**Annex E - Photo Plate 5.3-2**). As the construction works were still close to the exiting golf course, it is anticipated that the establishment of stream buffer zone demarcation will be finished before the works fronts reach each stream.

Stream buffer zone at Stream A

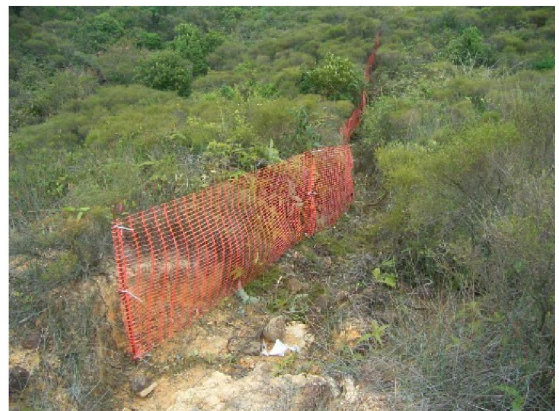
Close-up view of stream buffer zone

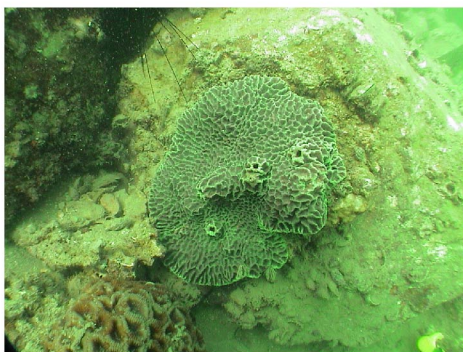
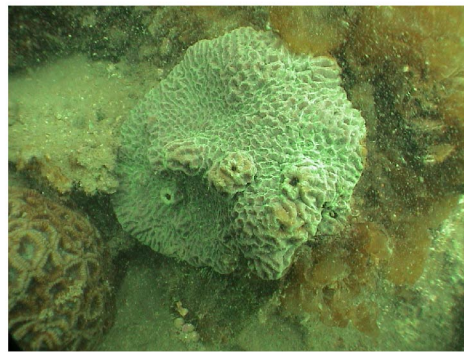
B-01

- 5.3.14 Site B2 was the location for the temporary barging point. Except some land works at the nearby abandoned pier, no marine construction works had been conducted at this location since the Baseline Survey when the present monitoring survey was conducted. All 20 tagged corals were recovered. No mortality, sedimentation or bleaching was found on any of the tagged corals (see **Table 5.3-1**). The corals remained similar conditions as during the Baseline Survey (**Annex E - Photo Plates 5.3-3 to 5.3-6**). No difference was found on the conditions of the tagged corals within and outside the proposed floating barging point boundary.

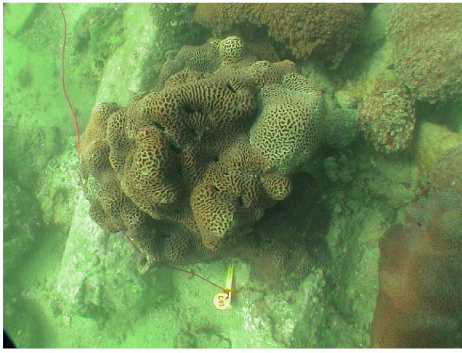
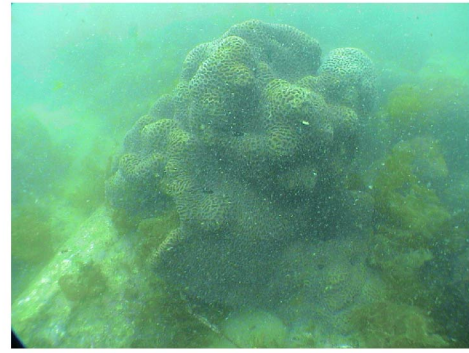
C-01

- 5.3.15 Site C was on the south-eastern coast of Kau Sai Chau Island and had a high coral coverage among the sites investigated during the EIA Study. The sizes of coral colonies at Site C were also larger than those at other sites. Site C was away from the boundary of the new golf course and would not be subject to direct impacts during construction. The site and its vicinity still remained similar conditions as during the Baseline Survey. All 20 tagged corals were recovered. No mortality, sedimentation or bleaching was found on any of the tagged corals (see **Table 5.3-2**). The corals remained similar conditions as during the Baseline Survey (**Annex E - Photo Plates 5.3-7 to 5.3-10**).
