Contract No.CV/2004/02
Reconstruction of Wong Shek and Ko Lau Wan
Public Piers

Wong Shek Pier Coral Translocation Report

May 2005

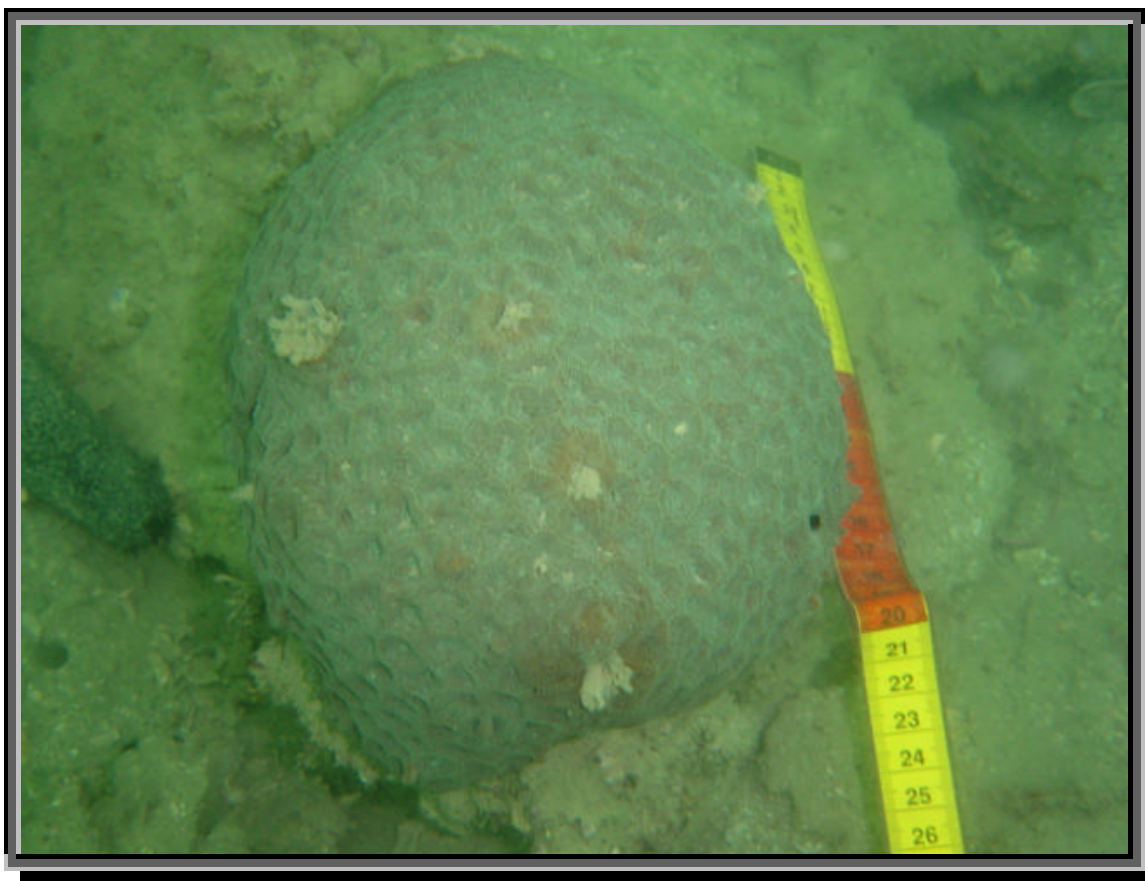
Photo A

From previous dive surveys the *Favia* colony was located approximately 10 meters to the south of Wong Shek Pier, under the proposed temporary pier. The colony (approx 20-30 cm diameter) was growing on a medium sized boulder on a sand/mud seafloor at a depth of -3.6m CD.

Wong Shek Coral Colony

1. A digital image of the coral colony was taken prior to translocation (Photo A);
2. The condition of the coral and substrate was noted for any partial mortality, bleaching or lesions (Table 1);
3. Comparisons of the colony were made from previous underwater images as taken by CEDD;
4. The coral colony was carefully placed in an oversized cradle and attached to a lifting bag and then moved underwater to Position B;
5. The coral colony was replaced in Position B (-3.5m CD) and photographed (Photo B);
6. The colony was tagged for future monitoring after completion of the reconstruction of the new pier.

In accordance with the Environmental Permit, at no time was the coral colony exposed above the water surface. The health and condition of the coral was noted prior to and after translocation and appeared to be in a healthy condition.
