**Proposed Extension of Public Golf Course
at Kau Sai Chau Island, Sai Kung**

**Monthly Environmental Monitoring & Audit (EM&A) Report
for February 2007**

(Report No. 382210/014)

March 2007

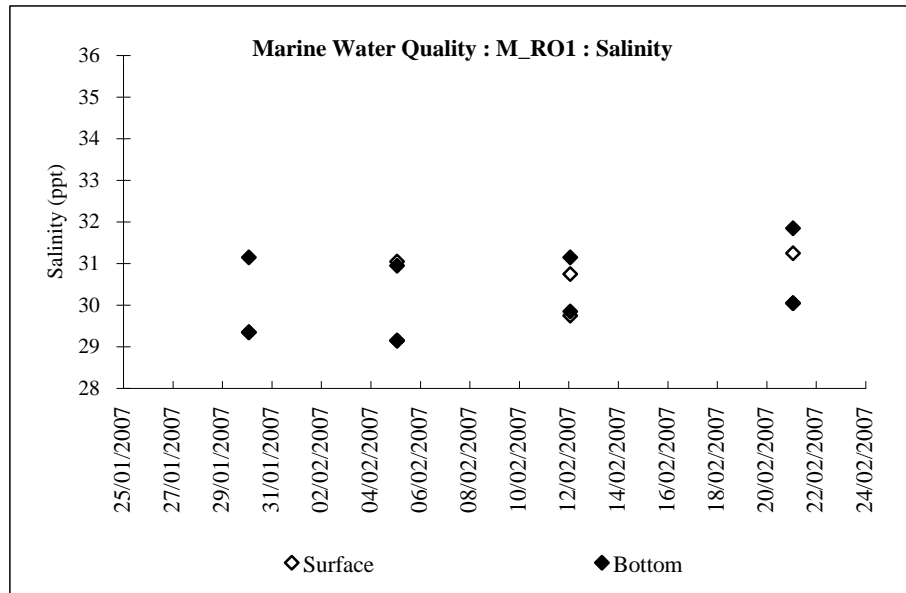
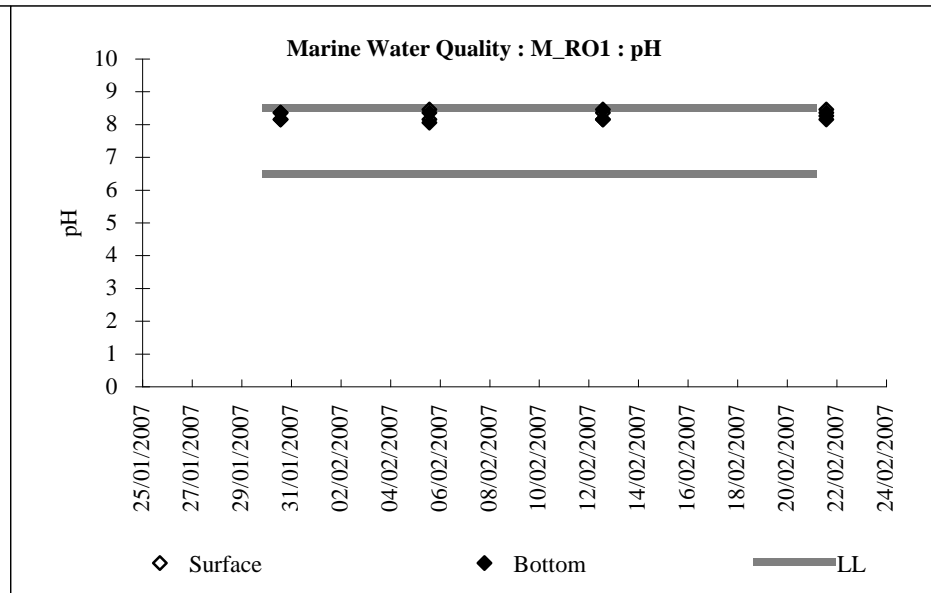
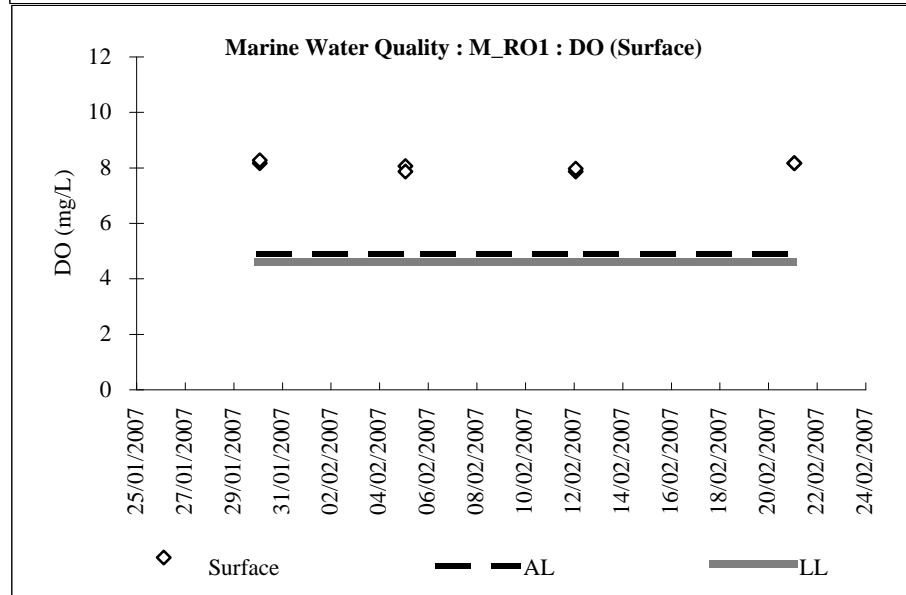
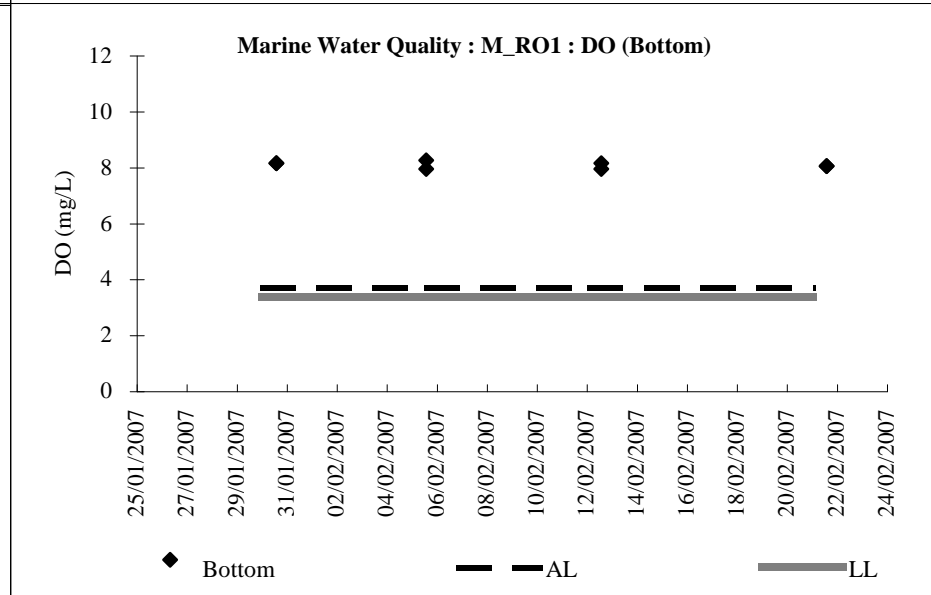
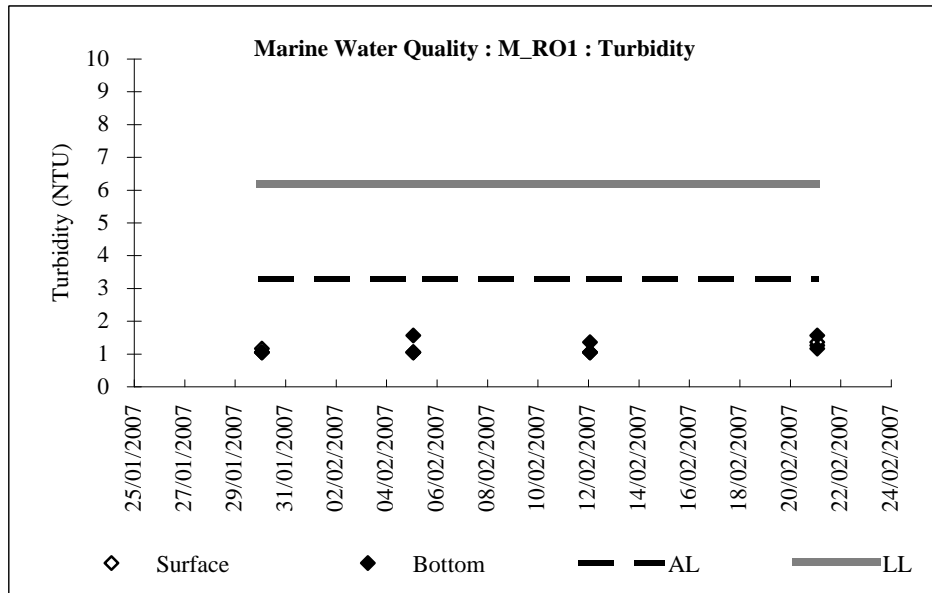
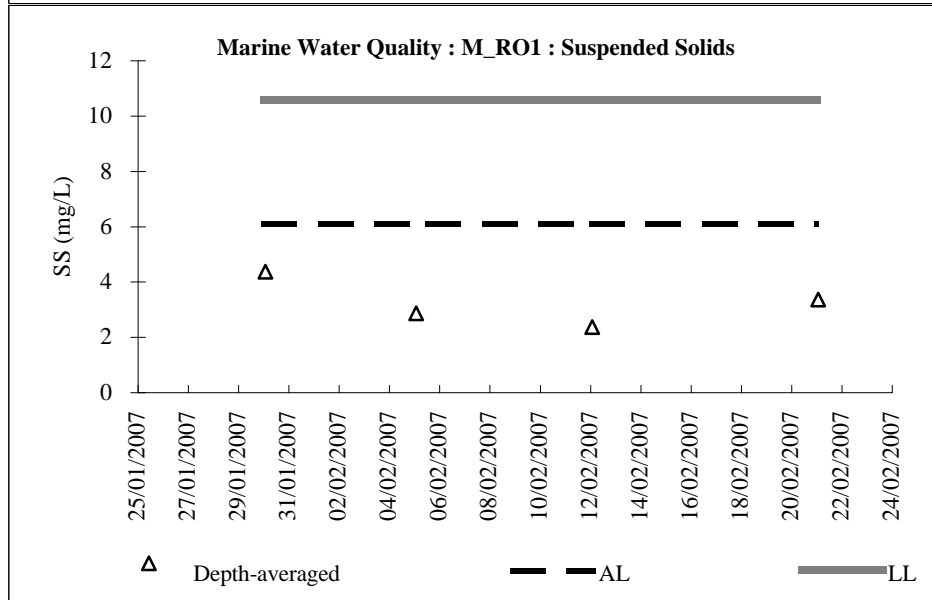
M_RO1		Bottom							
tide condition	Date	time	Water depth (m)	Sampling depth (m)	Temp (°C)	Salinity (ppt)	DO (mg/L)	pH	Turbidity (NTU)
Mid-Ebb	30/01/2007	9:00	5.6	4.6	18.4	29.3	7.8	8.1	1.0
Mid-Ebb	05/02/2007	9:00	5.5	4.5	19.1	29.1	7.6	8.0	1.0
Mid-Ebb	12/02/2007	8:30	5.4	4.4	18.4	29.8	7.8	8.1	1.0
Mid-Ebb	21/02/2007	13:00	5.7	4.7	20.0	30.0	7.7	8.1	1.5

M_RO1		Bottom							
tide condition	Date	time	Water depth (m)	Sampling depth (m)	Temp (°C)	Salinity (ppt)	DO (mg/L)	pH	Turbidity (NTU)
Mid-Flood	30/01/2007	12:00	5.6	4.6	18.9	31.1	7.8	8.3	1.0
Mid-Flood	05/02/2007	13:30	5.8	4.8	19.6	30.9	7.9	8.3	1.5
Mid-Flood	12/02/2007	13:00	5.7	4.7	18.9	31.1	7.6	8.4	1.3
Mid-Flood	21/02/2007	10:00	5.9	4.9	20.9	31.8	7.7	8.3	1.1

M_RO1	Mid-Ebb			Mid-Flood			Depth-averaged
	Surface	Middle	Bottom	Surface	Middle	Bottom	SS (mg/L)
30/01/2007	3.0	-	2.0	6.0	-	5.0	4.0
05/02/2007	2.0	-	2.0	3.0	-	3.0	2.5
12/02/2007	2.0	-	2.0	2.0	-	2.0	2.0
21/02/2007	4.0	-	2.0	3.0	-	3.0	3.0

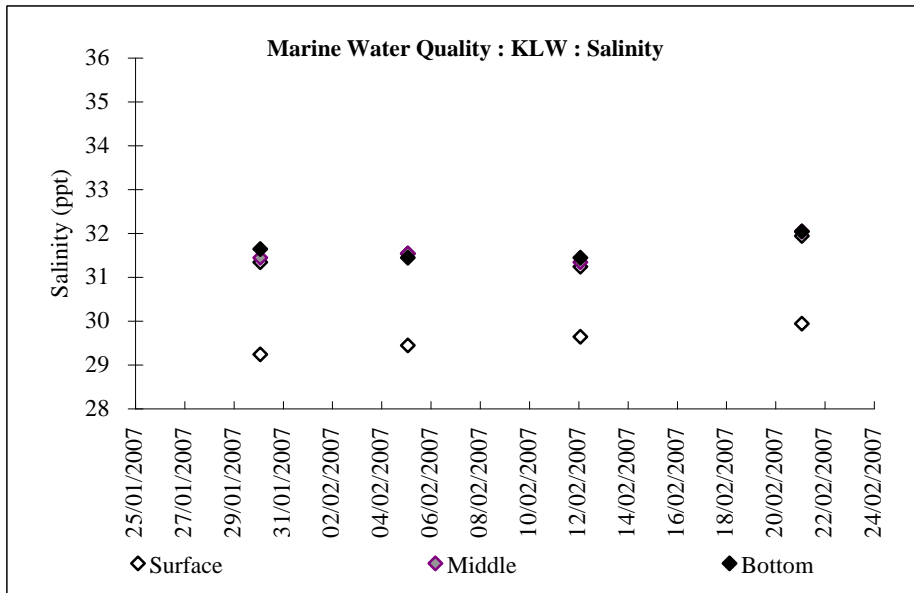
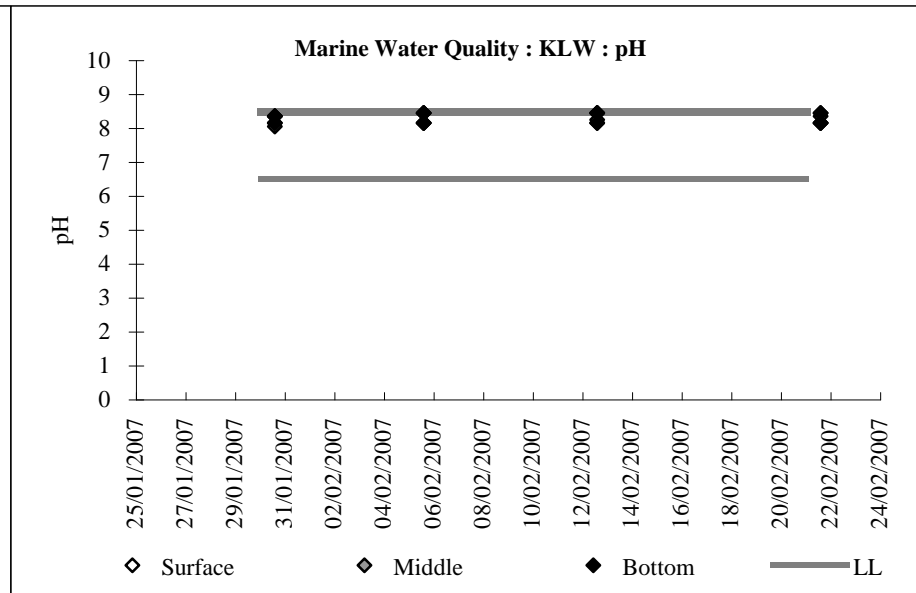
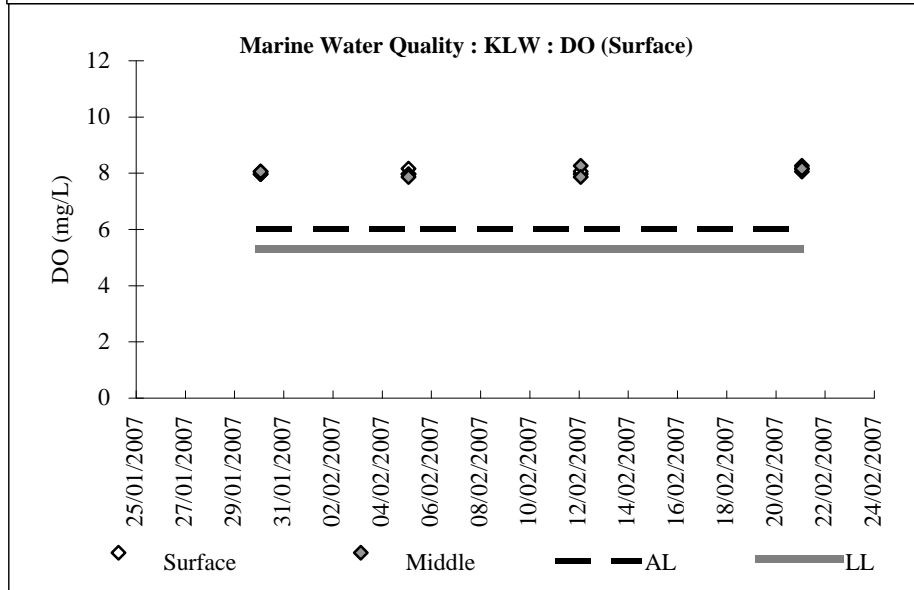
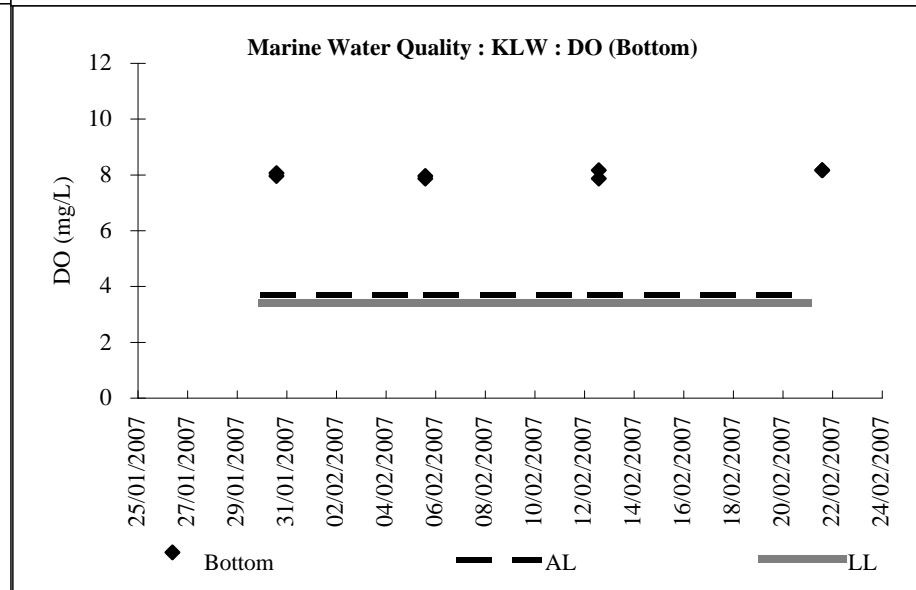
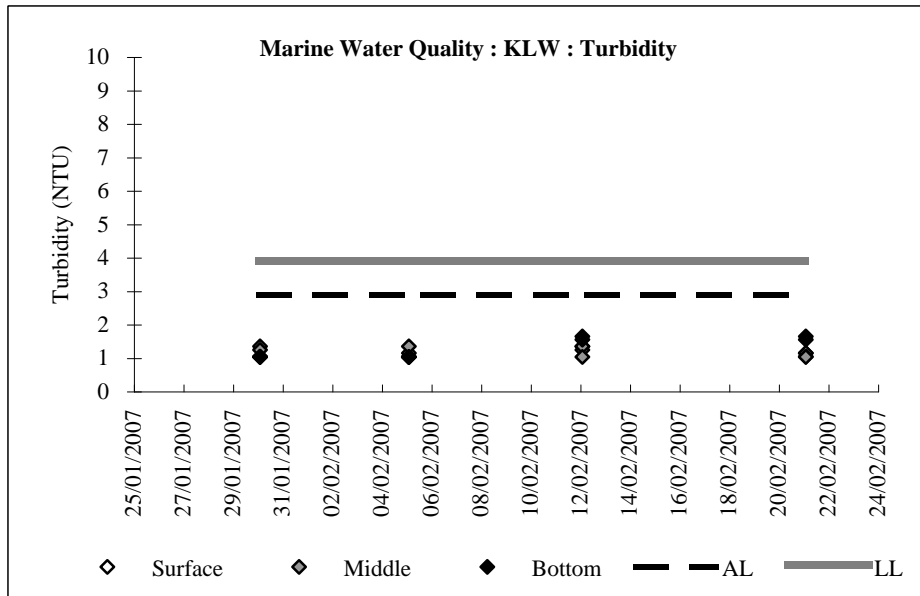
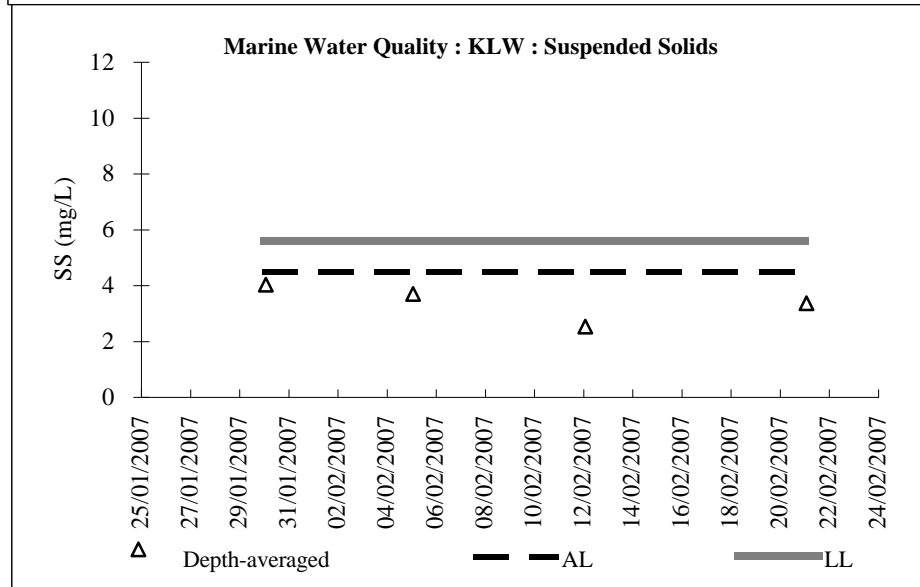
KLW		Surface							
tide condition	Date	time	Water depth (m)	Sampling depth (m)	Temp (°C)	Salinity (ppt)	DO (mg/L)	pH	Turbidity (NTU)
Mid-Ebb	30/01/2007	09:12	13.5	1.0	18.6	29.2	7.7	8.0	1.0
Mid-Ebb	05/02/2007	09:12	13.1	1.0	19.5	29.4	7.6	8.1	1.1
Mid-Ebb	12/02/2007	08:42	13.6	1.0	18.6	29.6	7.6	8.1	1.3
Mid-Ebb	21/02/2007	13:12	13.2	1.0	20.3	29.9	7.8	8.1	1.1

KLW		Surface							
tide condition	Date	time	Water depth (m)	Sampling depth (m)	Temp (°C)	Salinity (ppt)	DO (mg/L)	pH	Turbidity (NTU)
Mid-Flood	30/01/2007	12:12	14.1	1.0	18.8	31.3	7.6	8.3	1.3
Mid-Flood	05/02/2007	13:42	14.5	1.0	19.8	31.5	7.8	8.4	1.0
Mid-Flood	12/02/2007	13:12	13.9	1.0	18.9	31.2	7.7	8.4	1.2
Mid-Flood	21/02/2007	08:11	13.8	1.0	21.0	31.9	7.9	8.4	1.1

KLW		Middle							
tide condition	Date	time	Water depth (m)	Sampling depth (m)	Temp (°C)	Salinity (ppt)	DO (mg/L)	pH	Turbidity (NTU)
Mid-Ebb	30/01/2007	09:11	13.5	6.8	18.6	29.2	7.6	8.1	1.2
Mid-Ebb	05/02/2007	09:11	13.1	6.6	19.3	29.4	7.6	8.1	1.0
Mid-Ebb	12/02/2007	08:41	13.6	6.8	18.6	29.6	7.9	8.2	1.3
Mid-Ebb	21/02/2007	13:11	13.2	6.6	20.1	29.9	7.7	8.1	1.0

KLW		Middle							
tide condition	Date	time	Water depth (m)	Sampling depth (m)	Temp (°C)	Salinity (ppt)	DO (mg/L)	pH	Turbidity (NTU)
Mid-Flood	30/01/2007	12:11	14.1	7.1	18.7	31.4	7.7	8.3	1.0
Mid-Flood	05/02/2007	13:41	14.5	7.3	19.5	31.5	7.5	8.4	1.3
Mid-Flood	12/02/2007	13:11	13.9	7.0	18.7	31.3	7.5	8.4	1.0
Mid-Flood	21/02/2007	10:11	13.8	6.9	21.0	32.0	7.8	8.3	1.0

KLW		Bottom							
tide condition	Date	time	Water depth (m)	Sampling depth (m)	Temp (°C)	Salinity (ppt)	DO (mg/L)	pH	Turbidity (NTU)
Mid-Ebb	30/01/2007	9:10	13.5	12.5	18.5	29.3	7.6	8.1	1.0
Mid-Ebb	05/02/2007	9:10	13.1	12.1	19.3	29.4	7.6	8.1	1.0
Mid-Ebb	12/02/2007	8:40	13.6	12.6	18.5	29.6	7.8	8.1	1.5
Mid-Ebb	21/02/2007	13:10	13.2	12.2	20.0	29.8	7.8	8.1	1.6

KLW		Bottom							
tide condition	Date	time	Water depth (m)	Sampling depth (m)	Temp (°C)	Salinity (ppt)	DO (mg/L)	pH	Turbidity (NTU)
Mid-Flood	30/01/2007	12:10	14.1	13.1	18.7	31.6	7.7	8.3	1.0
Mid-Flood	05/02/2007	13:40	14.5	13.5	19.4	31.4	7.5	8.4	1.0
Mid-Flood	12/02/2007	13:10	13.9	12.9	18.7	31.4	7.5	8.4	1.6
Mid-Flood	21/02/2007	10:10	13.8	12.8	21.0	32.0	7.8	8.4	1.5

KLW	Mid-Ebb			Mid-Flood			Depth-averaged
	Surface	Middle	Bottom	Surface	Middle	Bottom	SS (mg/L)
30/01/2007	4.0	4.0	2.0	3.0	3.0	6.0	3.7
05/02/2007	3.0	4.0	4.0	4.0	3.0	2.0	3.3
12/02/2007	2.0	2.0	2.0	2.0	2.0	3.0	2.2
21/02/2007	2.0	4.0	2.0	4.0	3.0	3.0	3.0

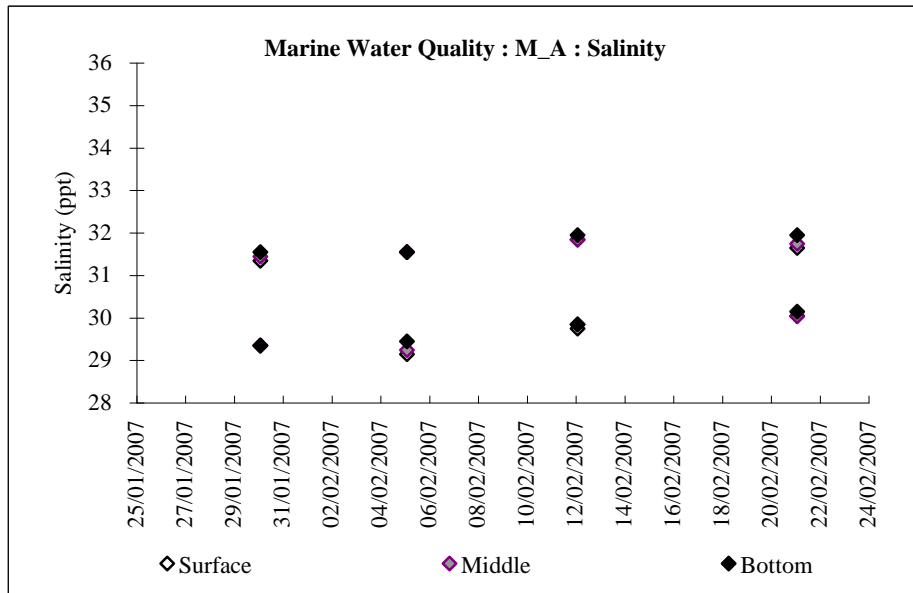
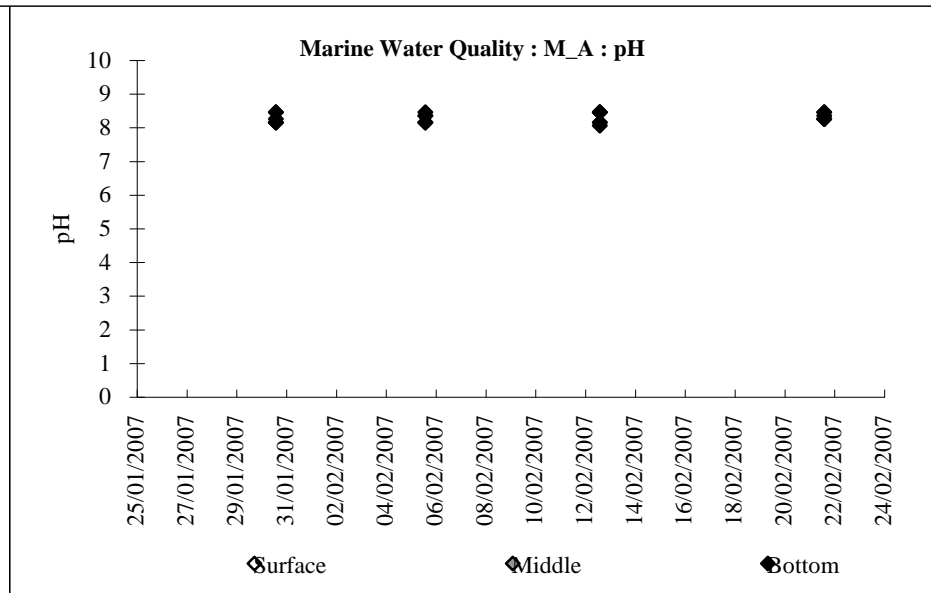
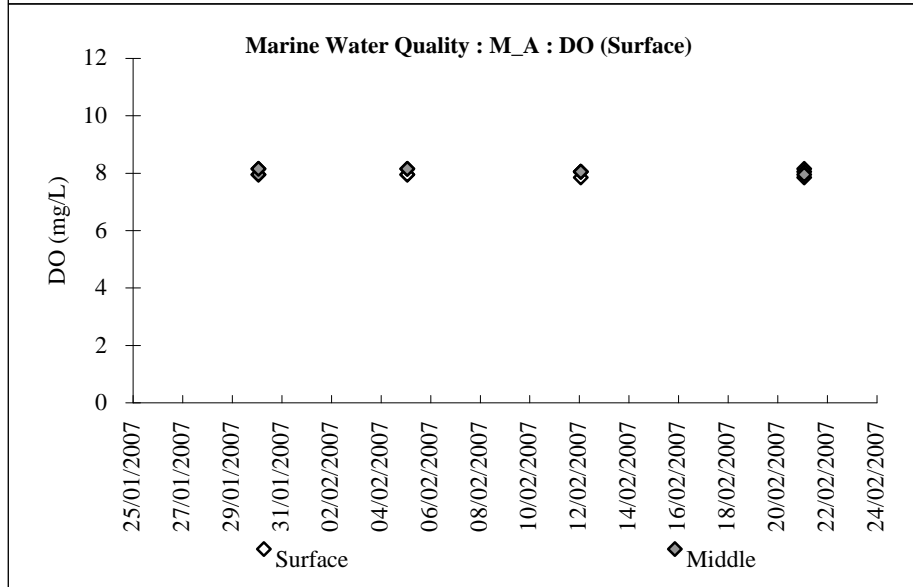
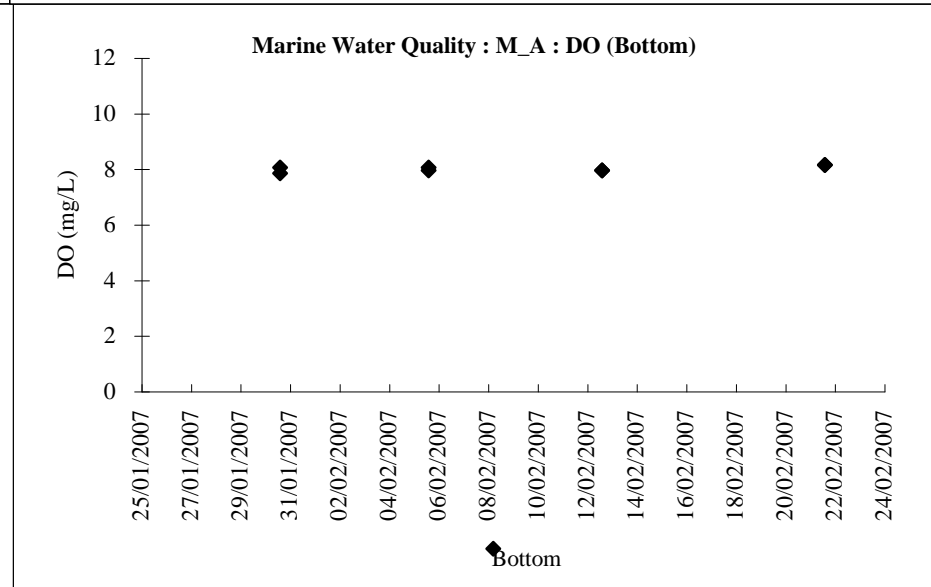
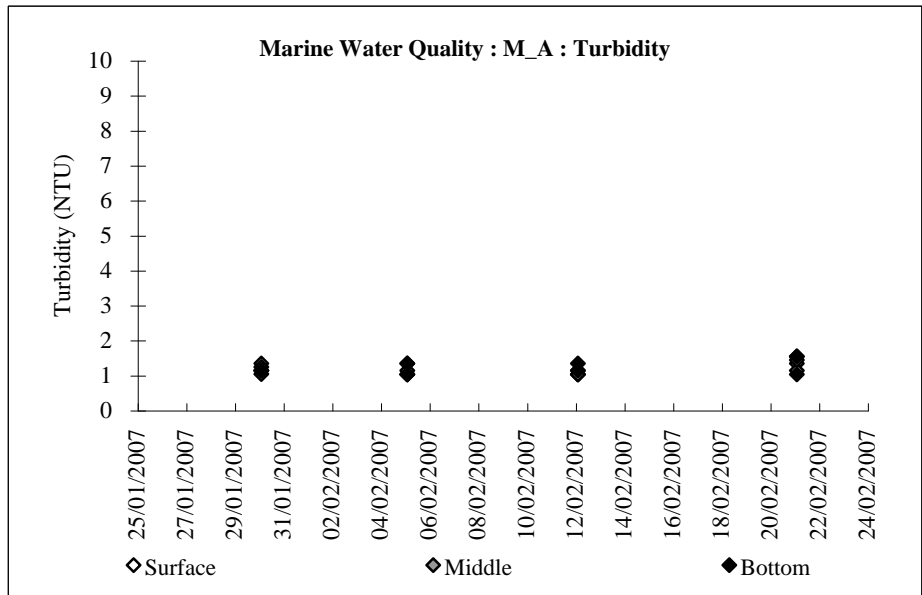
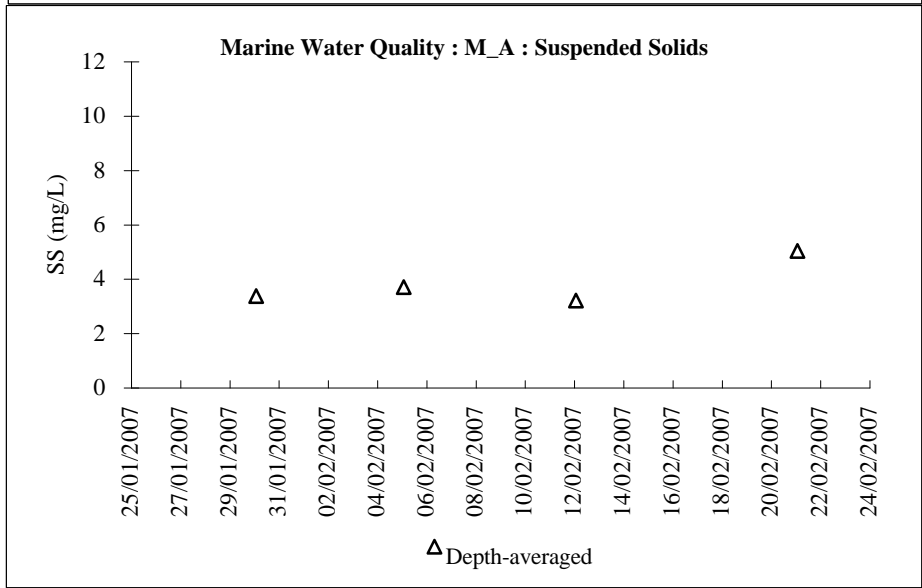
M_A		Surface							
tide condition	Date	time	Water depth (m)	Sampling depth (m)	Temp (°C)	Salinity (ppt)	DO (mg/L)	pH	Turbidity (NTU)
Mid-Ebb	30/01/2007	09:32	7.8	1.0	18.5	29.3	7.6	8.1	1.0
Mid-Ebb	05/02/2007	09:32	7.9	1.0	19.3	29.1	7.6	8.1	1.0
Mid-Ebb	12/02/2007	09:02	7.6	1.0	18.4	29.7	7.5	8.0	1.0
Mid-Ebb	21/02/2007	13:32	7.7	1.0	20.2	30.0	7.8	8.2	1.3

M_A		Surface							
tide condition	Date	time	Water depth (m)	Sampling depth (m)	Temp (°C)	Salinity (ppt)	DO (mg/L)	pH	Turbidity (NTU)
Mid-Flood	30/01/2007	12:32	8.3	1.0	18.9	31.3	7.8	8.2	1.3
Mid-Flood	05/02/2007	14:02	8.1	1.0	20.1	31.5	7.6	8.3	1.0
Mid-Flood	12/02/2007	13:32	8.3	1.0	18.9	31.8	7.7	8.4	1.1
Mid-Flood	21/02/2007	10:32	8.2	1.0	21.1	31.6	7.7	8.3	1.1

M_A		Middle							
tide condition	Date	time	Water depth (m)	Sampling depth (m)	Temp (°C)	Salinity (ppt)	DO (mg/L)	pH	Turbidity (NTU)
Mid-Ebb	30/01/2007	09:31	7.8	3.9	18.5	29.3	7.6	8.1	1.2
Mid-Ebb	05/02/2007	09:31	7.9	4.0	19.3	29.2	7.8	8.1	1.1
Mid-Ebb	12/02/2007	09:01	7.6	3.8	18.5	29.8	7.7	8.1	1.0
Mid-Ebb	21/02/2007	13:31	7.7	3.9	20.1	30.0	7.5	8.2	1.5

M_A		Middle							
tide condition	Date	time	Water depth (m)	Sampling depth (m)	Temp (°C)	Salinity (ppt)	DO (mg/L)	pH	Turbidity (NTU)
Mid-Flood	30/01/2007	12:31	8.3	4.2	18.9	31.4	7.8	8.4	1.1
Mid-Flood	05/02/2007	14:01	8.1	4.1	20.1	31.5	7.8	8.3	1.3
Mid-Flood	12/02/2007	13:31	8.3	4.2	19.0	31.8	7.7	8.4	1.0
Mid-Flood	21/02/2007	10:31	8.2	4.1	21.3	31.7	7.6	8.4	1.4

M_A		Bottom							
tide condition	Date	time	Water depth (m)	Sampling depth (m)	Temp (°C)	Salinity (ppt)	DO (mg/L)	pH	Turbidity (NTU)
Mid-Ebb	30/01/2007	9:30	7.8	6.8	18.6	29.3	7.7	8.1	1.1
Mid-Ebb	05/02/2007	9:30	7.9	6.9	19.4	29.4	7.7	8.1	1.0
Mid-Ebb	12/02/2007	9:00	7.6	6.6	18.5	29.8	7.6	8.1	1.3
Mid-Ebb	21/02/2007	13:30	7.7	6.7	20.2	30.1	7.8	8.2	1.5

M_A		Bottom							
tide condition	Date	time	Water depth (m)	Sampling depth (m)	Temp (°C)	Salinity (ppt)	DO (mg/L)	pH	Turbidity (NTU)
Mid-Flood	30/01/2007	12:30	8.3	7.3	18.9	31.5	7.5	8.4	1.1
Mid-Flood	05/02/2007	14:00	8.1	7.1	20.2	31.5	7.6	8.4	1.3
Mid-Flood	12/02/2007	13:30	8.3	7.3	19.1	31.9	7.6	8.4	1.1
Mid-Flood	21/02/2007	10:30	8.2	7.2	21.4	31.9	7.8	8.4	1.0

M_A	Mid-Ebb			Mid-Flood			Depth-averaged
	Surface	Middle	Bottom	Surface	Middle	Bottom	SS (mg/L)
30/01/2007	2.0	3.0	3.0	4.0	3.0	3.0	3.0
05/02/2007	4.0	4.0	4.0	2.0	3.0	3.0	3.3
12/02/2007	7.0	2.0	2.0	2.0	2.0	2.0	2.8
21/02/2007	2.0	6.0	4.0	5.0	5.0	6.0	4.7

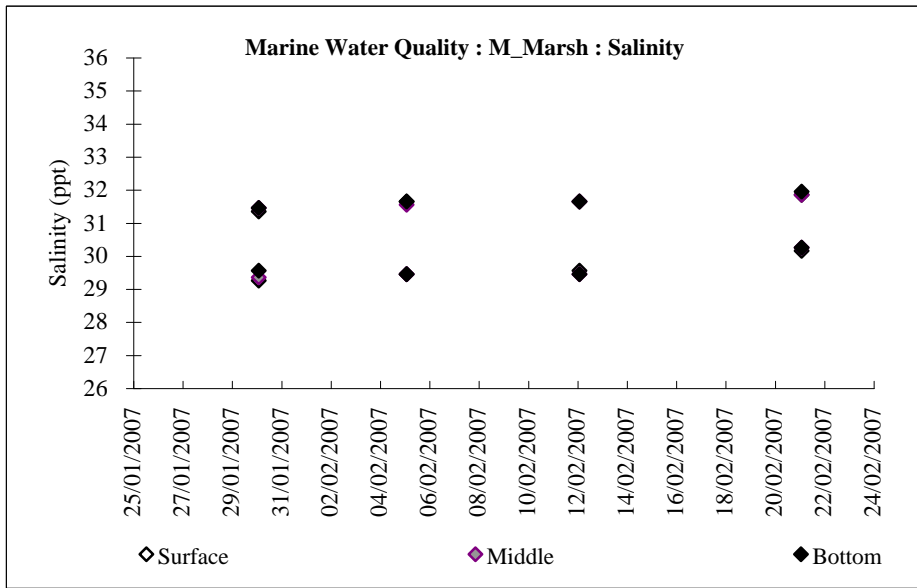
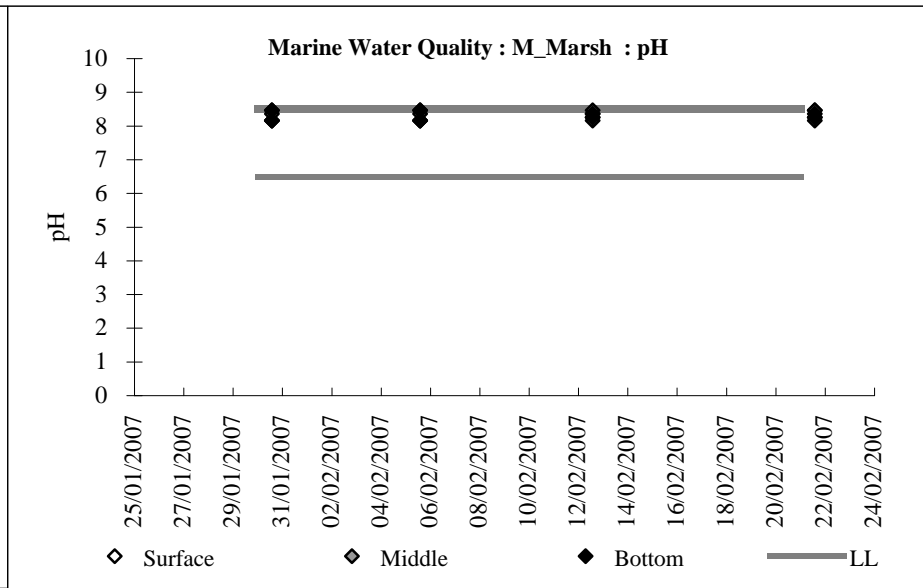
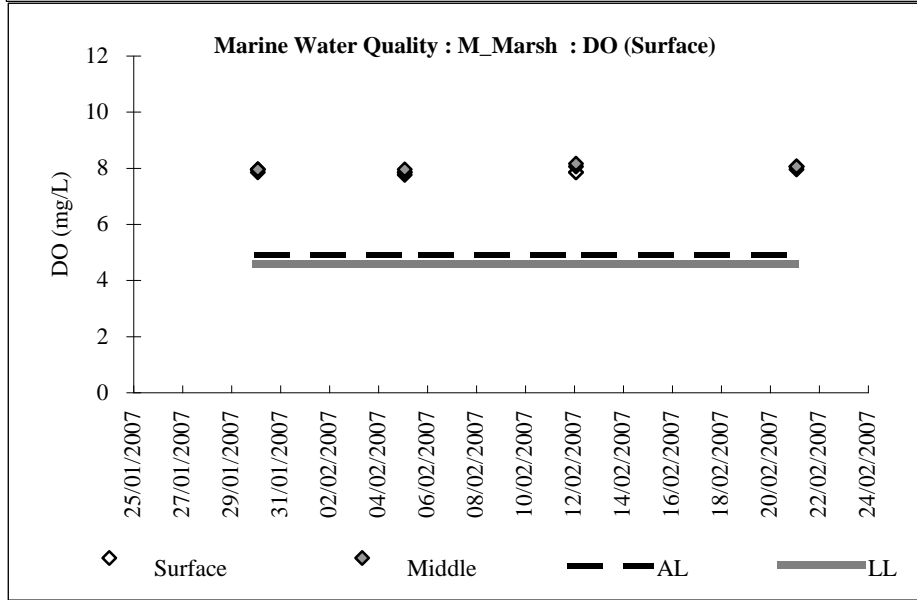
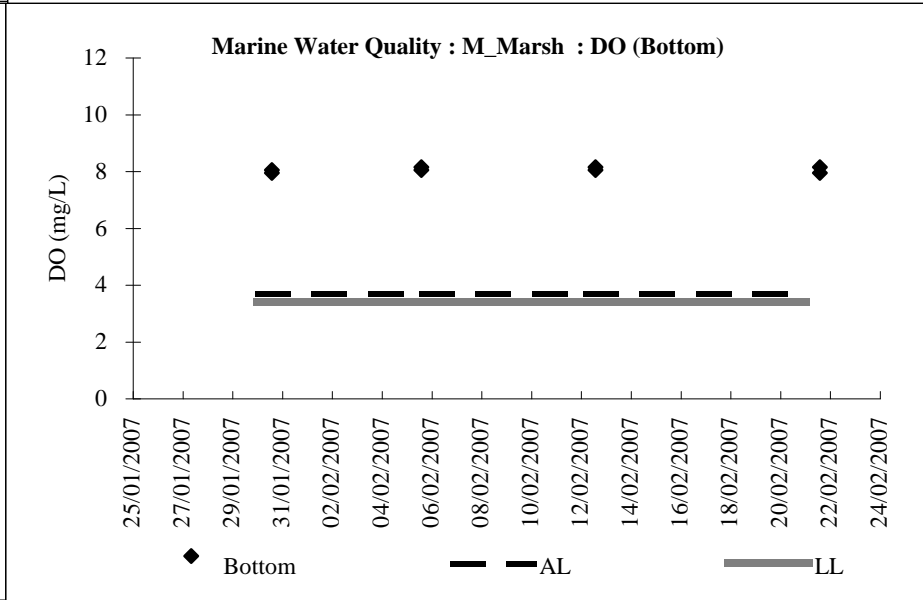
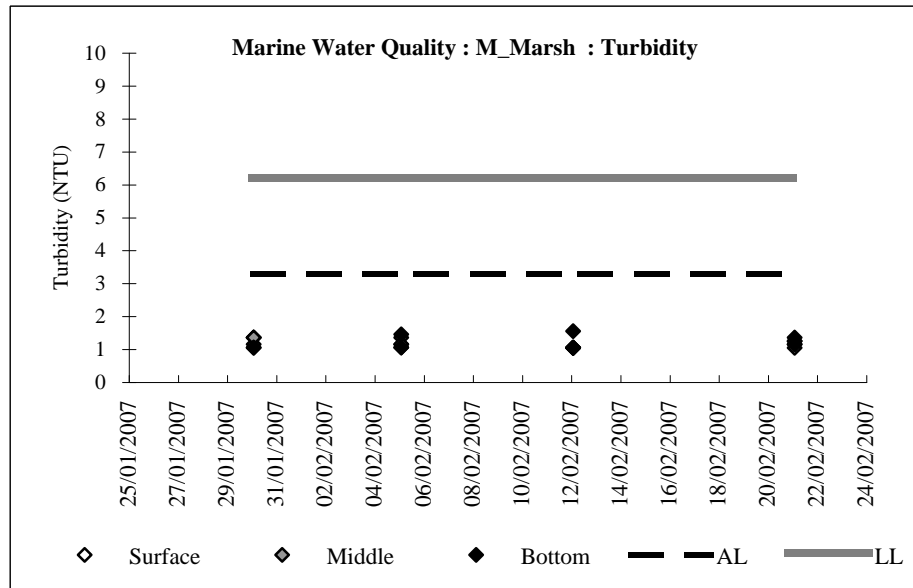
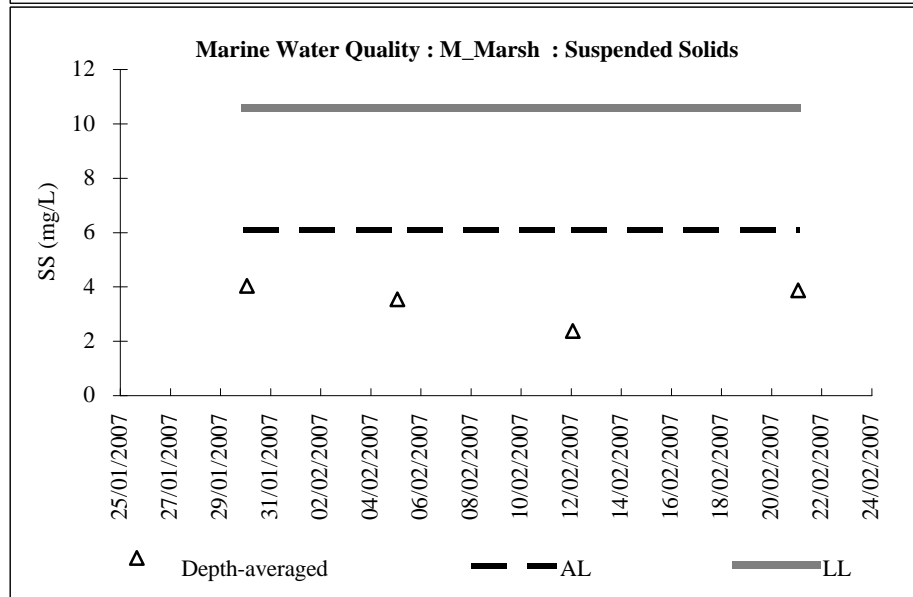
M_Marsh		Surface							
tide condition	Date	time	Water depth (m)	Sampling depth (m)	Temp (°C)	Salinity (ppt)	DO (mg/L)	pH	Turbidity (NTU)
Mid-Ebb	30/01/2007	09:47	8.1	1.0	18.6	29.2	7.5	8.1	1.1
Mid-Ebb	05/02/2007	09:47	8.0	1.0	19.2	29.4	7.5	8.1	1.3
Mid-Ebb	12/02/2007	09:17	8.3	1.0	18.5	29.5	7.5	8.2	1.0
Mid-Ebb	21/02/2007	13:47	8.2	1.0	20.3	30.1	7.6	8.1	1.2

M_Marsh		Surface							
tide condition	Date	time	Water depth (m)	Sampling depth (m)	Temp (°C)	Salinity (ppt)	DO (mg/L)	pH	Turbidity (NTU)
Mid-Flood	30/01/2007	12:47	8.4	1.0	19.3	31.3	7.6	8.4	1.3
Mid-Flood	05/02/2007	14:17	8.6	1.0	20.1	31.6	7.4	8.3	1.0
Mid-Flood	12/02/2007	13:47	8.5	1.0	20.0	31.6	7.5	8.3	1.0
Mid-Flood	21/02/2007	10:47	8.6	1.0	21.4	31.8	7.7	8.4	1.0

M_Marsh		Middle							
tide condition	Date	time	Water depth (m)	Sampling depth (m)	Temp (°C)	Salinity (ppt)	DO (mg/L)	pH	Turbidity (NTU)
Mid-Ebb	30/01/2007	09:46	8.1	4.1	18.6	29.3	7.6	8.1	1.3
Mid-Ebb	05/02/2007	09:46	8.0	4.0	19.3	29.4	7.5	8.1	1.1
Mid-Ebb	12/02/2007	09:16	8.3	4.2	18.6	29.4	7.7	8.1	1.0
Mid-Ebb	21/02/2007	13:46	8.2	4.1	20.3	30.2	7.7	8.2	1.2

M_Marsh		Middle							
tide condition	Date	time	Water depth (m)	Sampling depth (m)	Temp (°C)	Salinity (ppt)	DO (mg/L)	pH	Turbidity (NTU)
Mid-Flood	30/01/2007	12:46	8.4	4.2	19.3	31.4	7.6	8.3	1.3
Mid-Flood	05/02/2007	14:16	8.6	4.3	20.1	31.5	7.6	8.4	1.1
Mid-Flood	12/02/2007	13:46	8.5	4.3	20.1	31.6	7.8	8.4	1.0
Mid-Flood	21/02/2007	10:46	8.6	4.3	21.4	31.8	7.7	8.4	1.1

M_Marsh		Bottom							
tide condition	Date	time	Water depth (m)	Sampling depth (m)	Temp (°C)	Salinity (ppt)	DO (mg/L)	pH	Turbidity (NTU)
Mid-Ebb	30/01/2007	9:45	8.1	7.1	18.7	29.5	7.6	8.1	1.0
Mid-Ebb	05/02/2007	9:45	8.0	7.0	19.4	29.4	7.8	8.1	1.0
Mid-Ebb	12/02/2007	9:15	8.3	7.3	18.6	29.4	7.8	8.2	1.0
Mid-Ebb	21/02/2007	13:45	8.2	7.2	20.4	30.2	7.8	8.2	1.3

M_Marsh		Bottom							
tide condition	Date	time	Water depth (m)	Sampling depth (m)	Temp (°C)	Salinity (ppt)	DO (mg/L)	pH	Turbidity (NTU)
Mid-Flood	30/01/2007	12:45	8.4	7.4	19.4	31.4	7.7	8.4	1.0
Mid-Flood	05/02/2007	14:15	8.6	7.6	20.1	31.6	7.7	8.4	1.4
Mid-Flood	12/02/2007	13:45	8.5	7.5	20.1	31.6	7.7	8.3	1.5
Mid-Flood	21/02/2007	10:45	8.6	7.6	21.5	31.9	7.6	8.3	1.1

M_Marsh	Mid-Ebb			Mid-Flood			Depth-averaged
	Surface	Middle	Bottom	Surface	Middle	Bottom	SS (mg/L)
30/01/2007	5.0	3.0	3.0	3.0	3.0	5.0	3.7
05/02/2007	3.0	4.0	3.0	3.0	3.0	3.0	3.2
12/02/2007	2.0	2.0	2.0	2.0	2.0	2.0	2.0
21/02/2007	4.0	5.0	3.0	3.0	3.0	3.0	3.5

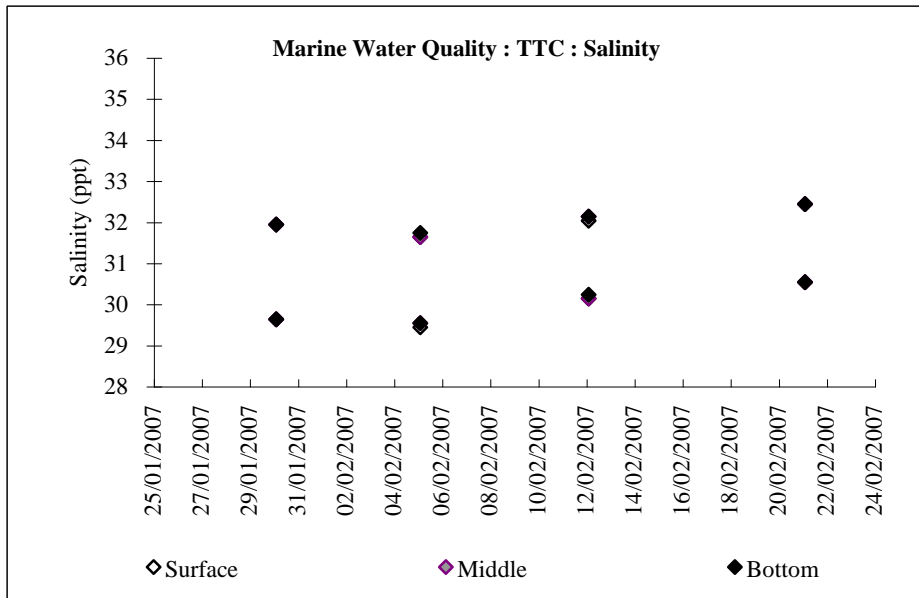
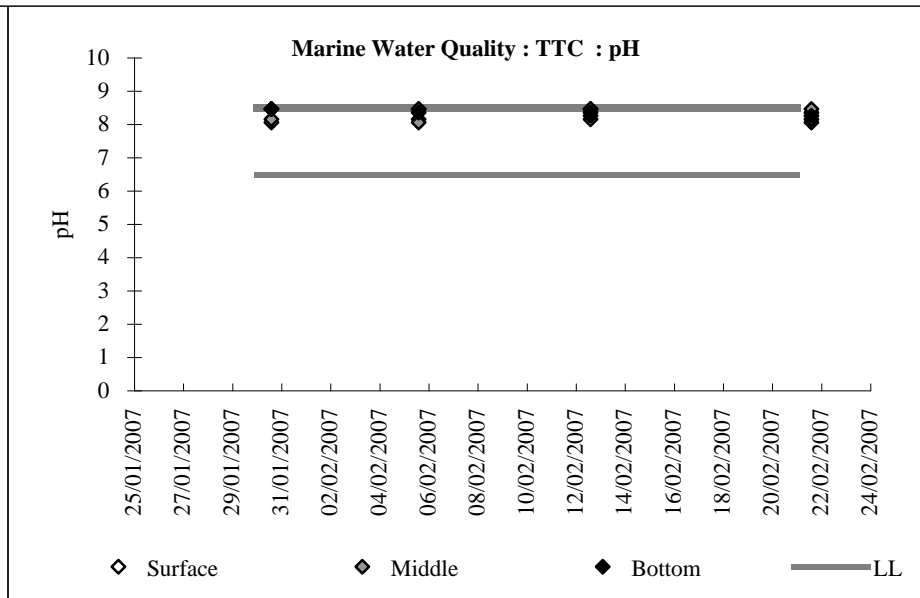
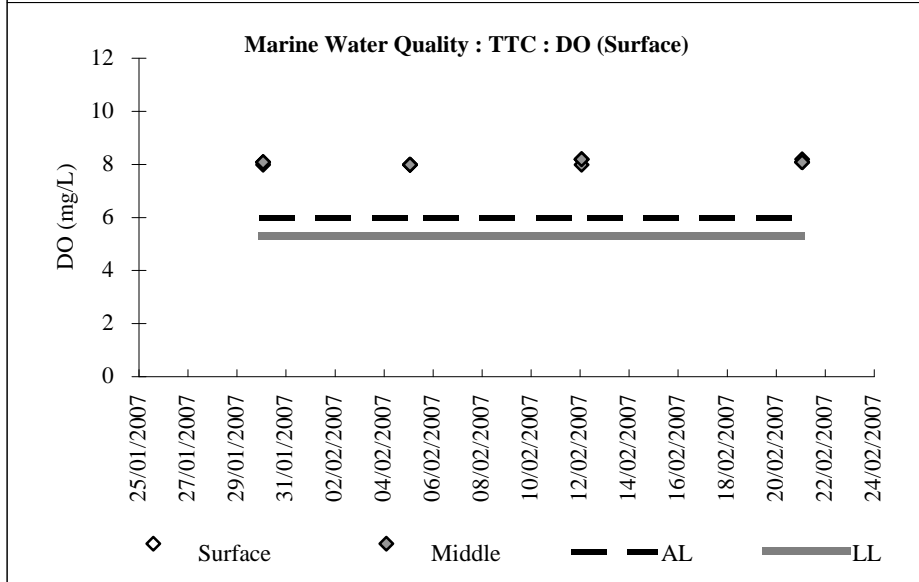
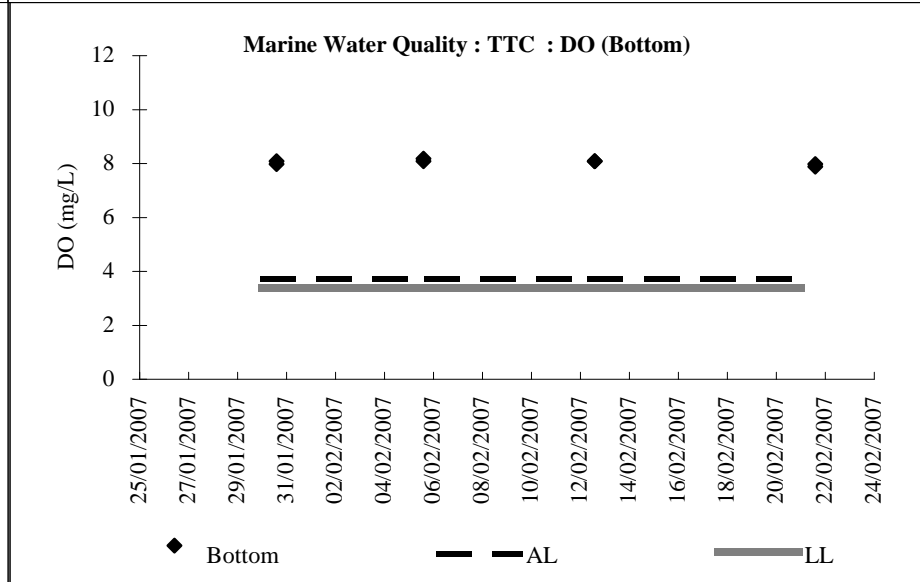
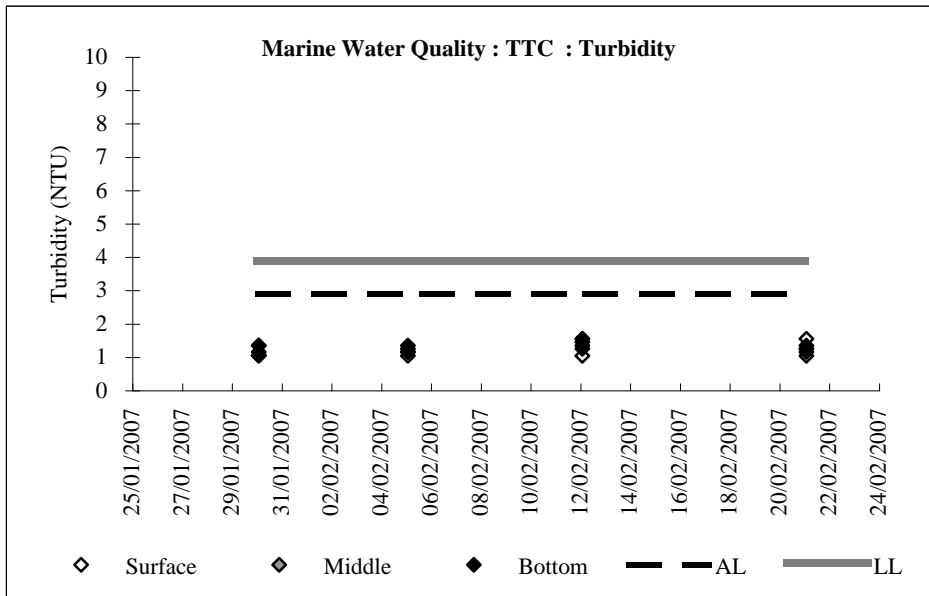
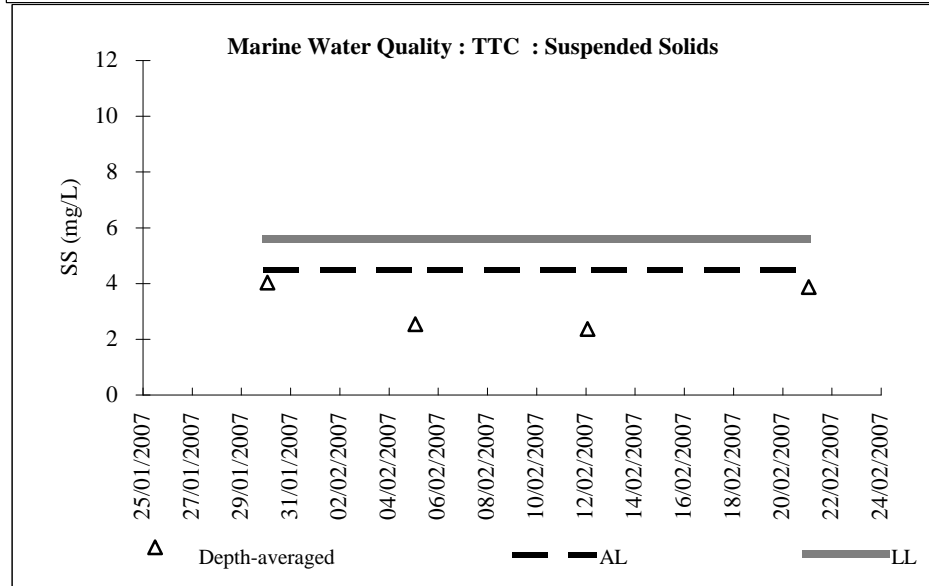
TTC		Surface							
tide condition	Date	time	Water depth (m)	Sampling depth (m)	Temp (°C)	Salinity (ppt)	DO (mg/L)	pH	Turbidity (NTU)
Mid-Ebb	30/01/2007	09:57	9.7	1.0	18.6	29.6	7.7	8.0	1.3
Mid-Ebb	05/02/2007	10:07	9.6	1.0	19.5	29.4	7.6	8.1	1.1
Mid-Ebb	12/02/2007	09:37	9.8	1.0	18.6	30.1	7.8	8.1	1.5
Mid-Ebb	21/02/2007	14:07	9.6	1.0	20.4	30.5	7.7	8.0	1.0

TTC		Surface							
tide condition	Date	time	Water depth (m)	Sampling depth (m)	Temp (°C)	Salinity (ppt)	DO (mg/L)	pH	Turbidity (NTU)
Mid-Flood	30/01/2007	13:07	10.1	1.0	19.6	31.9	7.6	8.4	1.0
Mid-Flood	05/02/2007	14:27	10.2	1.0	20.8	31.6	7.6	8.4	1.0
Mid-Flood	12/02/2007	13:57	9.9	1.0	19.4	32.0	7.8	8.4	1.0
Mid-Flood	21/02/2007	10:57	10.4	1.0	21.8	32.4	7.7	8.3	1.5

TTC		Middle							
tide condition	Date	time	Water depth (m)	Sampling depth (m)	Temp (°C)	Salinity (ppt)	DO (mg/L)	pH	Turbidity (NTU)
Mid-Ebb	30/01/2007	09:56	9.7	4.9	18.6	29.6	7.7	8.1	1.0
Mid-Ebb	05/02/2007	10:06	9.6	4.8	19.5	29.5	7.6	8.0	1.1
Mid-Ebb	12/02/2007	09:36	9.8	4.9	18.6	30.1	7.6	8.2	1.3
Mid-Ebb	21/02/2007	14:06	9.6	4.8	20.5	30.5	7.8	8.1	1.1

TTC		Middle							
tide condition	Date	time	Water depth (m)	Sampling depth (m)	Temp (°C)	Salinity (ppt)	DO (mg/L)	pH	Turbidity (NTU)
Mid-Flood	30/01/2007	13:06	10.1	5.1	19.6	31.9	7.7	8.4	1.1
Mid-Flood	05/02/2007	14:26	10.2	5.1	20.8	31.6	7.6	8.4	1.3
Mid-Flood	12/02/2007	13:56	9.9	5.0	19.4	32.1	7.8	8.4	1.4
Mid-Flood	21/02/2007	10:56	10.4	5.2	21.8	32.4	7.7	8.4	1.2

TTC		Bottom							
tide condition	Date	time	Water depth (m)	Sampling depth (m)	Temp (°C)	Salinity (ppt)	DO (mg/L)	pH	Turbidity (NTU)
Mid-Ebb	30/01/2007	9:55	9.7	8.7	18.7	29.6	7.7	8.1	1.0
Mid-Ebb	05/02/2007	10:05	9.6	8.6	19.6	29.5	7.7	8.1	1.1
Mid-Ebb	12/02/2007	9:35	9.8	8.8	18.7	30.2	7.7	8.2	1.5
Mid-Ebb	21/02/2007	14:05	9.6	8.6	20.5	30.5	7.6	8.1	1.3

TTC		Bottom							
tide condition	Date	time	Water depth (m)	Sampling depth (m)	Temp (°C)	Salinity (ppt)	DO (mg/L)	pH	Turbidity (NTU)
Mid-Flood	30/01/2007	13:05	10.1	9.1	19.7	31.9	7.6	8.4	1.3
Mid-Flood	05/02/2007	14:25	10.2	9.2	20.9	31.7	7.8	8.3	1.2
Mid-Flood	12/02/2007	13:55	9.9	8.9	19.4	32.1	7.7	8.3	1.2
Mid-Flood	21/02/2007	10:55	10.4	9.4	21.9	32.4	7.5	8.2	1.2

TTC	Mid-Ebb			Mid-Flood			Depth-averaged
	Surface	Middle	Bottom	Surface	Middle	Bottom	SS (mg/L)
30/01/2007	4.0	2.0	3.0	4.0	5.0	4.0	3.7
05/02/2007	2.0	2.0	2.0	3.0	2.0	2.0	2.2
12/02/2007	2.0	2.0	2.0	2.0	2.0	2.0	2.0
21/02/2007	4.0	4.0	4.0	4.0	2.0	3.0	3.5
