**Proposed Extension of Public Golf Course
at Kau Sai Chau Island, Sai Kung**

**Monthly Environmental Monitoring & Audit (EM&A) Report
for February 2007**

(Report No. 382210/014)

March 2007

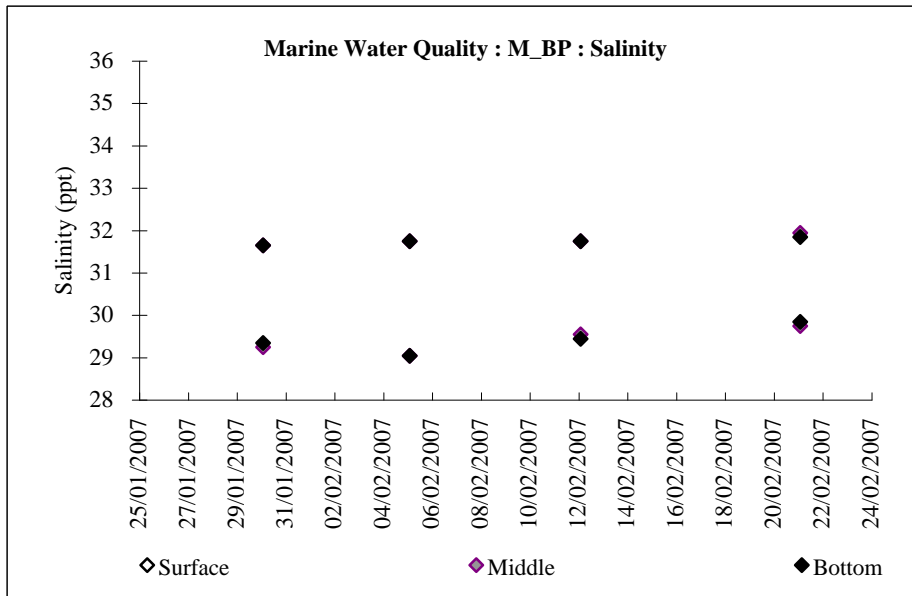
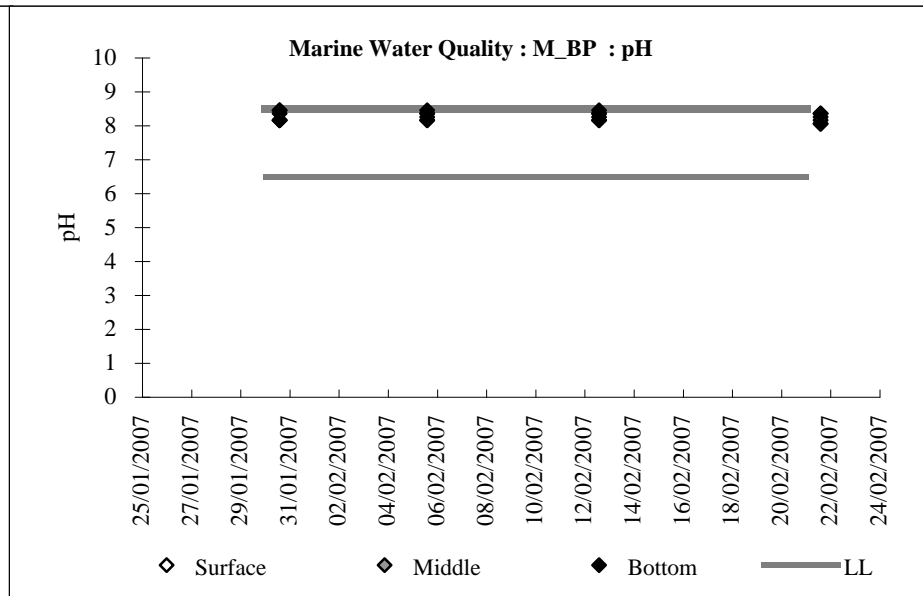
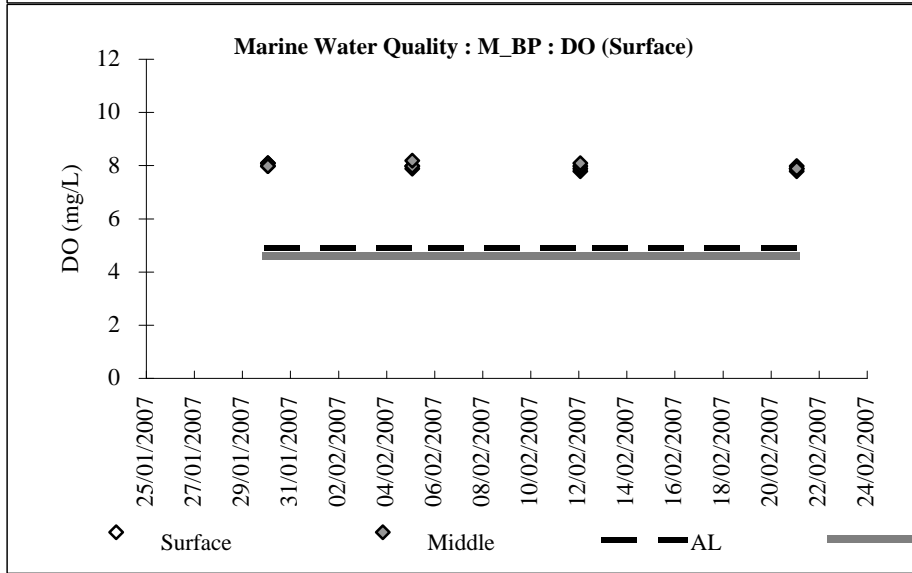
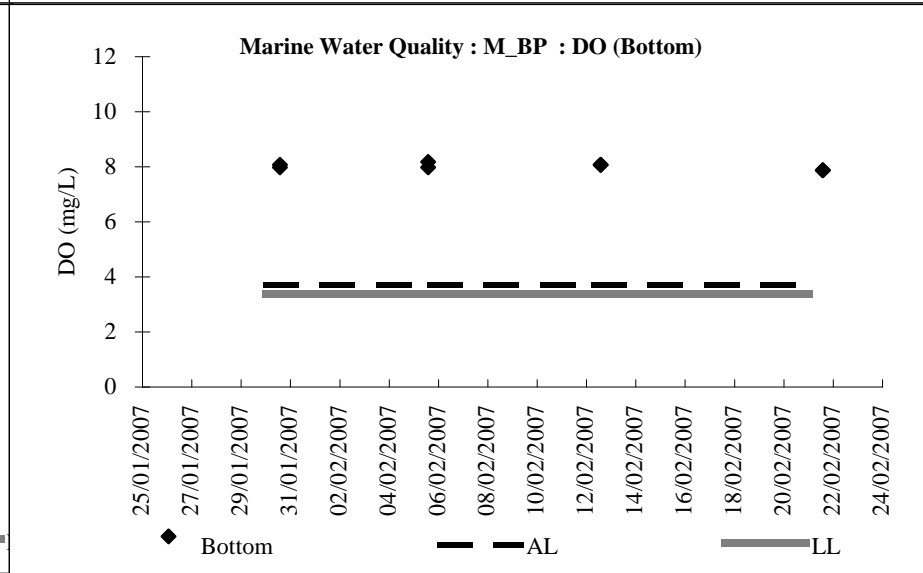
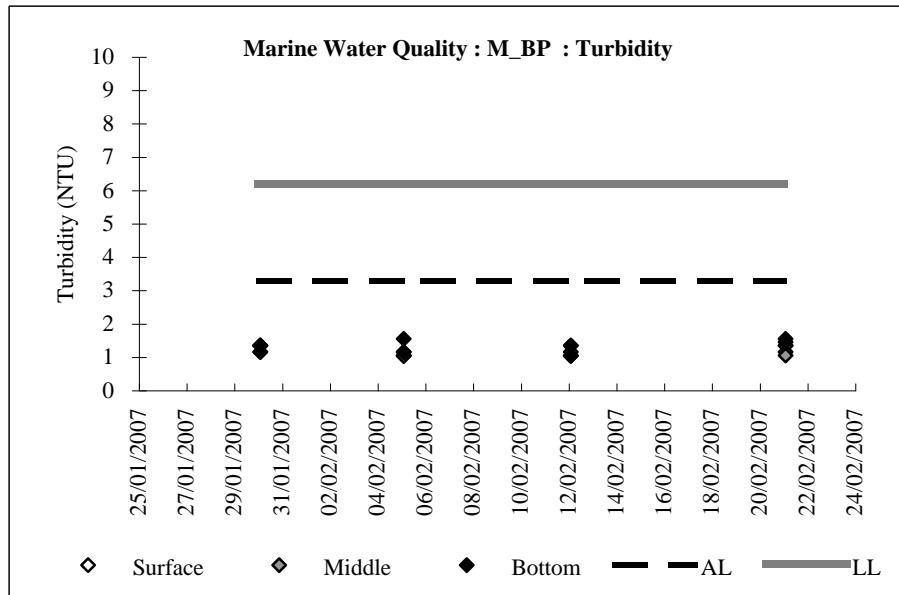
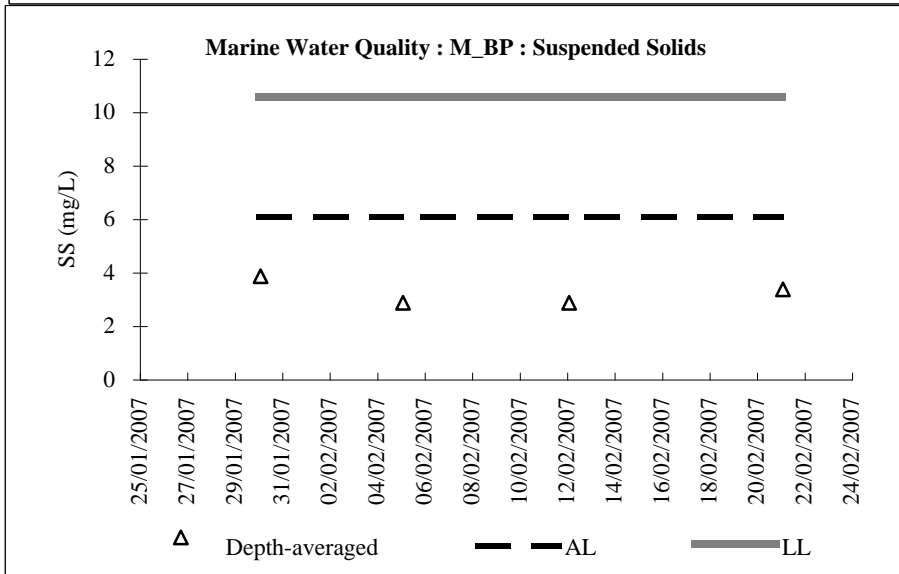
M_BP		Surface							
tide condition	Date	time	Water depth (m)	Sampling depth (m)	Temp (°C)	Salinity (ppt)	DO (mg/L)	pH	Turbidity (NTU)
Mid-Ebb	30/01/2007	10:07	8.1	1.0	18.4	29.1	7.7	8.1	1.1
Mid-Ebb	05/02/2007	10:17	8.3	1.0	19.4	29.0	7.6	8.2	1.0
Mid-Ebb	12/02/2007	09:47	8.3	1.0	18.3	29.6	7.4	8.1	1.0
Mid-Ebb	21/02/2007	14:17	8.1	1.0	20.3	29.7	7.5	8.0	1.3

M_BP		Surface							
tide condition	Date	time	Water depth (m)	Sampling depth (m)	Temp (°C)	Salinity (ppt)	DO (mg/L)	pH	Turbidity (NTU)
Mid-Flood	30/01/2007	13:17	8.6	1.0	19.6	31.6	7.6	8.3	1.3
Mid-Flood	05/02/2007	14:37	8.5	1.0	20.5	31.6	7.5	8.3	1.0
Mid-Flood	12/02/2007	14:07	8.7	1.0	19.6	31.7	7.5	8.3	1.1
Mid-Flood	21/02/2007	11:07	8.5	1.0	21.7	31.9	7.6	8.2	1.3

M_BP		Middle							
tide condition	Date	time	Water depth (m)	Sampling depth (m)	Temp (°C)	Salinity (ppt)	DO (mg/L)	pH	Turbidity (NTU)
Mid-Ebb	30/01/2007	10:06	8.1	4.1	18.4	29.2	7.7	8.1	1.3
Mid-Ebb	05/02/2007	10:16	8.3	4.2	19.4	29.0	7.6	8.1	1.3
Mid-Ebb	12/02/2007	09:46	8.3	4.2	18.3	29.5	7.6	8.2	1.3
Mid-Ebb	21/02/2007	14:16	8.1	4.1	20.3	29.7	7.4	8.1	1.1

M_BP		Middle							
tide condition	Date	time	Water depth (m)	Sampling depth (m)	Temp (°C)	Salinity (ppt)	DO (mg/L)	pH	Turbidity (NTU)
Mid-Flood	30/01/2007	13:16	8.6	4.3	19.6	31.6	7.6	8.4	1.3
Mid-Flood	05/02/2007	14:36	8.5	4.3	20.5	31.7	7.8	8.3	1.1
Mid-Flood	12/02/2007	14:06	8.7	4.4	19.7	31.7	7.7	8.3	1.0
Mid-Flood	21/02/2007	11:06	8.5	4.3	21.7	31.9	7.5	8.3	1.0

M_BP		Bottom							
tide condition	Date	time	Water depth (m)	Sampling depth (m)	Temp (°C)	Salinity (ppt)	DO (mg/L)	pH	Turbidity (NTU)
Mid-Ebb	30/01/2007	10:05	8.1	7.1	18.4	29.3	7.6	8.1	1.1
Mid-Ebb	05/02/2007	10:15	8.3	7.3	19.5	29.0	7.6	8.1	1.5
Mid-Ebb	12/02/2007	9:45	8.3	7.3	18.4	29.4	7.7	8.1	1.3
Mid-Ebb	21/02/2007	14:15	8.1	7.1	20.4	29.8	7.5	8.0	1.4

M_BP		Bottom							
tide condition	Date	time	Water depth (m)	Sampling depth (m)	Temp (°C)	Salinity (ppt)	DO (mg/L)	pH	Turbidity (NTU)
Mid-Flood	30/01/2007	13:15	8.6	7.6	19.7	31.6	7.7	8.4	1.3
Mid-Flood	05/02/2007	14:35	8.5	7.5	20.6	31.7	7.8	8.4	1.1
Mid-Flood	12/02/2007	14:05	8.7	7.7	19.8	31.7	7.7	8.4	1.0
Mid-Flood	21/02/2007	11:05	8.5	7.5	21.7	31.8	7.5	8.3	1.5

M_BP	Mid-Ebb			Mid-Flood			Depth-averaged
	Surface	Middle	Bottom	Surface	Middle	Bottom	SS (mg/L)
30/01/2007	4.0	5.0	4.0	3.0	2.0	3.0	3.5
05/02/2007	2.0	2.0	3.0	2.0	2.0	4.0	2.5
12/02/2007	2.0	2.0	2.0	2.0	5.0	2.0	2.5
21/02/2007	2.0	5.0	3.0	3.0	2.0	3.0	3.0

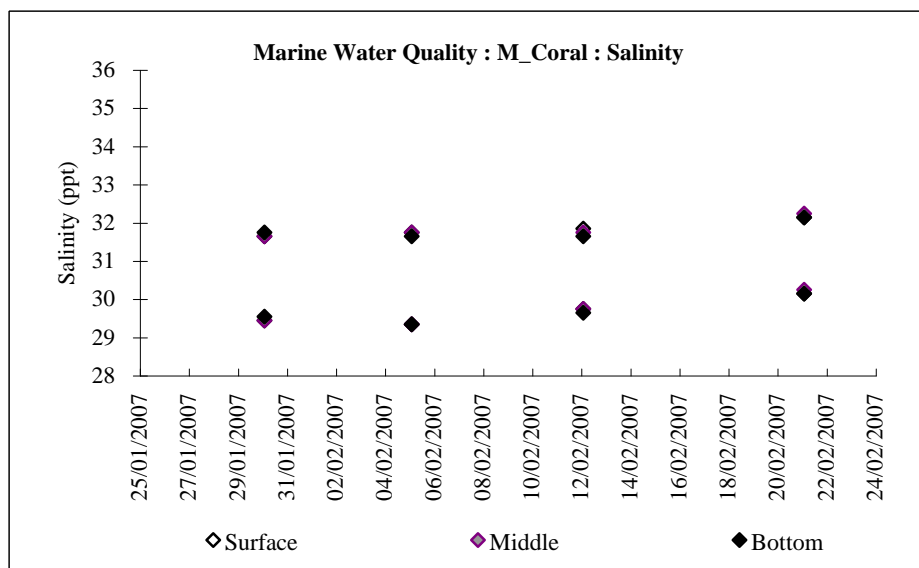
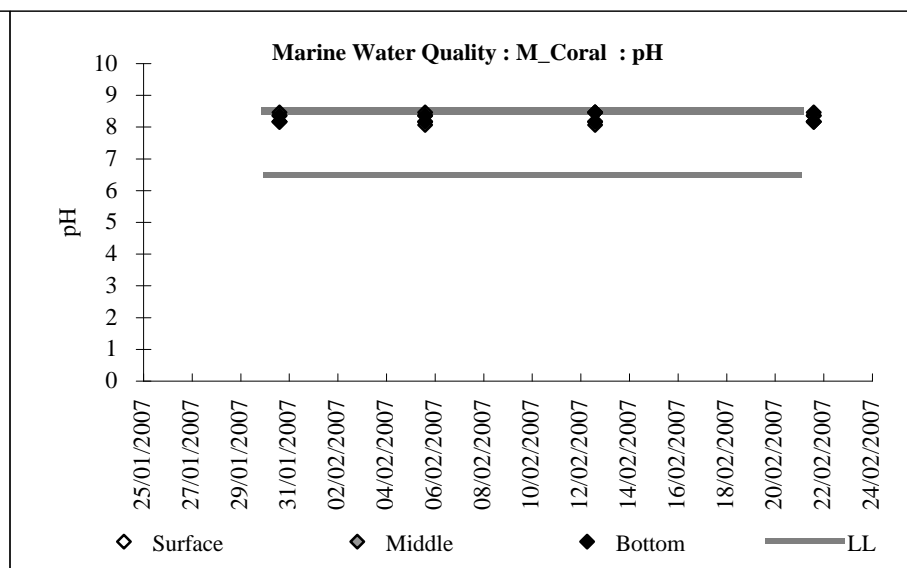
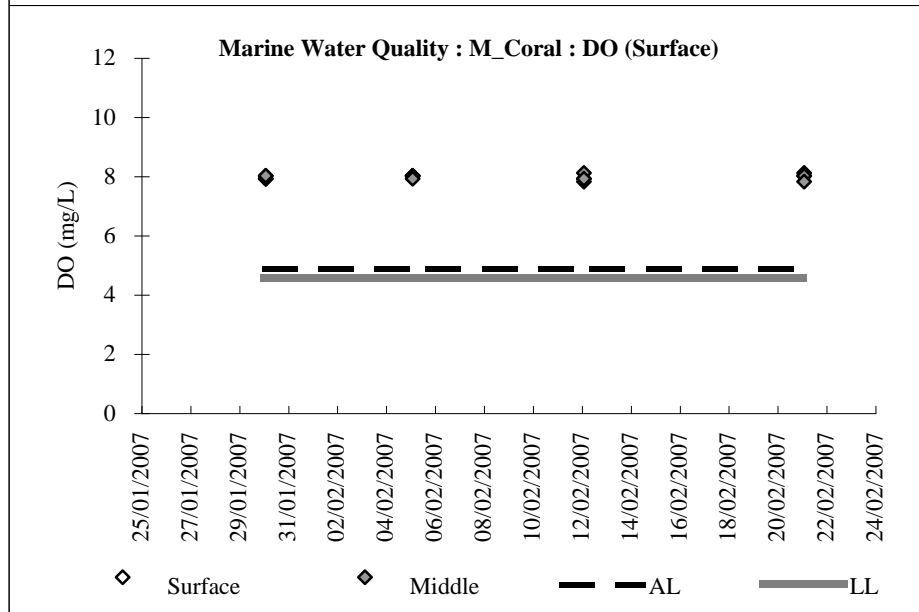
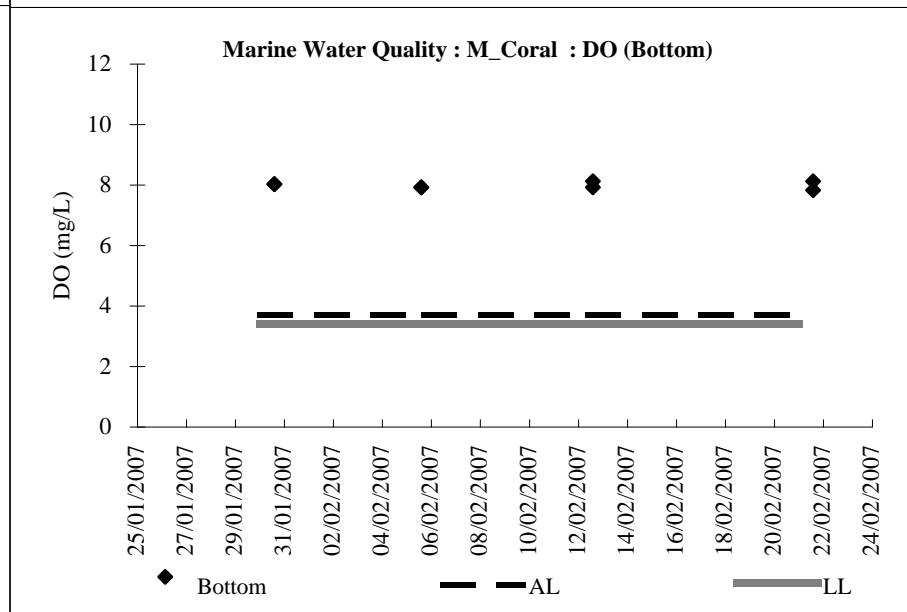
M_Coral		Surface							
tide condition	Date	time	Water depth (m)	Sampling depth (m)	Temp (°C)	Salinity (ppt)	DO (mg/L)	pH	Turbidity (NTU)
Mid-Ebb	30/01/2007	10:17	8.1	1.0	18.4	29.4	7.7	8.1	1.3
Mid-Ebb	05/02/2007	11:27	8.1	1.0	19.6	29.3	7.7	8.1	1.1
Mid-Ebb	12/02/2007	10:57	8.3	1.0	18.5	29.7	7.6	8.0	1.0
Mid-Ebb	21/02/2007	15:27	8.4	1.0	20.1	30.1	7.8	8.1	1.0

M_Coral		Surface							
tide condition	Date	time	Water depth (m)	Sampling depth (m)	Temp (°C)	Salinity (ppt)	DO (mg/L)	pH	Turbidity (NTU)
Mid-Flood	30/01/2007	14:52	8.6	1.0	19.6	31.6	7.6	8.3	1.1
Mid-Flood	05/02/2007	14:47	8.6	1.0	20.5	31.7	7.7	8.3	1.0
Mid-Flood	12/02/2007	14:17	8.7	1.0	19.8	31.8	7.5	8.4	1.0
Mid-Flood	21/02/2007	11:17	8.8	1.0	21.8	32.1	7.7	8.3	1.1

M_Coral		Middle							
tide condition	Date	time	Water depth (m)	Sampling depth (m)	Temp (°C)	Salinity (ppt)	DO (mg/L)	pH	Turbidity (NTU)
Mid-Ebb	30/01/2007	10:16	8.1	4.1	18.4	29.4	7.6	8.1	1.3
Mid-Ebb	05/02/2007	11:26	8.1	4.1	19.6	29.3	7.7	8.0	1.1
Mid-Ebb	12/02/2007	10:56	8.3	4.2	18.6	29.7	7.8	8.1	1.0
Mid-Ebb	21/02/2007	15:26	8.4	4.2	20.1	30.2	7.7	8.1	1.0

M_Coral		Middle							
tide condition	Date	time	Water depth (m)	Sampling depth (m)	Temp (°C)	Salinity (ppt)	DO (mg/L)	pH	Turbidity (NTU)
Mid-Flood	30/01/2007	14:51	8.6	4.3	19.6	31.6	7.7	8.4	1.3
Mid-Flood	05/02/2007	14:46	8.6	4.3	20.6	31.7	7.6	8.4	1.1
Mid-Flood	12/02/2007	14:16	8.7	4.4	19.7	31.7	7.6	8.4	1.0
Mid-Flood	21/02/2007	11:16	8.8	4.4	21.8	32.2	7.5	8.3	1.5

M_Coral		Bottom							
tide condition	Date	time	Water depth (m)	Sampling depth (m)	Temp (°C)	Salinity (ppt)	DO (mg/L)	pH	Turbidity (NTU)
Mid-Ebb	30/01/2007	10:15	8.1	7.1	18.4	29.5	7.7	8.1	1.0
Mid-Ebb	05/02/2007	11:25	8.1	7.1	19.7	29.3	7.6	8.1	1.0
Mid-Ebb	12/02/2007	10:55	8.3	7.3	18.7	29.6	7.8	8.1	1.3
Mid-Ebb	21/02/2007	15:25	8.4	7.4	20.2	30.1	7.8	8.1	1.5

M_Coral		Bottom							
tide condition	Date	time	Water depth (m)	Sampling depth (m)	Temp (°C)	Salinity (ppt)	DO (mg/L)	pH	Turbidity (NTU)
Mid-Flood	30/01/2007	14:50	8.6	7.6	19.7	31.7	7.7	8.3	1.1
Mid-Flood	05/02/2007	14:45	8.6	7.6	20.7	31.6	7.6	8.3	1.3
Mid-Flood	12/02/2007	14:15	8.7	7.7	19.6	31.6	7.6	8.4	1.5
Mid-Flood	21/02/2007	11:15	8.8	7.8	21.9	32.1	7.5	8.4	1.1

M_Coral	Mid-Ebb			Mid-Flood			Depth-averaged
	Surface	Middle	Bottom	Surface	Middle	Bottom	SS (mg/L)
30/01/2007	4.0	4.0	5.0	3.0	2.0	3.0	3.5
05/02/2007	3.0	4.0	3.0	2.0	2.0	2.0	2.7
12/02/2007	2.0	2.0	2.0	3.0	2.0	2.0	2.2
21/02/2007	4.0	2.0	3.0	3.0	2.0	2.0	2.7

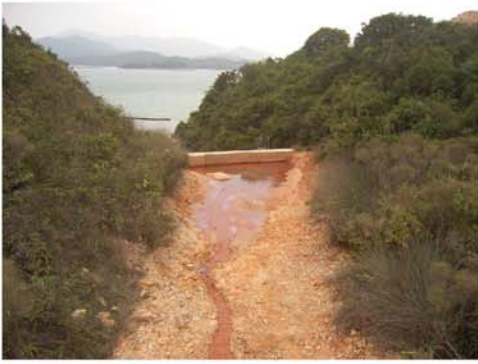
5.3.5 In the present monitoring survey, the main stream course of Stream A (the section downstream to the confluence of tributaries A1 and A2) was found still to be filled up by rubbles which was first report in June 2006 (see **Photo Plate 5.3-1**). The rubbles were reported to be washed down from the upper Tributary A2 which was under pipe culvert construction. Although the riparian vegetation was not affected by the rubbles, this section of stream channel was temporarily lost. Tributary A2 had been converted to underground pipeline as proposed in the EIA report. It was found in the present survey that the flow in the main stream course of Stream A was very turbid. It might be attributed to the earthworks on the stream banks of Tributary A1 (just upstream to the main stream). Stream A was of the lowest ecological value among the four natural streams as it was heavily silted with sediments from eroded hillsides all year round. No stream fish and only very limited aquatic fauna were recorded in Stream A before. The impact from this temporary loss of stream channel would not be severe. But remedial works should be implemented to clear the rubbles and restore the channel as the condition of this stream is expected to improve after the construction of the golf course extension (in which the eroded hill slopes would be replaced by turf).

Stream A and Buffer Zone

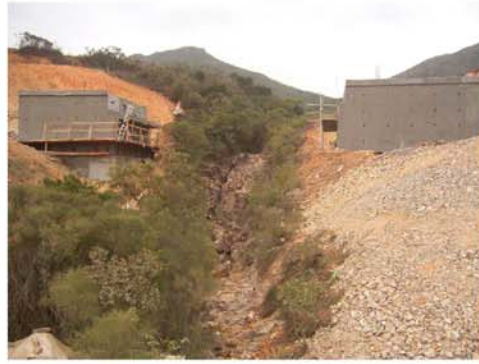
5.3.7 Water levels and flow volume in the 4 streams were all much lower than in previous monitoring surveys during wet season and early dry season. There was only very limited flow in Stream A and Stream C (**Photo Plate 5.3-1 in Annex E**). The flow in B2 tributary and Stream D was also low. Similar conditions (i.e. low water level and flow volume) were recorded before during the EIA study and the baseline survey for the monitoring, so this might be attributed to the seasonal

Stream Flow in upper Stream A

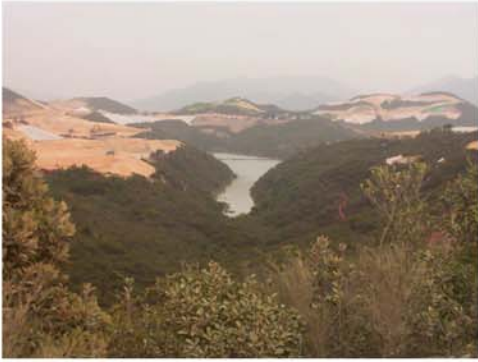
Buuffer zone for Stream B Main Stream

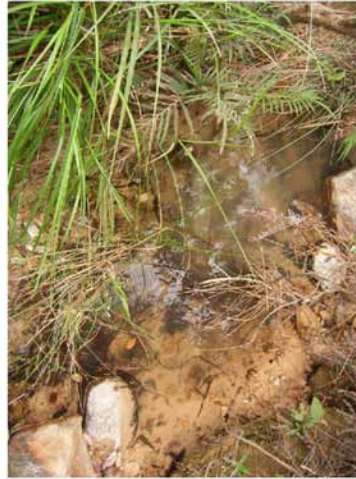
Stream B close-up

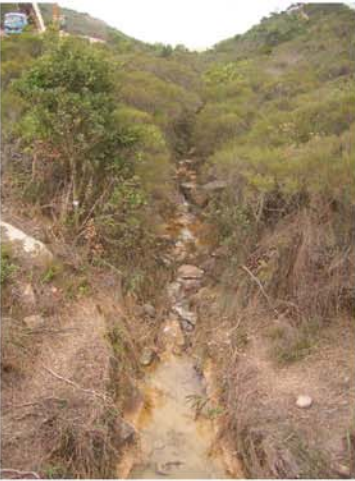
Stream C buffer zone

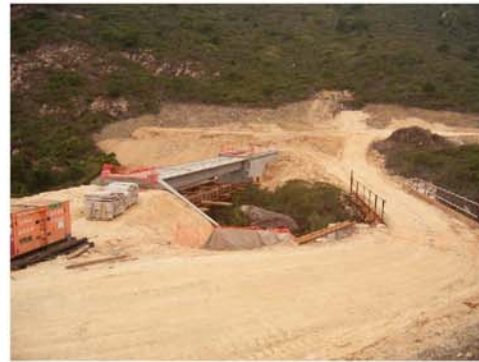
Temporary bridge and permanent bridge at Stream C

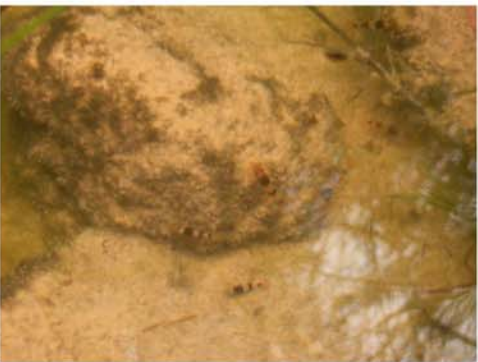
- 5.3.9 Aquatic fauna communities were checked during the monitoring survey. Atyid shrimp *Caridina trifasciata* were found in Stream B, Stream C & Stream D during the present monitoring survey (**Annex E - Photo Plate 5.3-1**). Although the low water levels and flow volume, Atyid shrimp *Caridina trifasciata* was still recorded in the streams, especially among the emergent plants, in the present survey. The sedimentation incident in November 2006 made a large portion of the stream bed in Stream C covered by sediment and this limit the habitat size for the shrimps. Measures should be taken to prevent any similar incidents in the future.

Shrimps in Stream C

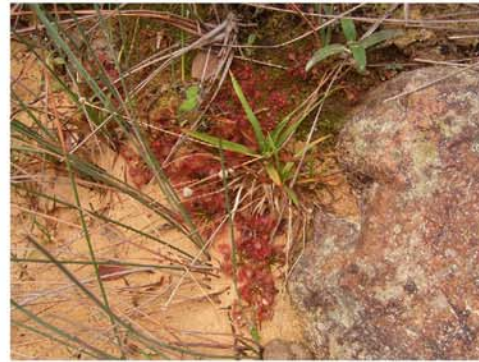
Riparian plants in Stream C

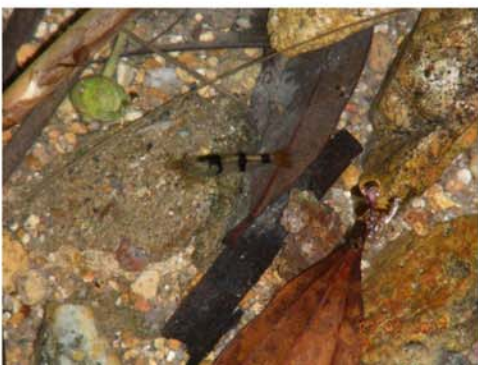
Shrimps in Stream D

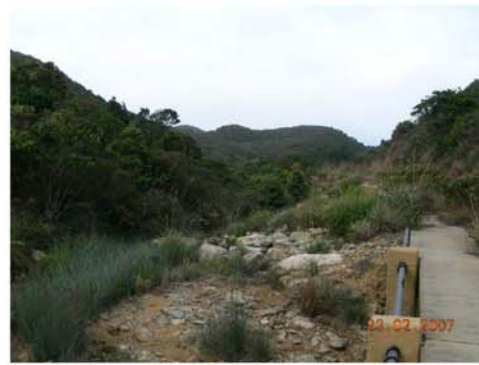
Close-up of Stream D

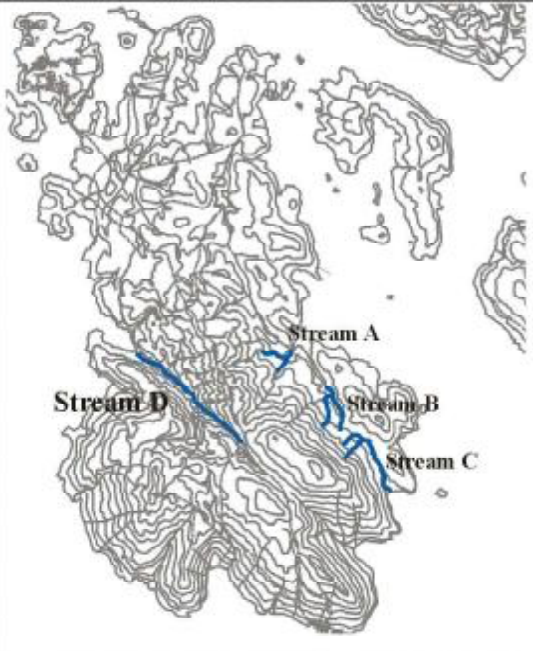
Fig 3.3	
ET	JW
July 2005

5.3.4 Stream A is located within the Project Area. Its main stream section (downstream to the confluence of two tributaries) would be protected by stream buffer zone (**Figure 3.3**). Stream A was heavily silted with sediments from eroded hillsides all year round, particularly at the main stream section. The stream had low flow.

5.3.6 Stream B is located within the Project Area. It had clear flow (with little sediment in the stream beds) of moderate volume during the wet season. This stream also has two main tributaries, B1 and B2. The full length of Stream B (two tributaries and the main stream) would all be protected by buffer zone (**Figure 3.3**). Stream B also contains a long estuarine section of muddy sandy substrate.

- 3.3.10 During the weekly site inspection, ET also monitored and audited the implementation of the recommended mitigation measures for terrestrial and marine ecology. Monitoring locations for ecology are shown in **Figures 3.3 – 3.5**. The monitoring programme for the reporting period is shown in **Annex B**.

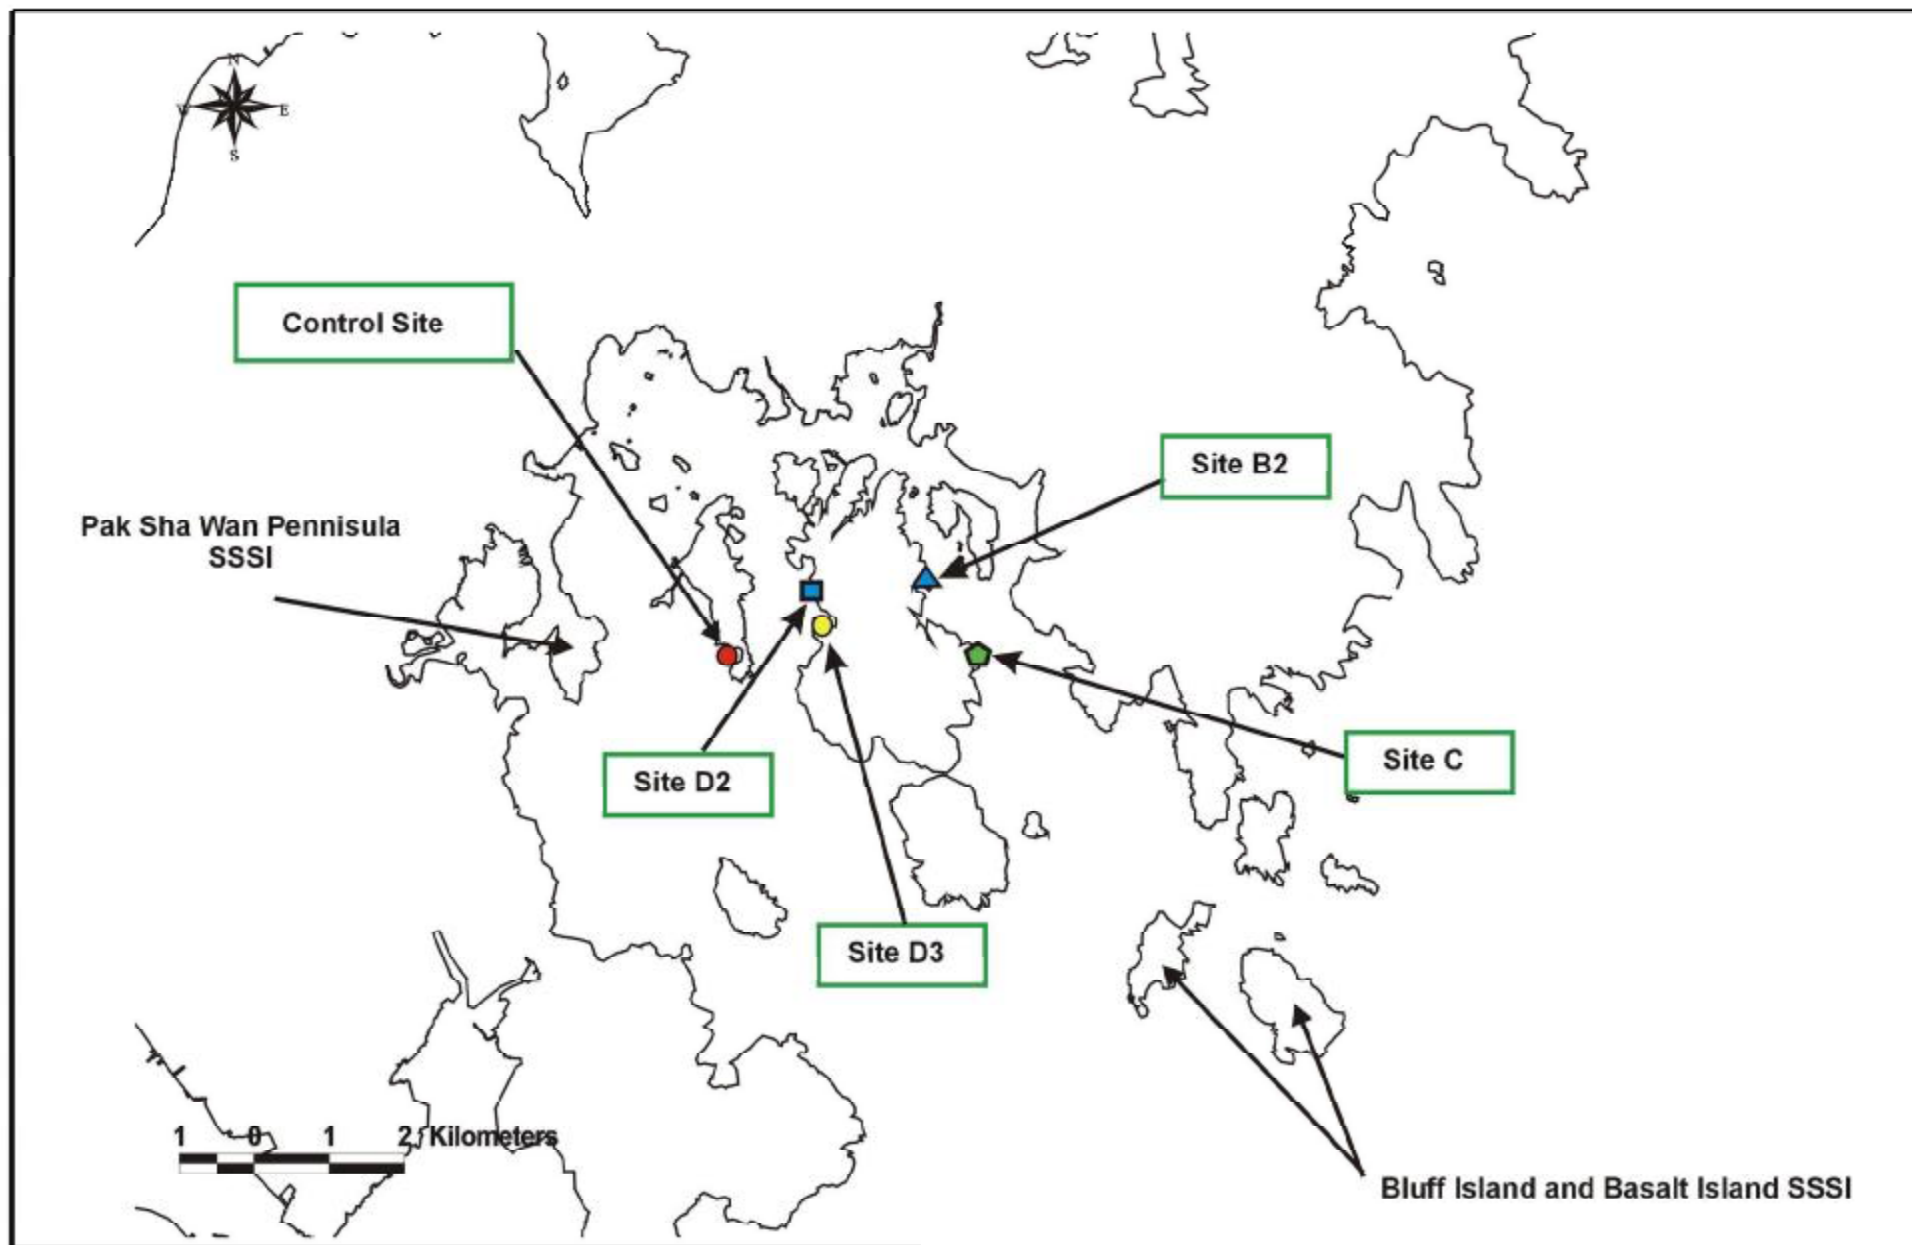
Figure 3.4 Site C, Site B2, Site D2 and a Control Site near the AFCD's Coral Buoy at Sharp Island

- 3.3.7 As required in the EM&A Manual, prior to the commencement of all construction works, a baseline survey of natural corals were conducted in December 2005. At each of the Site C, Site B2, Site D2 and a Control Site near the AFCD's Coral Buoy at Sharp Island (**Figure 3.4**), 20 natural coral colonies in good conditions (i.e. generally intact and no sign of bleaching) and significant sizes (preferably over 20 cm in diameter) were selected and tagged. Each of the tagged coral colonies was identified to species level and their conditions, in terms of percentages of survival, sedimentation and bleaching, were recorded. Each coral was attached with a plastic label with assigned number and then photographed. The species and the size of each tagged corals were also recorded. The species of corals to have been tagged included the following 15 species: *Cyphastrea serailia*, *Favia speciosa*, *Favites abdita*, *Favites pentagona*, *Goniastrea aspera*, *Goniopora columna*, *Hydnophora exesa*, *Leptastrea pruinosa*, *Lithophyllon undulatum*, *Pavona decussate*, *Platygyra acuta*, *Platygyra carnosus*, *Plesiastrea versipora*, *Psammocora superficialis*, and *Turbinaria peltata*. All tagged corals were in good conditions during the baseline survey, without significant sign of bleaching or being covered by sediments, and therefore were all recommended as the monitored coral colonies (all 80 tagged corals, 20 from each site). The seagrass beds in Site D3 were also surveyed for their extent, coverage percentage and health conditions during the baseline survey. The results of the baseline survey has presented in the Baseline Monitoring Report. The original 20 tagged corals at Site B2 were re-organised in April 2006, with B-11 to B-20 retained, but 40 new tagged corals (B-21 to B-60) were established. The number of tagged corals at Site B2 was therefore increased from 20 nos. to 50 nos. The baseline conditions of these newly tagged corals (40 nos.) were presented in the monthly monitoring report of April 2006.
