Proposed Extension of Public Golf Course at Kau Sai Chau Island, Sai Kung

Monthly Environmental Monitoring & Audit (EM&A) Report for March 2007

(Report No. 382210/015)

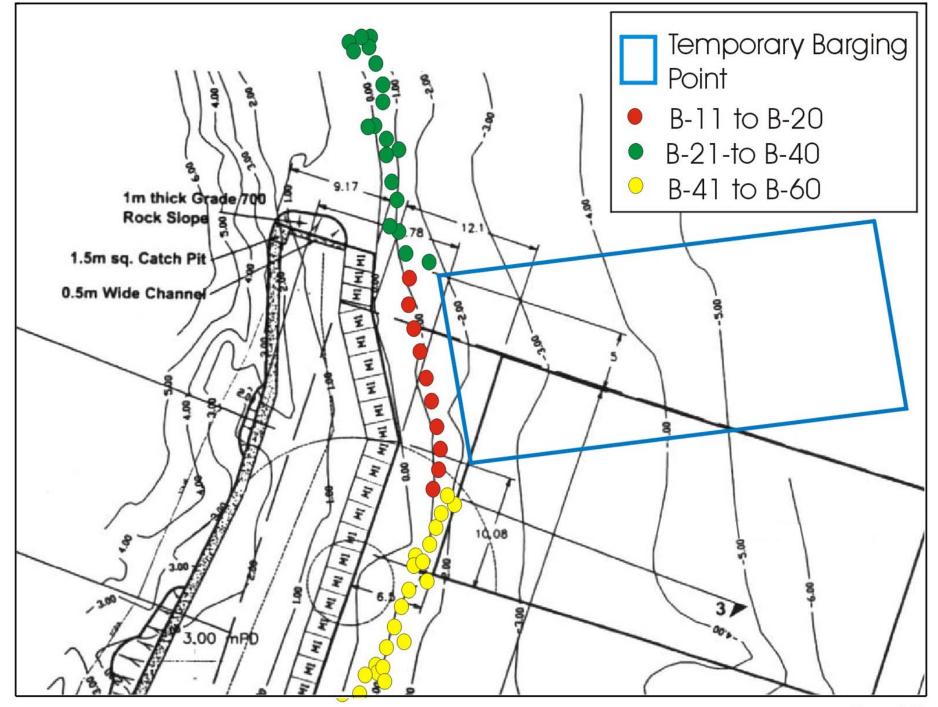
Figure 3.4a Site C, Site B2, Site D2 and a Control Site near the AFCD's Coral Buoy at Sharp Island

3.3.7 As required in the EM&A Manual, prior to the commencement of all construction works, a baseline survey of natural corals were conducted in December 2005. At each of the Site C, Site B2, Site D2 and a Control Site near the AFCD's Coral Buoy at Sharp Island (Figure 3.4), 20 natural coral colonies in good conditions (i.e. generally intact and no sign of bleaching) and significant sizes (preferably over 20 cm in diameter) were selected and tagged. Each of the tagged coral colonies was identified to species level and their conditions, in terms of percentages of survival, sedimentation and bleaching, were recorded. Each coral was attached with a plastic label with assigned number and then photographed. The species and the size of each tagged corals were also recorded. The species of corals to have been tagged included the following 15 species: Cyphastrea serailia, Favia speciosa, Favites abdita, Favites pentagona, Goniastrea aspera, Goniopora columna, Hydnophora exesa, Leptastrea pruinosa, Lithophyllon undulatum, Pavona decussata, Platygyra acuta, Platygyra carnosus, Plesiastrea versipora, Psammocora superficialis, and Turbinaria peltata. All tagged corals were in good conditions during the baseline survey, without significant sign of bleaching or being covered by sediments, and therefore were all recommended as the monitored coral colonies (all 80 tagged corals, 20 from each site). The seagrass beds in Site D3 were also surveyed for their extent, coverage percentage and health conditions during the baseline survey. The results of the baseline survey has presented in the Baseline Monitoring Report. The original 20 tagged corals at Site B2 were re-organised in April 2006, with B-11 to B-20 retained, but 40 new tagged corals (B-21 to B-60) were established. The number of tagged corals at Site B2 was therefore increased from 20 nos. to 50 nos. The baseline conditions of these newly tagged corals (40 nos.) were presented in the monthly monitoring report of April 2006.

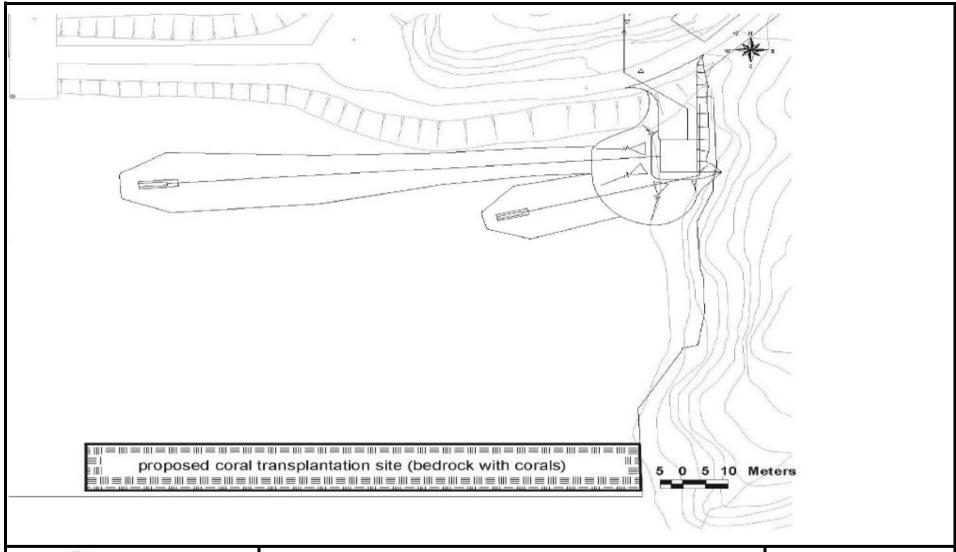
Figure 3.4b Indicative map of additional tagged corals at Site B2

In the present survey, most of these tagged corals at Site B2 were in similar conditions as in the last monitoring (December 2006), but one colony which had previously been found toppled were missing in the present survey. Mortality on B-13 and damages (mortality and anchor damages) on other tagged corals (such as C-04 and C-10) recorded in previous monitoring were found similar in the present survey. The Control Site still remained similar conditions as during the Baseline Survey (no mortality, sedimentation or bleaching was found), except the missing of X-05 colony. All 89 transplanted corals were recovered and their conditions were similar to the baseline conditions (during the transplantation
