Public Golf Course at Kau Sai Chau Island, Sai Kung
Operation Phase
Environmental Monitoring & Audit (EM&A) Report
for August 2008

(Report No. 382812/0201/006)

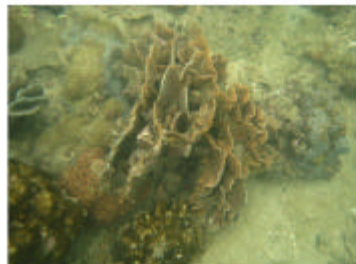
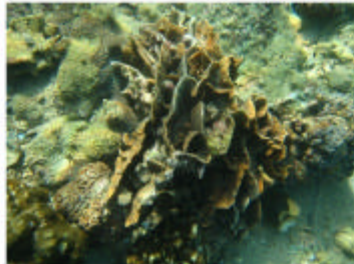
X-04

- 4.2.7 The Control Site is the buoy of coral marker established by AFCD in Sharp Island. Similar with Site C, both the coral coverage percentage and the sizes of coral colonies were high at this site and would not be impacted by the Project. The site and its vicinity still remained similar conditions as during the Construction Phase Monitoring. Coral X-05 was lost in previous construction phase monitoring in June 2006. Replacement coral for X-05 was selected in the present monitoring survey. The remaining 19 tagged corals remained similar conditions as during the July 08 baseline monitoring and construction phase monitoring (**Annex E - Photo Plates 4.2-5 to 4.2-6**). No mortality, sedimentation or bleaching was found on any of the tagged corals (see **Table 4.2-3**).

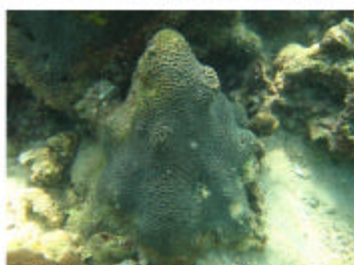
* The original X-05 has been missing during the construction phase monitoring and a replacement colony of *Platygyra carnosus* was selected.

Missing

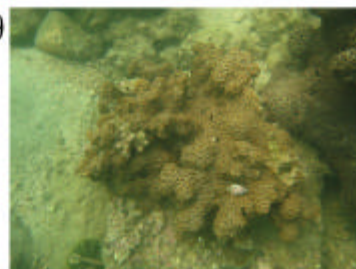
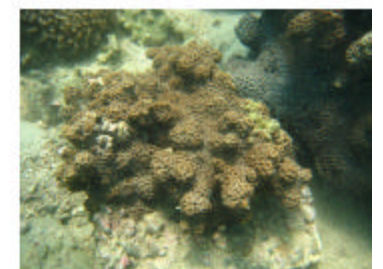
C-19

- 4.2.4 Site C was on the south-eastern coast of Kau Sai Chau Island and had a high coral coverage among the sites investigated during the EIA Study. The sizes of coral colonies at Site C were also larger than those at other sites. Site C was away from the boundary of the East course and would not be subject to direct impacts during construction and operation. The site and its vicinity still remained similar conditions as during the Baseline Survey. Among the 20 tagged corals in Site C, C-04 and C-20 were found missing during the July 2008 baseline survey. Replacement coral colonies were selected. For other recovered corals, no mortality or sedimentation was found except C-17 on which about 10% of mortality was observed. But there was no sign of sedimentation or other adverse impacts caused by the East course operation was found. The mortality on C-17 might be caused by natural factors such as attacks from coral-feeding snails. (see **Table 4.2-1** and **Annex E - Photo Plates 4.2-1 to 4.2-2**).

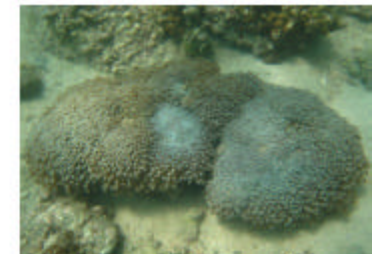
**The original C-20 has been missing during the construction phase monitoring and a replacement colony of *Goniopora columna* was selected.

Missing
