Public Golf Course at Kau Sai Chau Island, Sai Kung
Operation Phase
Environmental Monitoring & Audit (EM&A) Report
for September 2008

(Report No. 382812/0201/007)

This is the seventh Operation Phase Monthly Environmental Monitoring and Audit (EM&A) Report prepared by Black & Veatch for the Project "Proposed Extension of Public Golf Course at Kau Sai Chau Island, Sai Kung". This report presents the results of the EM&A works conducted in the month of September 2008 (25th August to 24th September 2008).

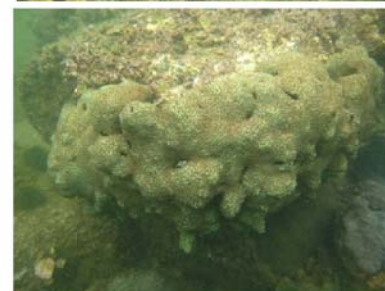
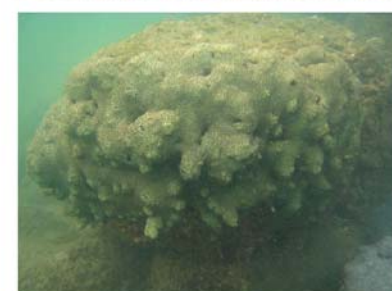
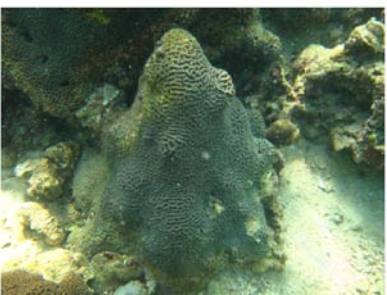
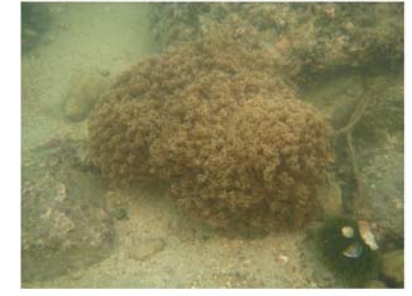
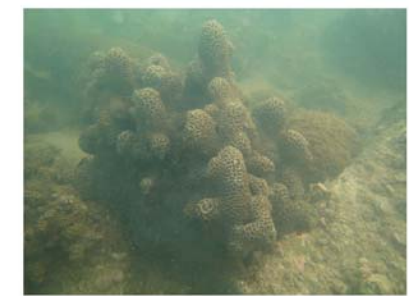
- 4.2.4 Site C was on the south-eastern coast of Kau Sai Chau Island and had a high coral coverage among the sites investigated during the EIA Study. The sizes of coral colonies at Site C were also larger than those at other sites. Site C was away from the boundary of the new golf course and would not be subject to direct impacts during construction. The site and its vicinity still remained similar conditions as during the Baseline Survey. Among the 20 tagged corals in Site C, C-04 and C-20 were found missing during the July 08 baseline survey. Replacement coral colonies were selected in August 2008. For all tagged corals, no mortality or sedimentation was found. The coral colony C-17 on which about 10% of mortality was observed during August 08 monitoring. The partial mortality on C-17 is considered to be caused by physical damages by boat anchors or other objects suspended by wave actions during adverse weather, or by natural factors such as attacks from coral-feeding snails, rather than factors related to the Golf Course operation such as water quality, as there was no sign of sedimentation or other adverse impacts caused by the golf course operation was found and no similar damages were observed in other coral colonies in Site C. It was however observed during the present monitoring that C-17 was recovered from the partial mortality and resume to 100% survival (see **Table 4.2-1** and **Annex E - Photo Plates 4.2-1 to 4.2-2**).

- 4.2.7 The Control Site is the buoy of coral marker established by AFCD in Sharp Island. Similar with Site C, both the coral coverage percentage and the sizes of coral colonies were high at this site and would not be impacted by the Project. The site and its vicinity still remained similar conditions as during the Construction Phase Monitoring. Coral X05 was lost in previous construction phase monitoring in June 2006. Replacement coral for X05 was selected in the August 2008. All 20 tagged corals remained similar conditions as during the baseline monitoring (**Annex E - Photo Plates 4.2-5 to 4.2-6**). No mortality, sedimentation or bleaching was found on any of the tagged corals (see **Table 4.2-3**).

- 4.2.8 **Photo Plates 4.2-1 to 4.2-6** showed the photos of each tagged corals. The assigned numbers, species, mortality percentage, sedimentation coverage percentage and bleaching percentage of the baseline conditions of tagged corals and their present conditions were presented in **Tables 4.2-1 to 4.2-3** below.
