Public Golf Course at Kau Sai Chau Island, Sai Kung
Operation Phase
Environmental Monitoring & Audit (EM&A) Report
for October 2008

(Report No. 382812/0201/008)

Public Golf Course at Kau Sai Chau Island, Sai Kung
 Operation Phase - Monthly EM&A Report

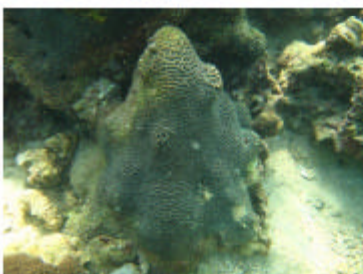
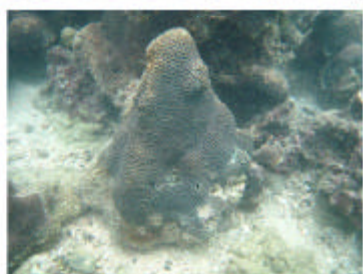
X-05*
tagged in
Aug08 to
replace
missing

* The original X-05 has been missing during the construction phase monitoring and a replacement colony of *Platygyra carnosus* was selected.

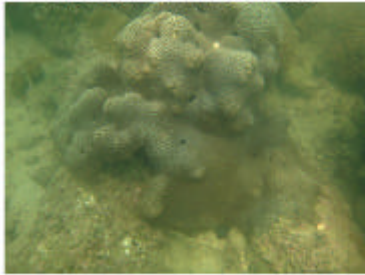
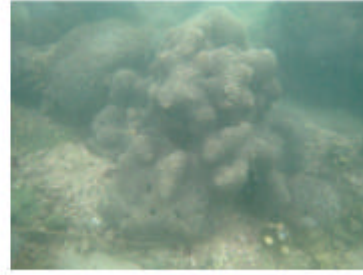
C-01

4.2.4 Site C was on the south-eastern coast of Kau Sai Chau Island and had a high coral coverage among the sites investigated during the EIA Study. The sizes of coral colonies at Site C were also larger than those at other sites. Site C was away from the boundary of the new golf course and would not be subject to direct impacts during construction. The site and its vicinity still remained similar conditions as during the Baseline Survey. Among the 20 tagged corals in Site C, C-04 and C-20 were found missing during the July 08 baseline survey. Replacement coral colonies were selected in August 2008. For all tagged corals, no mortality, bleaching or sedimentation was found (see **Table 4.2-1** and **Annex E - Photo Plates 4.2-1 to 4.2-2**).

- 4.2.8 **Photo Plates 4.2-1 to 4.2-6** showed the photos of each tagged corals. The assigned numbers, species, mortality percentage, sedimentation coverage percentage and bleaching percentage of the baseline conditions of tagged corals and their present conditions were presented in **Tables 4.2-1 to 4.2-3** below.

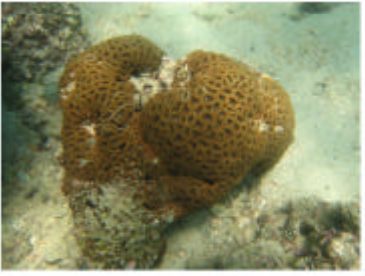
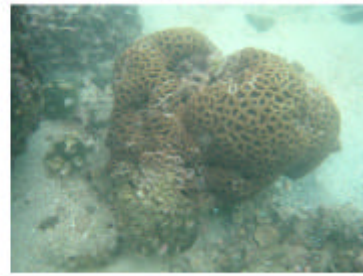
C-04*

*The original C-04 has been missing during the construction phase monitoring and a replacement colony of *Favia speciosa* was selected.

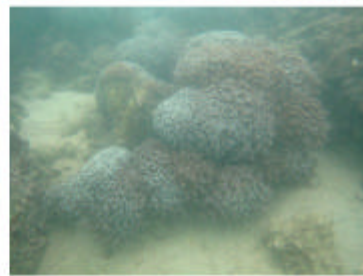
C-20*
Replacement
coral tagged
in Aug08

**The original C-20 has been missing during the construction phase monitoring and a replacement colony of *Goniopora columna* was selected.

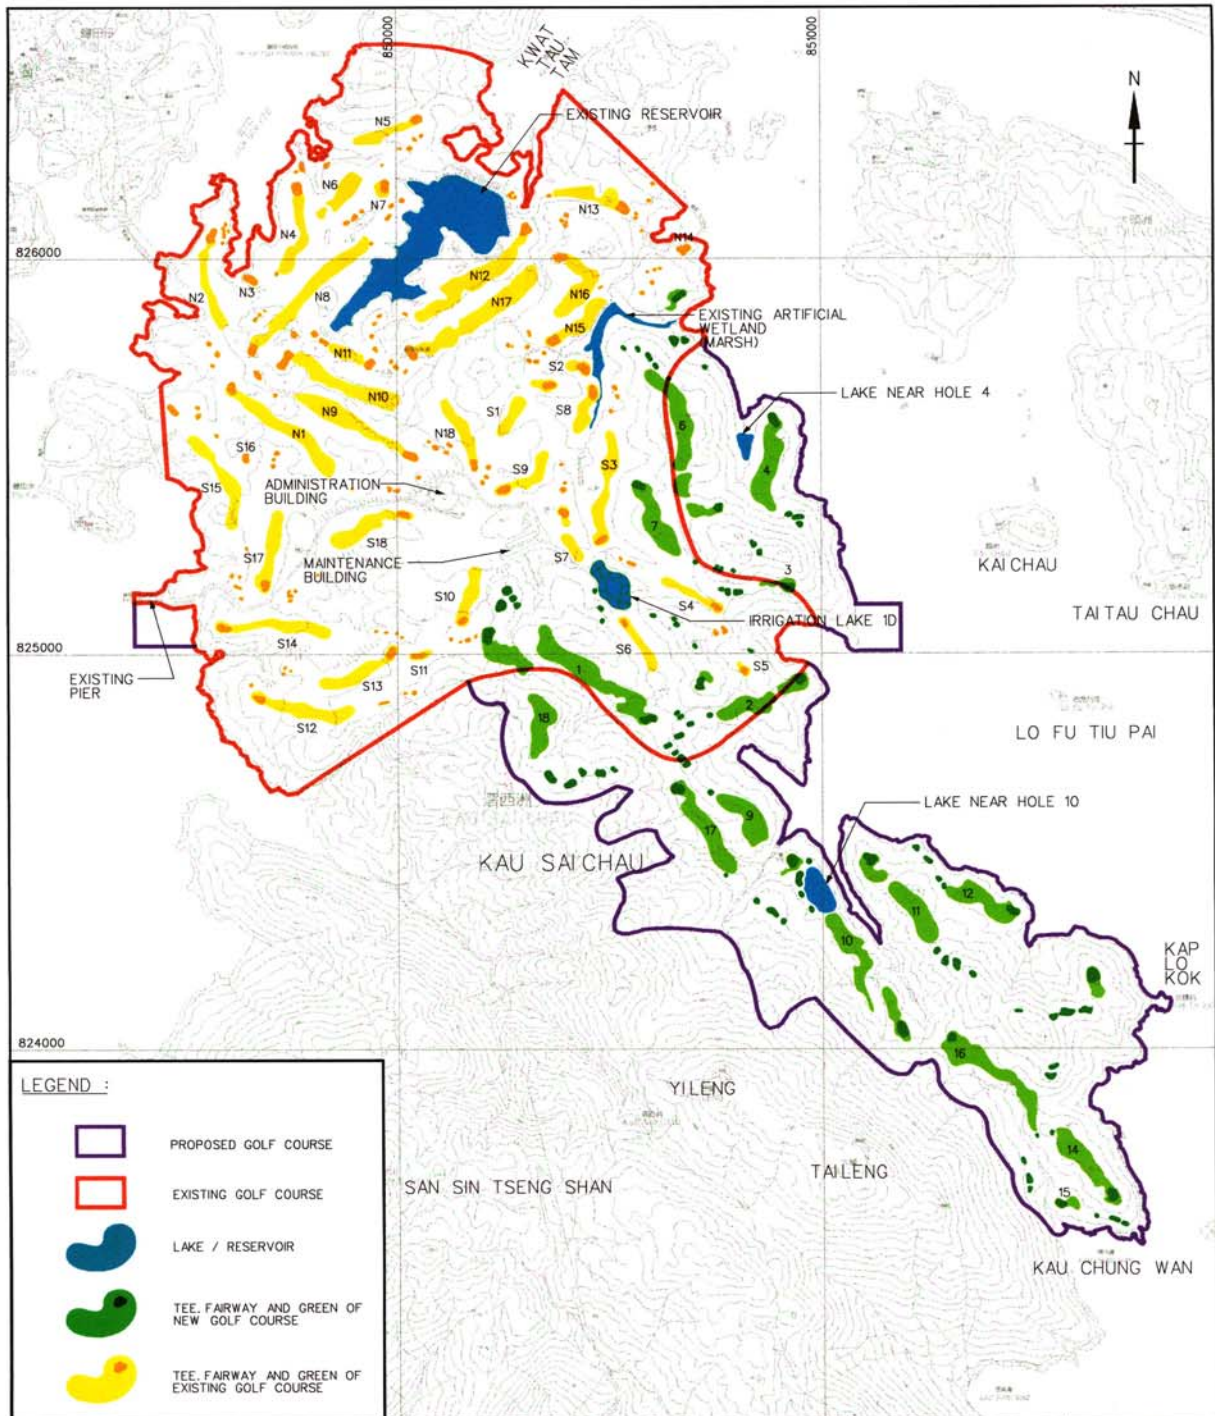
Fig 1.1	Revision
Reference	File Name
Prepared	Checked
Date	Scale
ET	PKL
Apr 08	1 : 15000 (A4)

Master Layer Plan

2.2.1 A layout plan of the Project is provided in **Figure 1.1**.
