**Public Golf Course at Kau Sai Chau Island, Sai Kung**  
**Operation Phase**  
**Environmental Monitoring & Audit (EM&A) Report**  
**for November 2009**

**(Report No. 382812/0201/021)**

**December 2009**

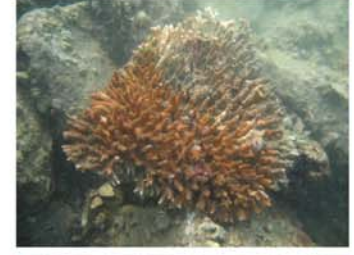
- 5.1.2 No exceedance on marine stations and fresh water stations are recorded.
- 5.1.3 Coral monitoring was carried out in October 2009. No mortality, bleaching or sedimentation was found on most of the tagged corals except bleaching was observed on D-17 (about 50%).

The coral monitoring would change to semi-annually. The coral monitoring was carried out in October 2009 (wet season) which is the fifth operation phase coral monitoring and the second semi-annual monitoring. The upcoming coral monitoring will be carried out in February 2010 (dry season). The conditions, mortality, sedimentation and bleaching of the tagged corals at Control, Site C (south-eastern coast of Kau Sai Chau Island had high coral coverage) and Site D (near desalination plant) were monitored during the report month. No mortality, bleaching or sedimentation was found on most of the tagged corals except bleaching was observed on D-17 (about 50%). Given that no other bleaching was observed on other tagged corals at Site D, the bleaching on D-17 is not considered to be caused by the Project.
