# Ocean Park Master Redevelopment Project

Monthly Environmental Monitoring & Audit  
Report – September 2007

**Environmental Permit No. EP-249/2006/A - Condition 3.4**

**Monthly EM&A Report – September 2007**

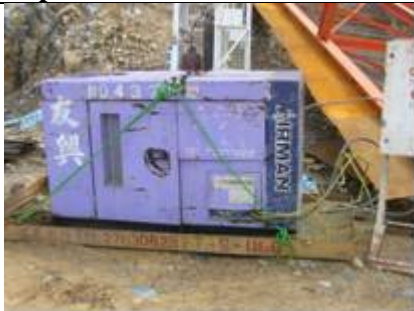
N/A
P1030770: Rainwater was accumulated in the drip tray. The Contractor should remove them as soon as possible.	Closed – The drip tray with generator was not observed in the site inspection session.
<b>Adit Portal</b>

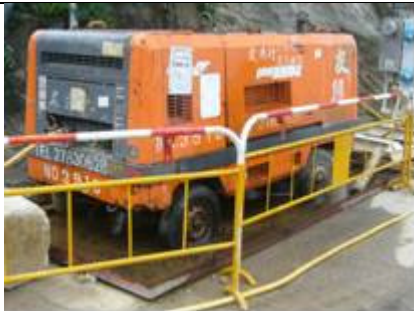
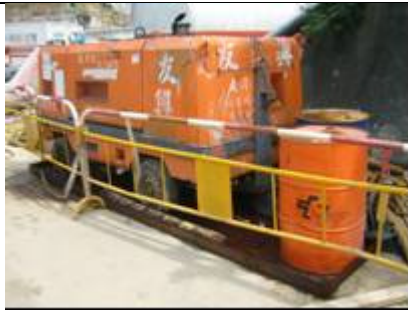
P1030786: Rainwater was accumulated in the drip tray. The Contractor should remove them as soon as possible.	P1030032: Oil was accumulated in a drip tray. The Contractor should remove the oil accumulated in the drip tray as soon as possible.

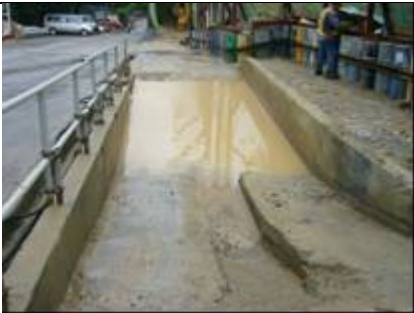
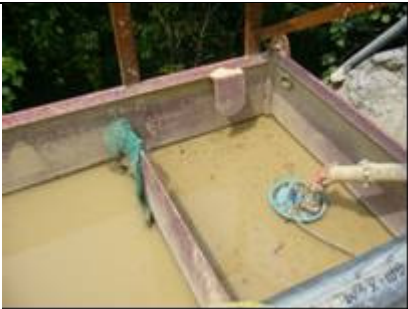
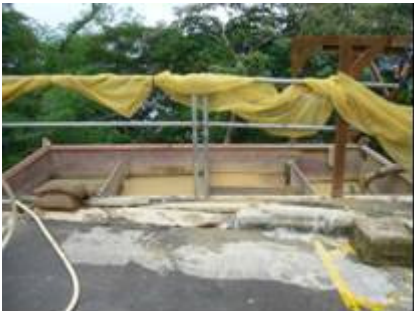
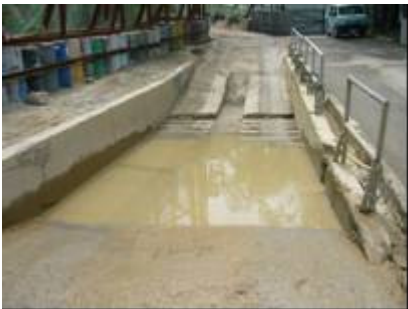
<p>P1030779 &amp; P1030781: The wheel wash bay and sedimentation tank were accumulated with sand and mud. The Contractor should maintain them more frequently.</p>		<p>Closed - P1040030 &amp; P1040031: The discharged water quality was observed to be satisfactory.</p>	
<p><b>Observations in September 2007</b></p>			
<p><b>Citybus Depot</b></p>

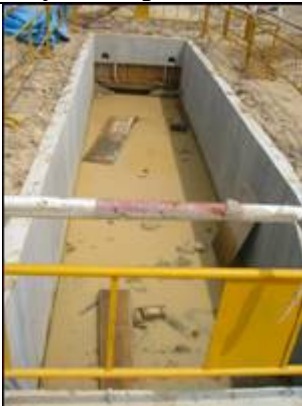
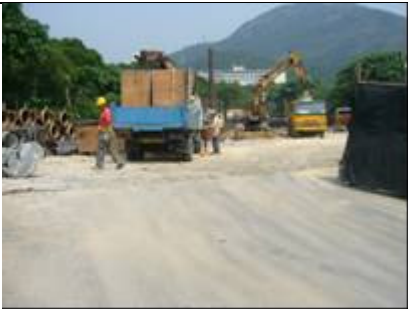
<p>P1040027: Stagnant water was observed in a trench. The Contractor should remove the stagnant water by pumps as soon as possible.</p>		<p>P1040028: Water hose and/or wheel wash bay was not available. The Contractor should ensure wheel wash be provided to all vehicles leaving the site.</p>

- (ii) Stagnant water was observed in the trench. The Contractor was reminded to remove them as soon as possible.
- (iii) Water hose and/or wheel wash bay was not available at Citybus site. The Contractor was reminded to ensure wheel wash be provided to all vehicles leaving the site.

- ① Stagnant water was observed in a trench. The Contractor shall remove them as soon as possible.
- ② Water hose and/or wheel wash bay were not available. The Contractor shall ensure wheel wash be provided to all vehicles leaving the site.

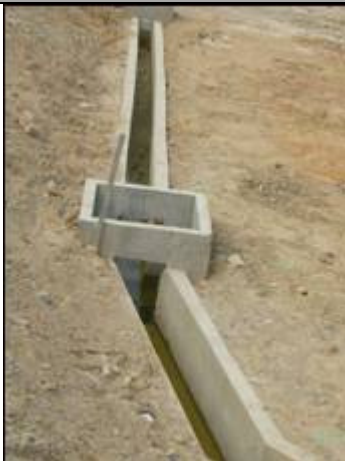
P1040049: Water associated with concrete wall cutting was discharged into the drain. The Contractor should ensure the drain was sealed by boards or sandbags to avoid accidental discharge from construction activities to the drain.		P1040051: Stagnant water was observed at the sandpit and channel at Panda Trail. The Contractor should ensure larvicides are applied to the stagnant water to avoid mosquito breeding.

- i) Water associated with concrete wall cutting was discharged into the drain. The drain should be covered by board or sandbags to avoid accidental discharge from construction activities to the drain.
- ii) Stagnant water was observed at the sandpit and channel at New Panda Habitat. Lavicides should be applied to avoid mosquito breeding.

- ① Water associated with concrete wall cutting was discharged into the drain. The Contractor shall ensure the drain was covered by board or sandbags to avoid accidental discharge from construction activities to the drain. Panda Trail. ✓
- ② Stagnant water was observed at the sandpit and channel at The Contractor shall ensure laricides are applied to avoid mosquito breeding.
