# Ocean Park Master Redevelopment Project

Monthly Environmental Monitoring & Audit  
Report – March 2008

Environmental Permit No. EP-249/2006/A - Condition 3.4

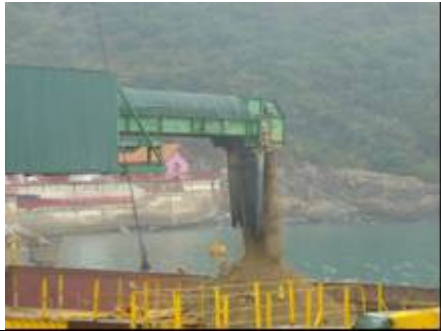
<p>P1050638: The flexible curtain at the outlet of the conveyor belt system was still partly damaged. The Contractor shall repair the damaged part as soon as possible to prevent dust emission.</p>

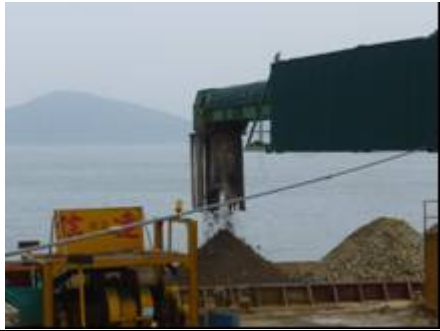
<p>Closed – P1050861: The flexible curtain at the outlet of the conveyor belt system was repaired.</p>
<b>Summit Terminus</b>

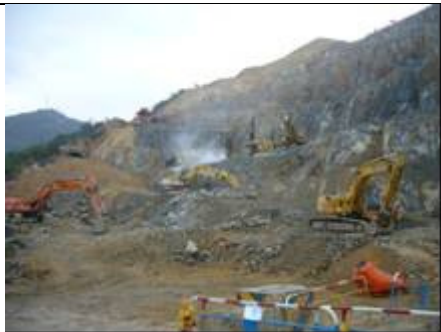
<p>P1050611: Some of the rock breaking and excavation activities were still not provided with water spray to suppress dust. More water sprinklers shall be provided to ensure dust generated from all rock breaking and excavation activities were suppressed.</p>

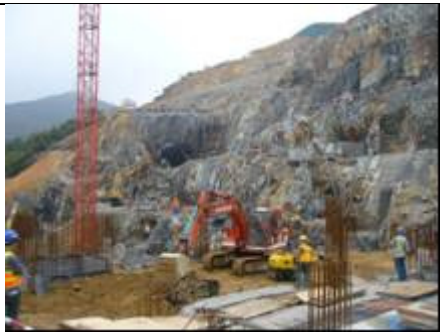
<p>Closed - P1050835: Water spray was generally provided to rock breaking activities at the Summit to suppress dust.</p>

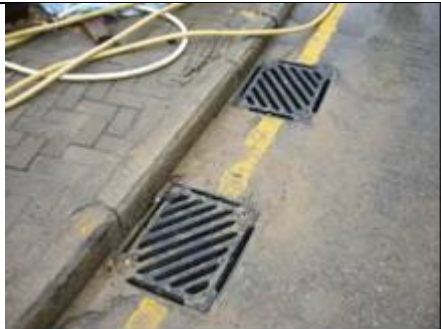
<p>P1050620 &amp; P1050646: The catchpit outlets within the site were blocked while a few gully pits were not provided with sandbags to divert the site runoff. The Contractor shall ensure discharge of muddy surface runoff into public drains be prohibited.</p>		<p>Closed - P1050866: The Contractor confirmed that the gully pits were no longer in use and were blocked.</p>
<b>Summit</b>

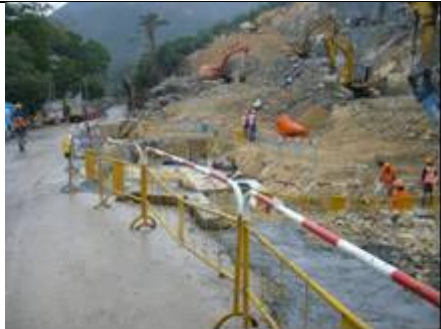
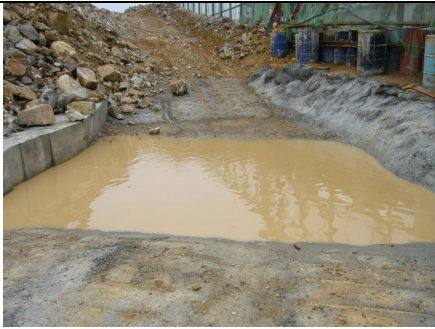
<p>P1050595: Wheel wash facility was removed due to permanent works. The Contractor was reminded to provide wheel wash to all vehicles leaving the site during the construction phase.</p>		<p>Closed - P1050838: A temporary wheel wash facility was provided for providing wheel wash to all vehicles leaving the Summit.</p>

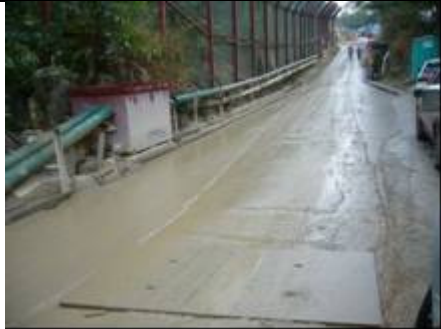
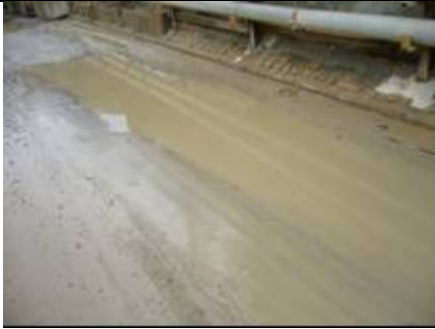
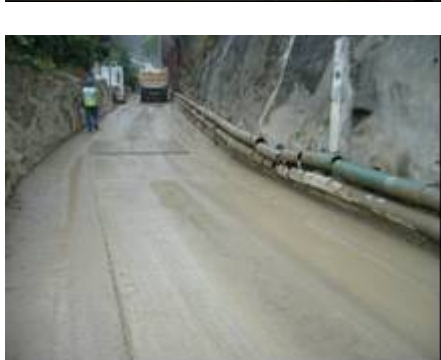
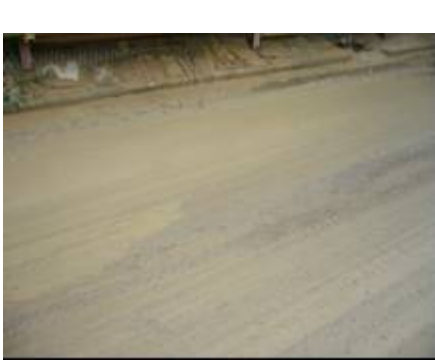
<p>P1050621 &amp; P1050622: The entire access road was accumulated with mud. The Contractor shall</p>		<p>P1050840 &amp; P1050841: Part of the access road was still accumulated with mud. The Contractor</p>

ensure the access road is clear of mud.		shall ensure that the entire access road is clear of mud.	
S Round

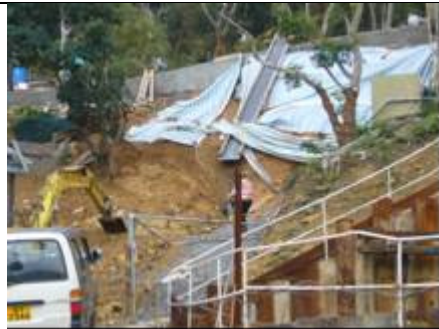
P1050643: Exposed slope surface was not covered with tarpaulin or other means. The Contractor shall cover it with tarpaulin or other means to avoid surface runoff.		Closed - P1050862: Part of the exposed slope surface was covered while part of it was being excavated.	
Observations in March 2008			
Conveyor Crusher Area

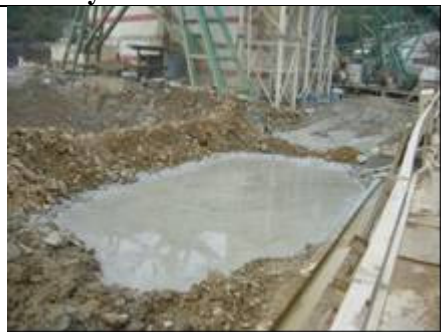
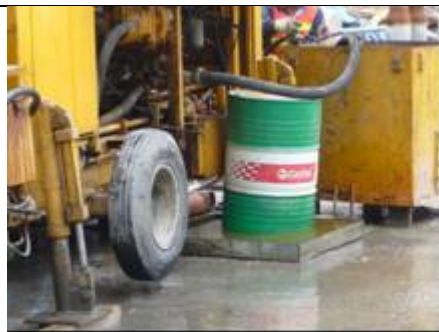
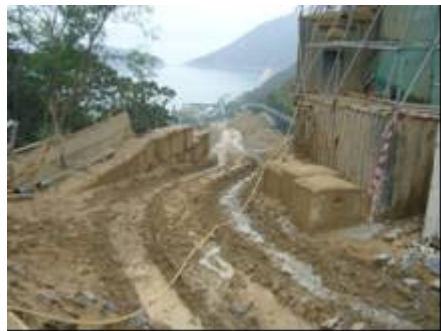
- ② Settled water from sludge removed from sedimentation tank was observed leaking and running down the slope.

P1050848 & P1050847: Sludge removed from sedimentation tank was placed next to the sedimentation tanks. Settled silty water from these sludge ponds was observed leaking and running down the slope. The Contractor shall provide bunds to the sludge ponds to prevent any leakage and potential risk to surrounding water receiving bodies.		P1050853: A drip tray with an oil tank was full of water after rain. The Contractor shall provide maintenance to drip trays more frequently during the rainy season.

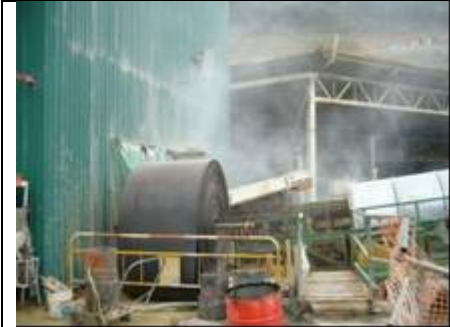
- ⑥ Conveyor - crusher connection point was observed dusty.

<p>P1050857: Dust was observed generated from the connection point between the crusher and the conveyor. The Contractor shall ensure adequate water spray was provided and the crusher-conveyor system is fully enclosed.</p>		
<p><b>Hong Kong Police Training School</b></p>

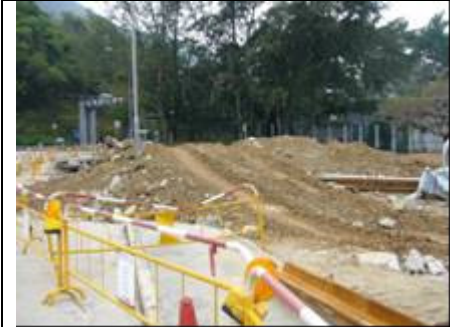
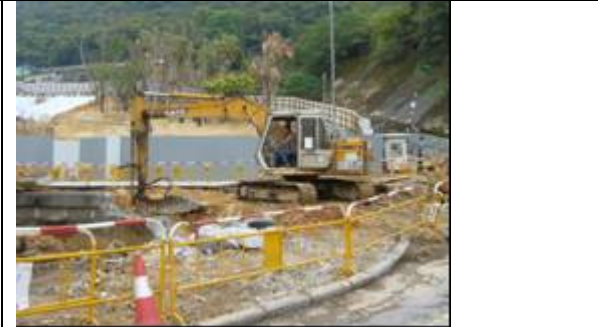
<p>P1050864: Stockpiles of construction materials were uncovered. The Contractor shall ensure all idle stockpiles on site were covered with tarpaulin sheets or other means.</p>		<p>P1050865: Concrete breaking activities was not operated with provision of water spray. The Contractor shall provide water spray during breaking operations to suppress dust.</p>

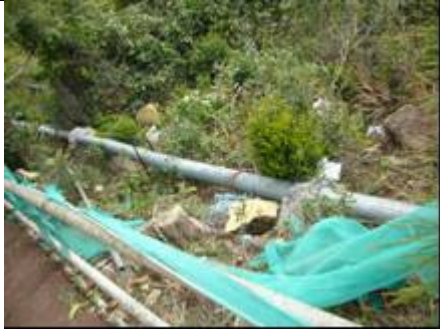
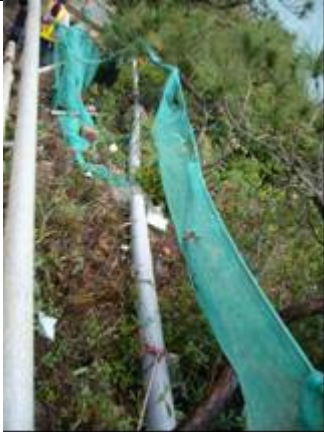
P1050575: Scrap material and general refuse was still scattered along the slope of Pool Block. The Contractor shall remove and dispose them properly.	Closed - P1050810: Scrap material and general refuse were removed from the site and disposed of regularly by the Contractor.

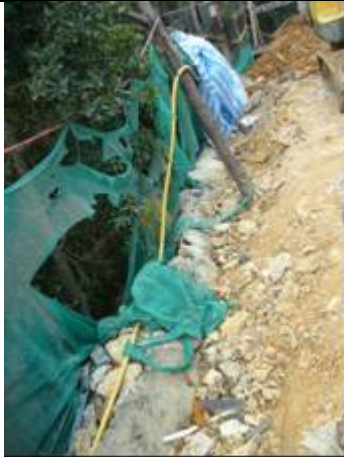
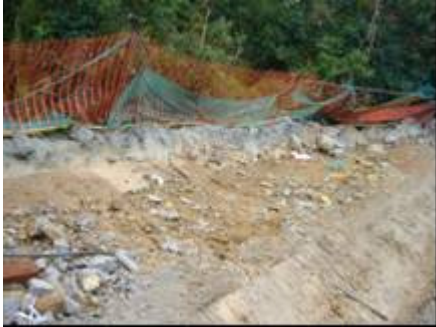
P1050572: The temporary drainage channel was still blocked by rocks and scrap materials. The Contractor shall ensure that it is clear of blockage at all times.	P1050807: The temporary drainage channel was still blocked by rocks and construction materials. The Contractor shall ensure that it is clear of blockage at all times.

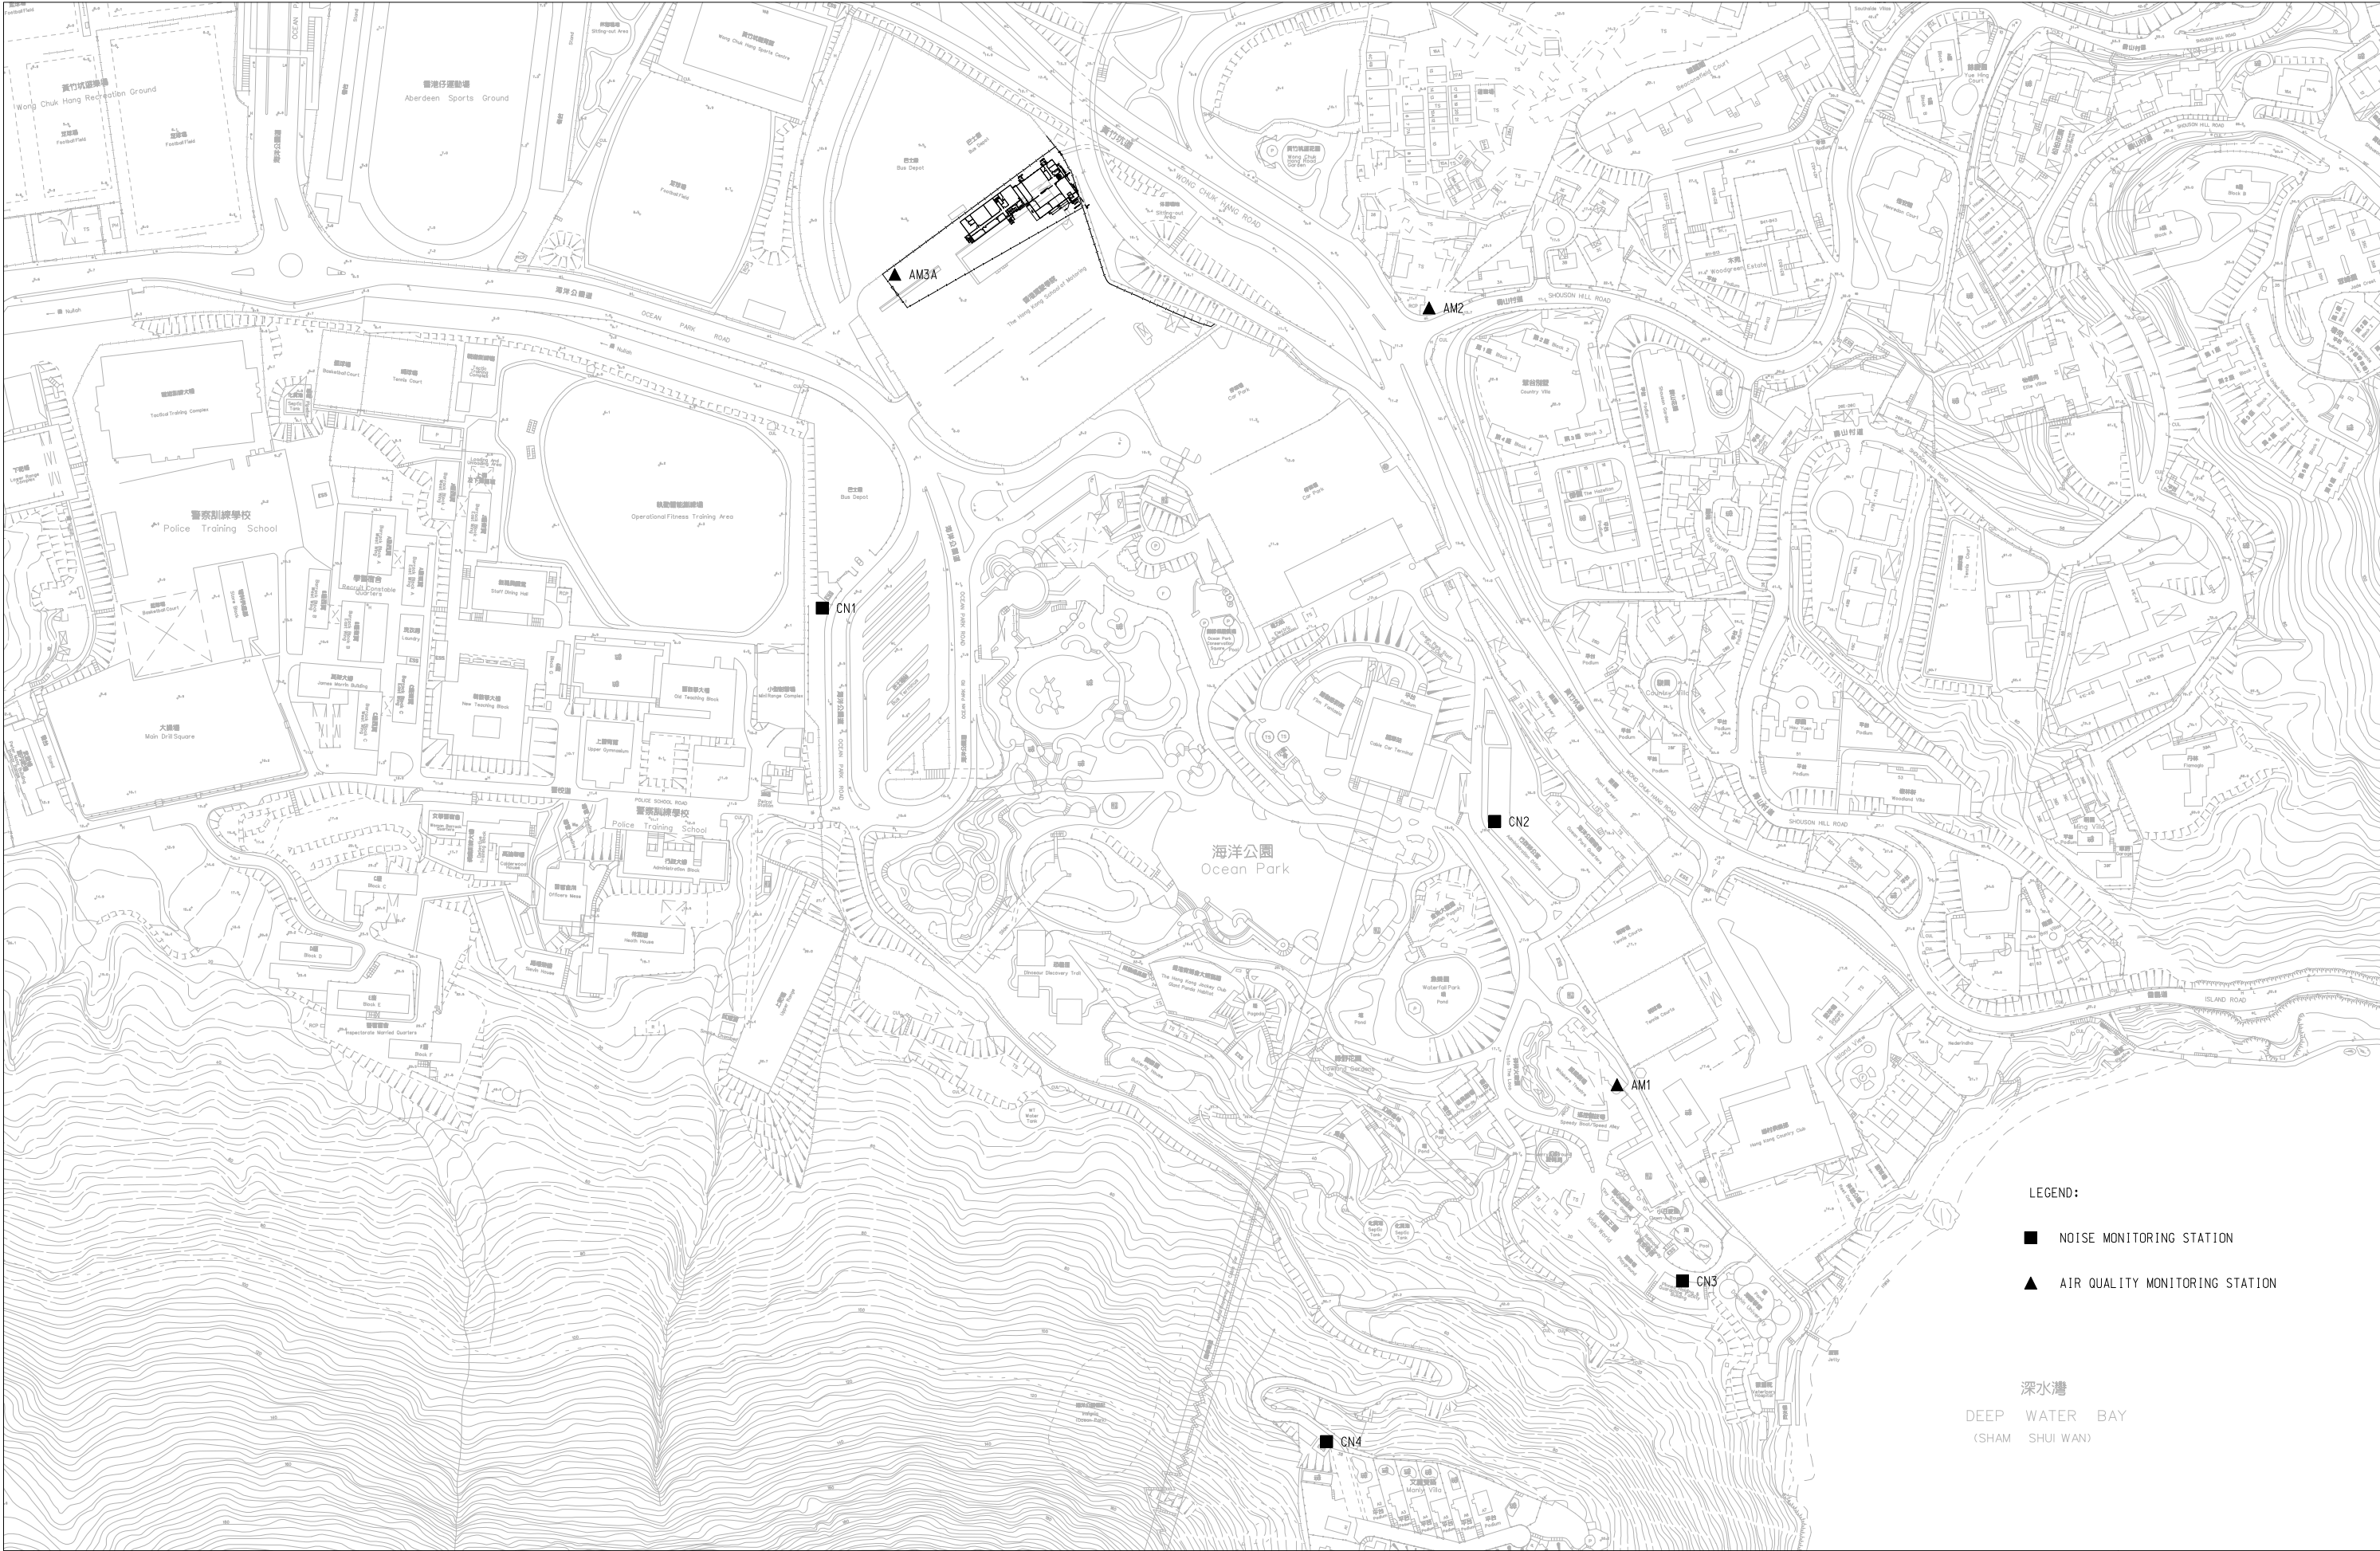
FIGURE 1.4  
AIR QUALITY AND  
NOISE MONITORING STATIONS  
LOCATION PLAN

- NOISE MONITORING STATION
- ▲ AIR QUALITY MONITORING STATION

- 2.4 In accordance with the EM&A Manual, three air quality monitoring stations, as shown in Figure 1.4, were selected for 24-hour and 1-hour TSP sampling. Table 2.3 describes the location of the air quality monitoring stations.

- 3.4 In accordance with the EM&A Manual, noise monitoring was conducted at four designated monitoring stations as shown in Figure 1.4. Table 3.3 describes the locations of these monitoring stations.

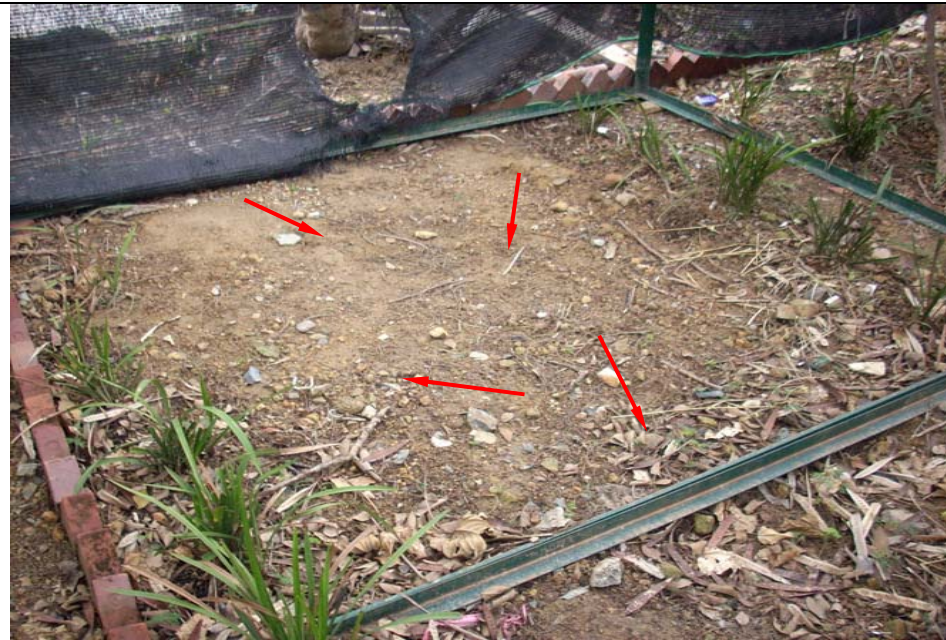
Photo 1 – The withered part of Chinese Lily (red arrow)

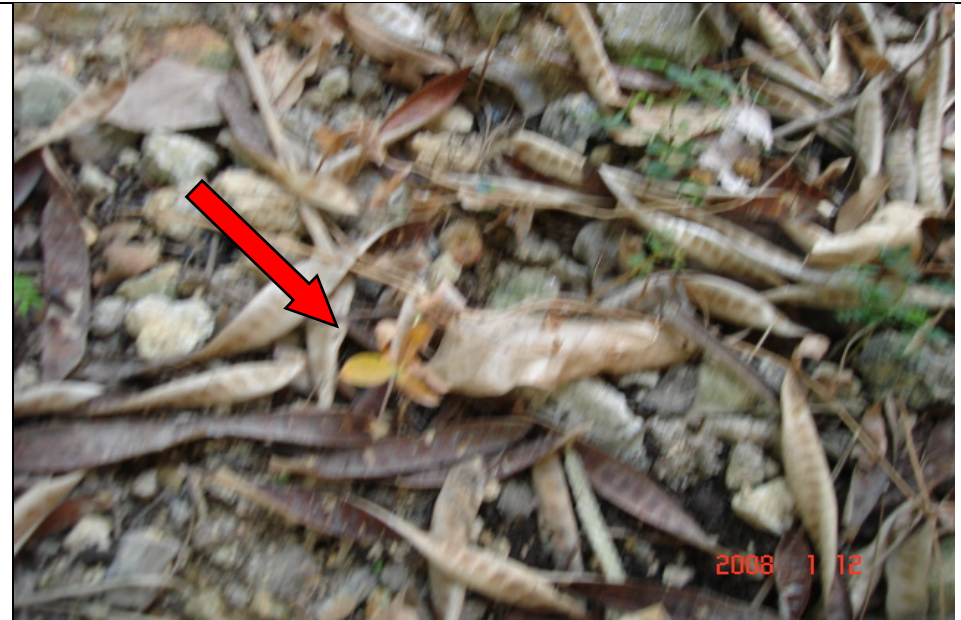
Photo 2 - The shrunk Balloon Flower (red arrow)
