AECOM

Ocean Park Master Redevelopment Project

Monthly Environmental Monitoring & Audit
Report – August 2009

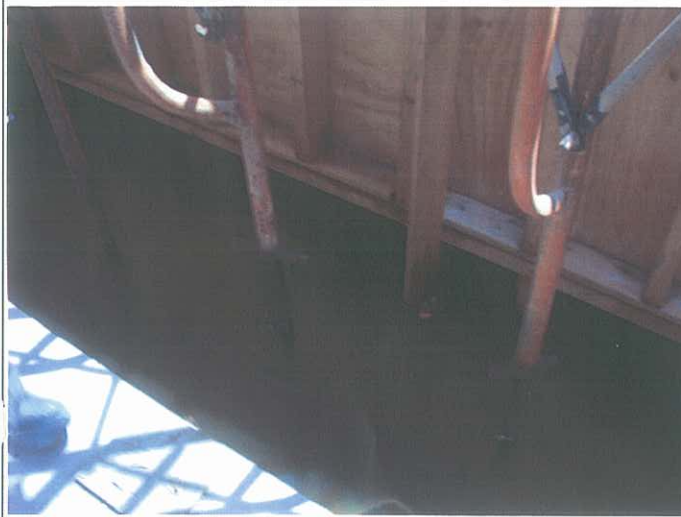
1. Stagnant water was observed.

1. The contractor was reminded to pump the water away immediately.

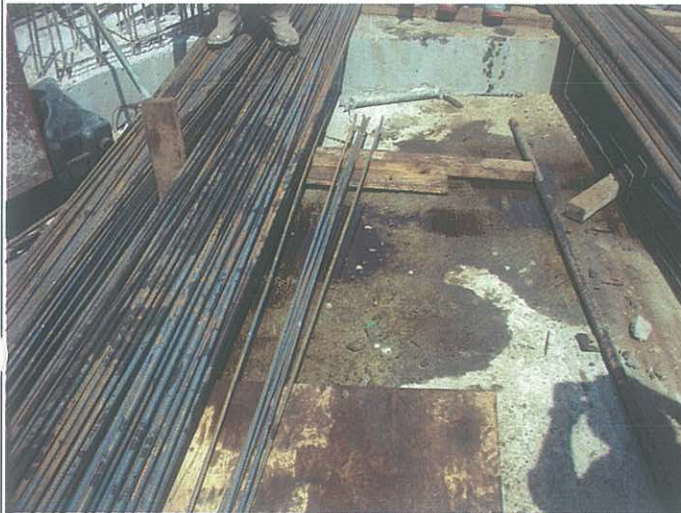
2. Oil spill was observed on the around

2. The contractor was requested to clean up immediately and properly.

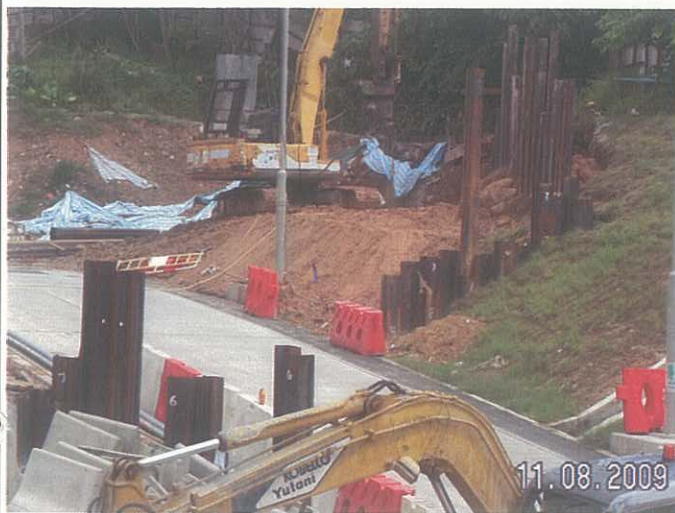
1. Exposed slope was observed without tarpaulin covering.

1. The contractor was reminded to cover the slope and provide sandbag to direct surface runoff away from the drainage.

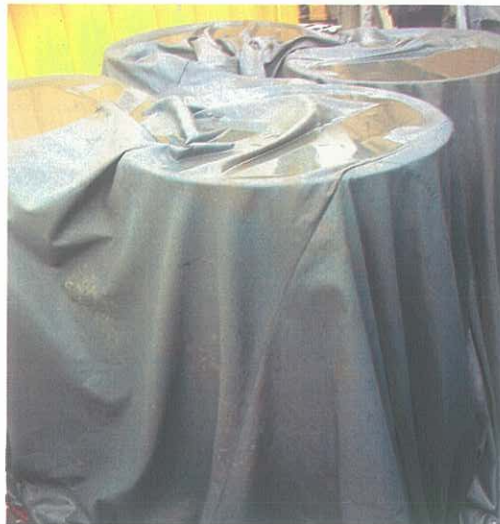
2. The contractor was reminded to cover oil drum and chemical drum to avoid storm water mixing and reduce chemical waste.

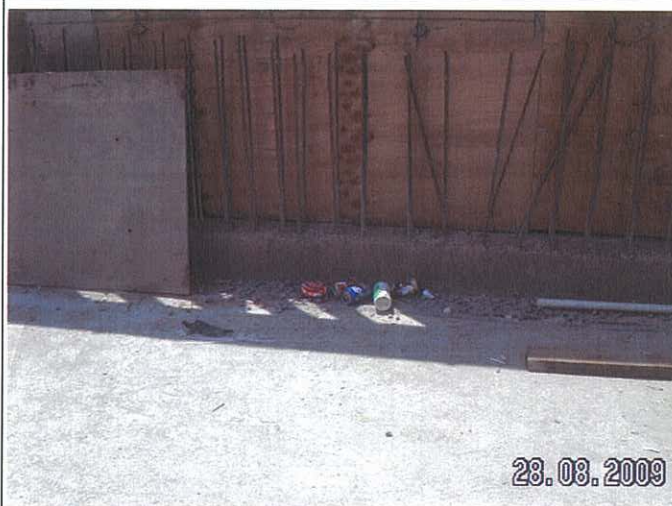
1. General refuse was observed being scattered on the podium.

1. The contractor was reminded to clean up and maintain a tidy environment.

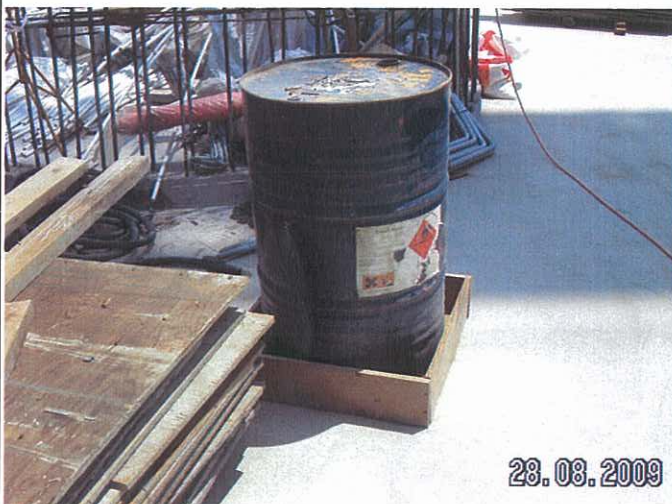
2. Oil drum was observed being placed on a wooden drip tray.

21/08/09	Two chemical drums were placed on bare ground.	Provided drip tray underneath (completed)
	28/08/09	Oil drum was observed being placed on a wooden drip tray.	Replace with a metal drip tray (completed)

2. The contractor was requested to replace with a metal drip tray.

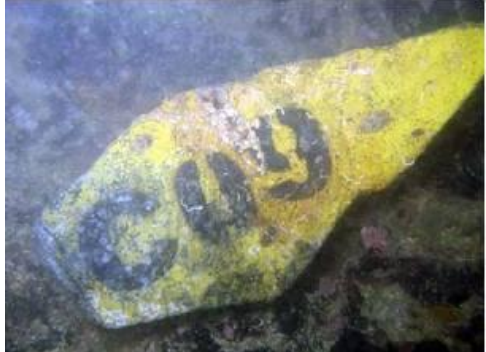
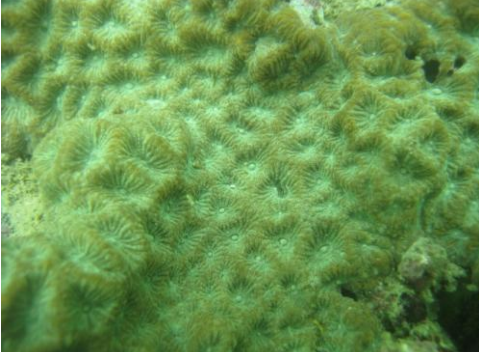
C08	<i>Favia fava</i>

sedimentation cover was recorded on 3 colonies (C02, C06 and C08), ranged from 2 to 4%. Decrease in sedimentation was observed in 1 colony (C07) by 2%. Bleaching was not recorded. Partial mortality was recorded in 3 colonies (C02, C08 and C09), ranged from 2 to 5%, and had no further increase (Table 3.2).

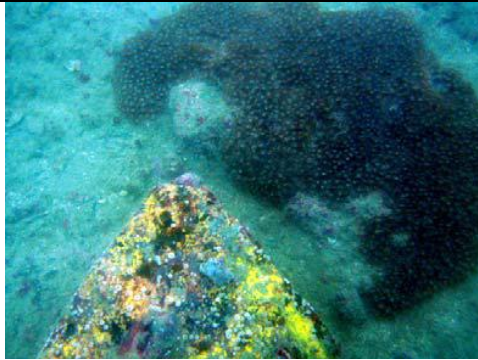
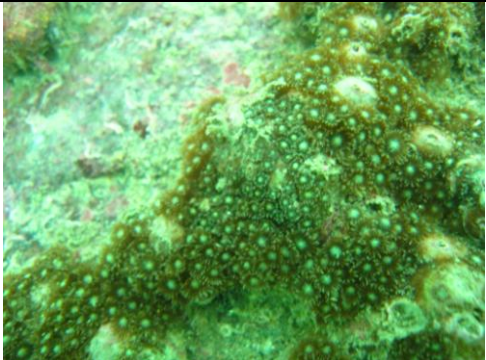
E01	<i>Goniopora stutchburyi</i>

- 3.1.6 When compared with baseline data in April 2007, increased sedimentation cover was recorded on 3 colonies (E01, E03 and E06), ranged from 1 to 2%. Decrease in sedimentation was observed in 2 colonies (E07 and E09), by 5%. Bleaching was not recorded. Partial mortality founded in 3 colonies (E04, E09 and E10), and had no further increase since it was first recorded in February 2008 survey (Table 3.2).

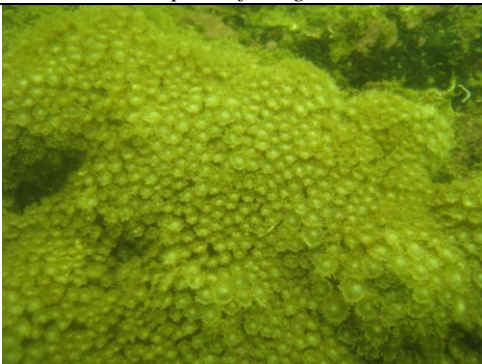
D03	<i>Goniopora stutchburyi</i>
Colony Loss	Colony Loss
D04	<i>Leptastrea pruinosa</i>

- 3.1.7 Two colonies (D04 and D09) were not found on their previous attached substrates. When compared with baseline data in April 2007 among the remained 8 colonies, increased sedimentation cover was recorded on 4 colonies (D03, D06, D08 and D10), ranged from 1 to 5%. Decrease in sedimentation was observed in 2 colonies (D01 and D2), ranged from 3 to 7%. Bleaching was not observed. Partial mortality observed in 4 colonies (D01, D05, D06 and D10) ranged from 2 to 4%, in which new mortality was recorded only in D10 which is likely to be caused by physical damage (Table 3.3, Appendix Ie).

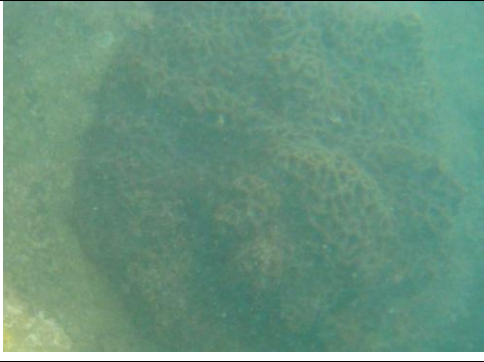
F03	<i>Favites pentagona</i>

- 3.1.8 One colonies (F10) was not found on their previous attached substrates. When compared with baseline data in April 2007 among the remained 9 colonies, increased sedimentation cover was recorded on 4 colonies (F03, F06, F08a and F08b), ranged from 2 to 5%. Decrease in sedimentation was observed in 3 colonies (F03, F04 and F09), ranged from 1 to 3%. Bleaching was not recorded. Partial mortality was found in 7 colonies (F02, F03, F04, F05, F06, F07 and F09) by 2 to 12%, and had no further increase (Table 3.3).

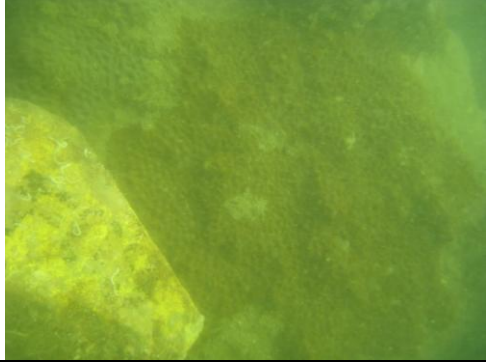
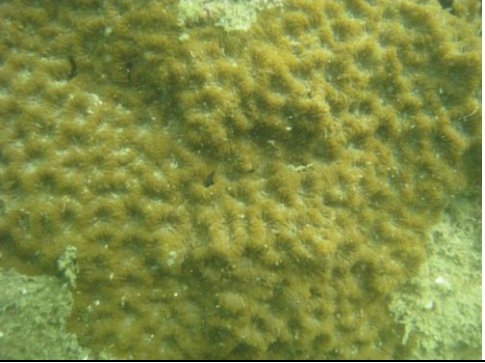
F09	<i>Favites pentagona</i>
Colony Loss	
F10	<i>Platygyra carnosus</i>

- 4.1.2 Among the tagged corals, 6 of the colonies were not found from their substrates in Site 1, 3, 5 and Control Site C (Table 4.1). There was little or no remain of skeleton at the location of all the lost colonies, indicating the colonies may be detached from the substrate. The detachment was likely to be caused by physical damage from the tropical cyclones. Between the previous (9 May 2009) and the present monitoring survey, Hong Kong has been attacked by 5 tropical cyclones, including 2 tropical storms, 2 severe tropical storms and 1 typhoon. Detached or turned over of untagged colonies have been recorded in Site 1, 2 and Control Site C in the present monitoring. Such physical damage on the coral community is not uncommon during the typhoon season (Cornish 2003).

- 5.3 In the view of a continuous monitoring for an additional year or more, a retagging exercise is proposed for replacement of the lost colonies and installation of new tagging stones for both original and newly tagged colonies at the Monitoring and Control Sites.
