Ocean Park Master Redevelopment Project

Monthly Environmental Monitoring & Audit Report – February 2010

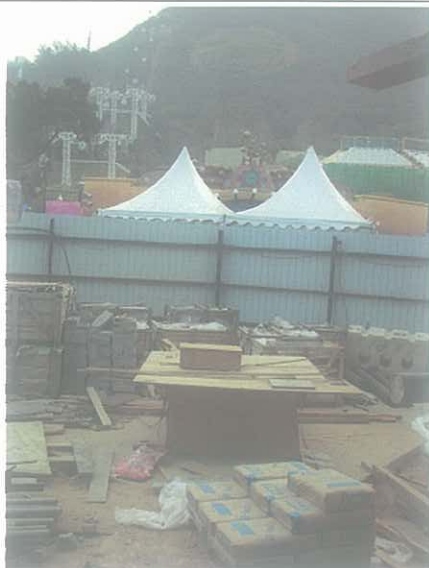
1. The saw located near the hoarding inside Carousel Plaza did not have bag provided to collect saw dust.

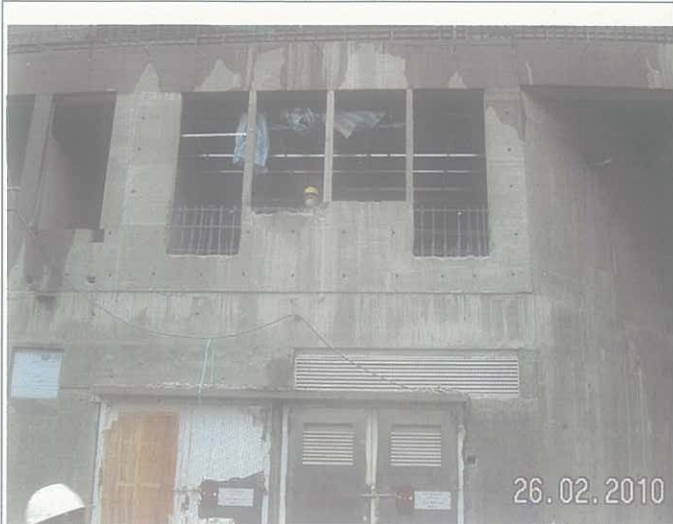
Inspection / Follow up Report No 065.

1. Dust was generated during surface grinding along the exterior of West Building.

1. The contractor was reminded to wet the surface to suppress dust.

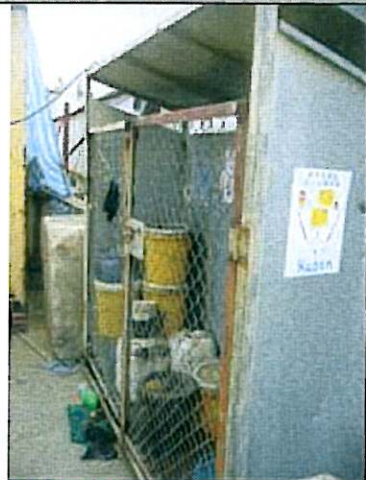
Chemical waste storage area was properly labelled but not properly secured. The Contractor should ensure the chemical waste storage area is properly secured/ locked.	P1080540: Chemical waste storage area was accumulated with water due to rainy weather. The Contractor should ensure the chemical waste storage area is maintained properly.

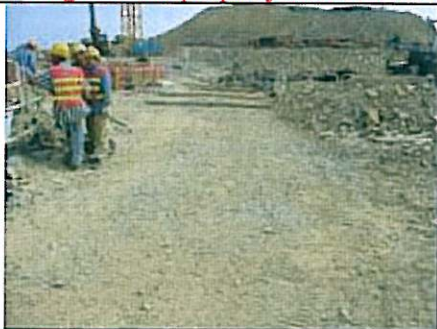
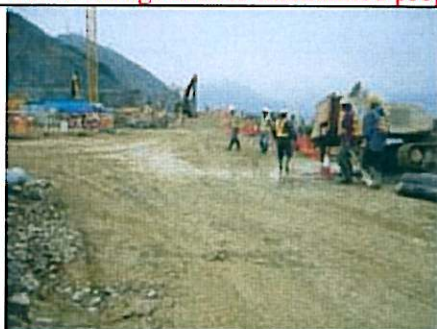
P1080429: Haul road near the site entrance was dry and dusty. The Contractor should provide water spray to all haul road on-site more frequently.	Closed - P1080529: Water spray was provided to all haul roads on-site.
Observations in February 2010

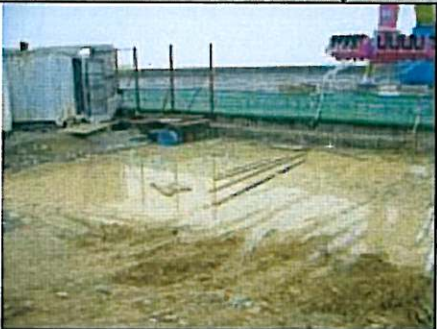
P1080534: Stagnant water was accumulated on-site. The Contractor should remove them as soon as possible.
