#### Ocean Park Master Redevelopment Project EP-249/2006A - Condition 3.4 of Monthly EM & A Report (February 2011)

## EP-249/2006/A – Condition 3.4 Monthly EM&A Report – February 2011

Monthly Environmental Monitoring & Audit Report – February 2011

Report for Coral Monitoring Survey

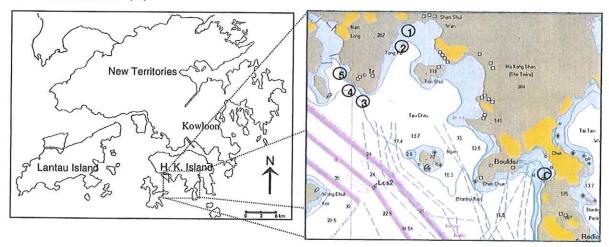
Fig. 2.1 Map Showing the Locations of the Five Impact Monitoring Sites (1 to 5) and One Control Site (C).

2.1.1 Five locations close to the potential impact areas were identified and designated as Impact Monitoring Sites (Sites 1 to 5; Fig. 2.1). In order to identify background environmental perturbations that are not associated with the construction, St. Stephen Beach, which is away from the impact areas, was designated as the Control Site (Control Site C; Fig. 2.1). Locations (GPS coordinates) of the five Impact Monitoring Sites and one Control Site C are summarized in Table 3.1.
