Ocean Park Master Redevelopment Project

Monthly EM&A Report – May 2011

Monthly Environmental Monitoring & Audit Report – May 2011

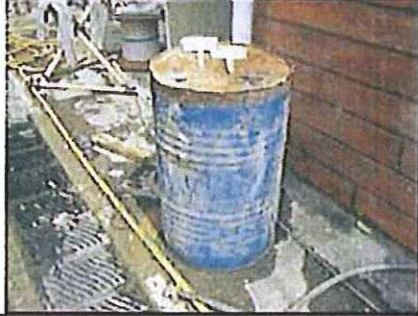
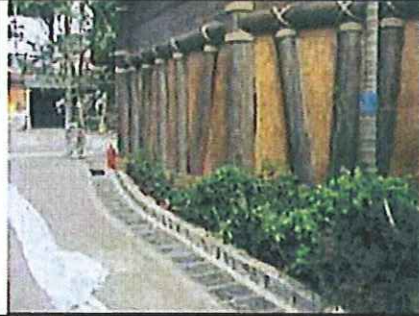
P1120987: An empty oil drum was placed on bare ground. The Contractor was reminded to place it in chemical waste storage area and dispose it properly.	Closed - P1130211: Empty oil drums on site had been disposed off-site.

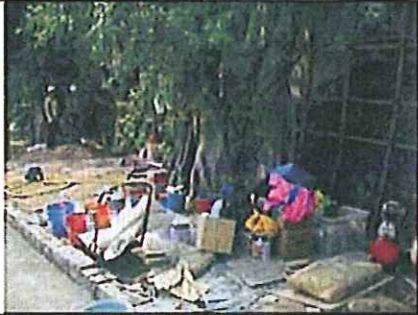
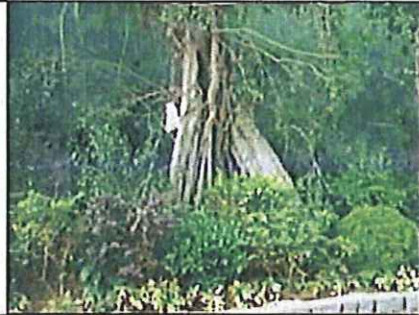
P1120990: Materials were banked around several trees. The Contractor was reminded to avoid placing construction materials and equipment too close to the trees to avoid spillage of oil and paints to the soil.	Closed - P1130218: Materials banked around trees had been removed.

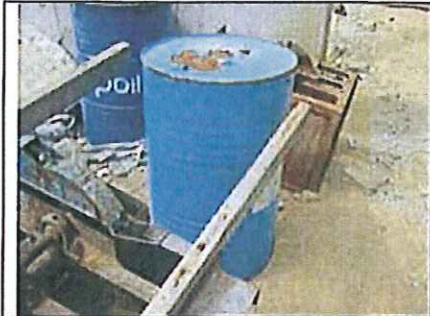
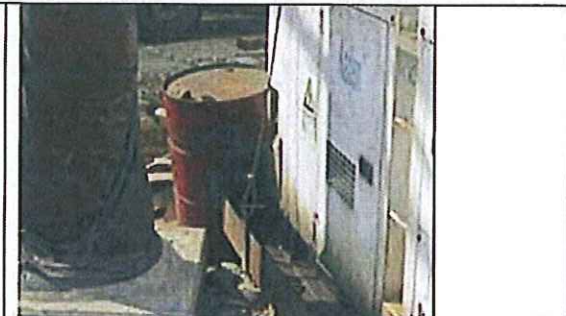
P1120976: An empty oil drum was placed on bare ground. The Contractor was reminded to place it in chemical waste storage area and dispose it properly.		P1130214: An empty oil drum was placed on bare ground. The Contractor was reminded to place it in chemical waste storage area and dispose it properly.

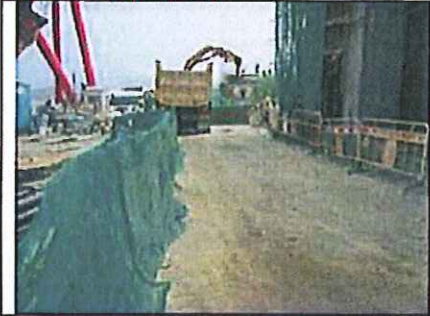
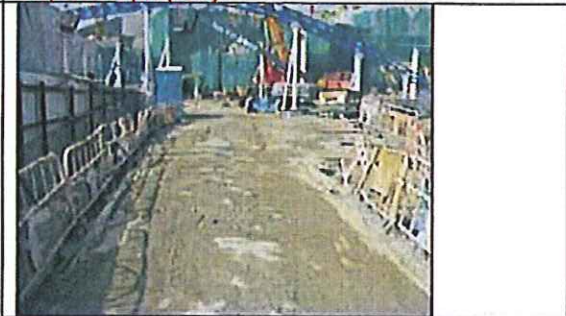
P1120984: Some parts of the haul road were dry and dusty. The Contractor was reminded to provide water spray to cover the entire site and more frequently during dry weather.		Closed - P1130202: Water spray was provided regularly along haul roads to suppress dust.

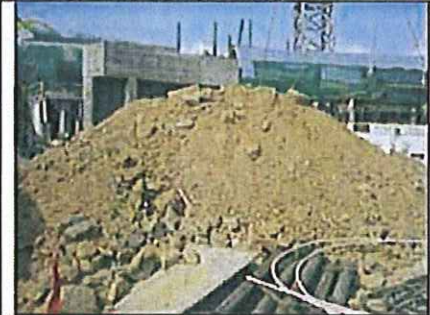
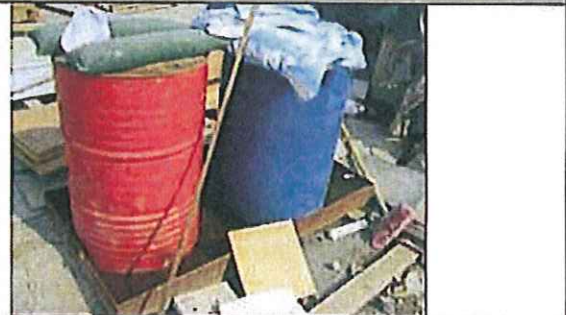
P1130207: Idled stockpiles of excavated materials were not covered. The Contractor was reminded to cover them with tarpaulin sheets or other means to suppress dust.		P1130209: Water was accumulated in drip tray with oil drums. The Contractor was reminded to drain the water away to ensure effectiveness of the drip tray.
