## **Ocean Park Master Redevelopment Project**

**Monthly EM&A Report – October 2011**

## Monthly Environmental Monitoring & Audit Report – October 2011

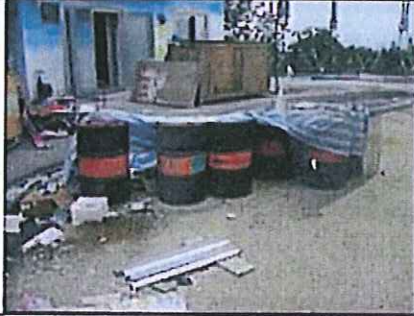
N/A
P1130862: A few hydraulic vegetable oil drums were placed on bare ground. The Contractor indicated that the oil will be used for installation works and any oil drums not used will be placed in permanent storage area.	Closed – The area had been handed over for operation.

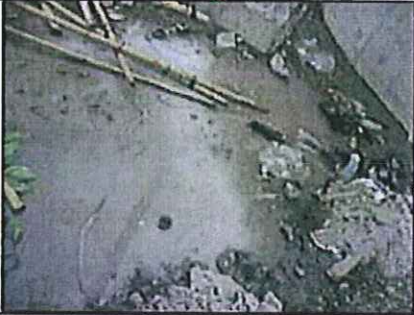
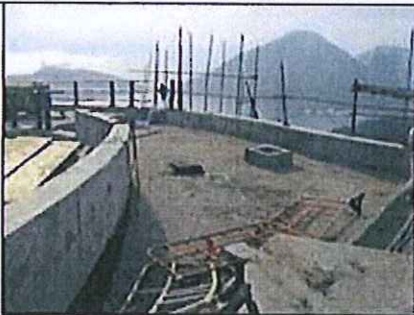
P1130861: Stagnant water was accumulated on site after heavy rain. The Contractor was reminded to backfill the area as soon as possible to avoid accumulation of stagnant water.	Closed - P1140178: Accumulation of stagnant water was no longer observed.

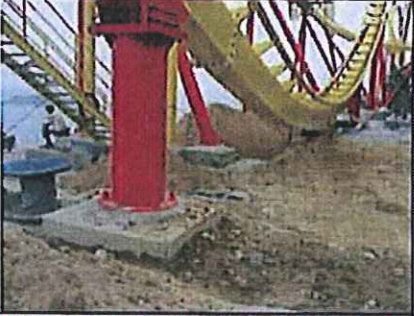
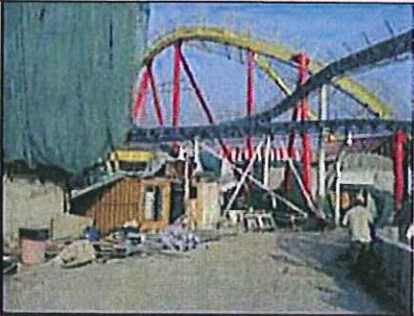
P1130859: Stockpiles of C&D materials awaiting backfilling were uncovered. The Contractor was reminded to cover them with tarpaulin sheets or other means to suppress dust.	Closed - P1140174: Stockpiles of C&D materials were no longer observed.

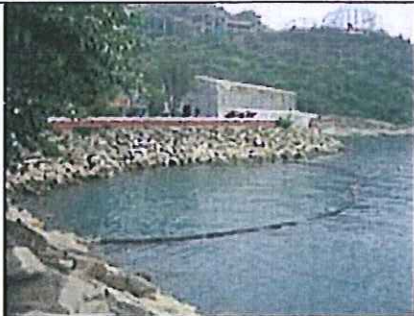
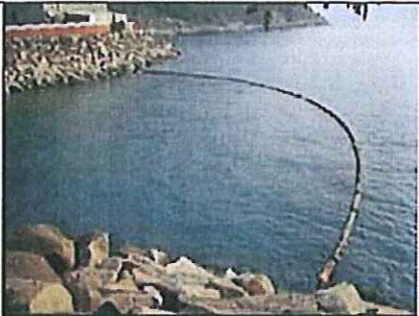
P1130871: The Contractor was recommended to maintain the silt curtain regularly and properly.		Closed - P1140182: The silt curtain had been repaired and being maintained properly.

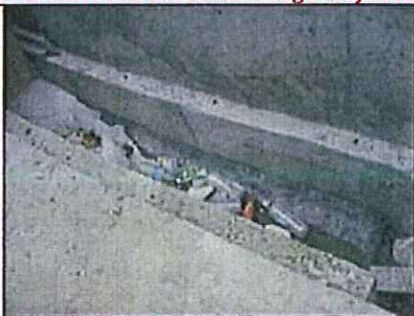
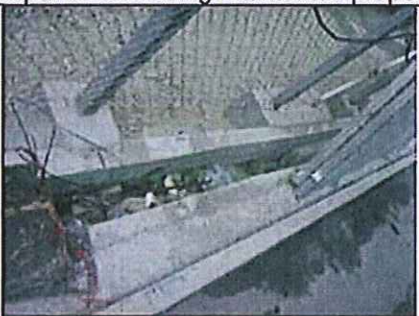
P1130864: General refuse were scattered around the site. The Contractor was reminded to provide more waste skips for storage of general refuse.		P1140165: General refuse were scattered around the site. The Contractor was reminded to provide more waste skips for storage of general refuse.

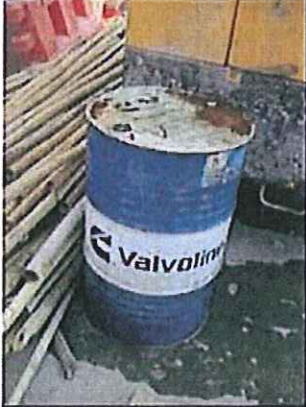
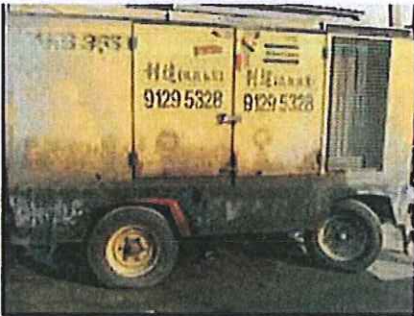
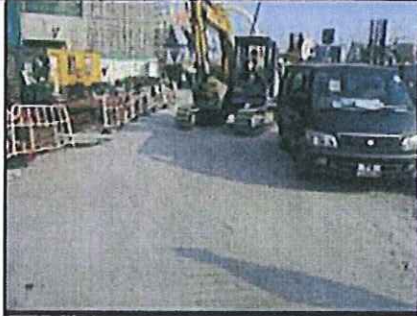
<p>P1140170 &amp; P1140171: A diesel drum and an air compressor were placed on bare ground. The Contractor was reminded to provide drip trays to them to avoid oil spillage, if any.</p>	<p>P1140176: The paved access road was dry and dusty. The Contractor was reminded to remove the deposits or provide water spray to suppress dust.</p>

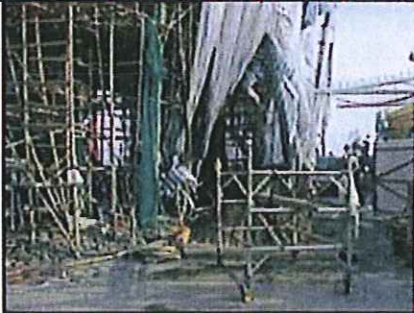
<p>P1140173: The Contractor was recommended to ensure all cement mixing works were carried out within an enclosure with the top and three sides enclosed.</p>
