TEST REPORT

**NGONG PING SEWAGE TREATMENT PLANT,
TRUNK SEWERS AND EFFLUENT EXPORT
PIPELINE
OPERATION PHASE
ANNUAL REPORT
FOR
GROUND WATER MONITORING
(FROM APRIL 2007 TO MARCH 2008)**

**Re: Ngong Ping Sewerage Project
Annual Report of Groundwater Monitoring at Ngong Ping STW and Effluent
Export Pipe (April 2007 – March 2008)**

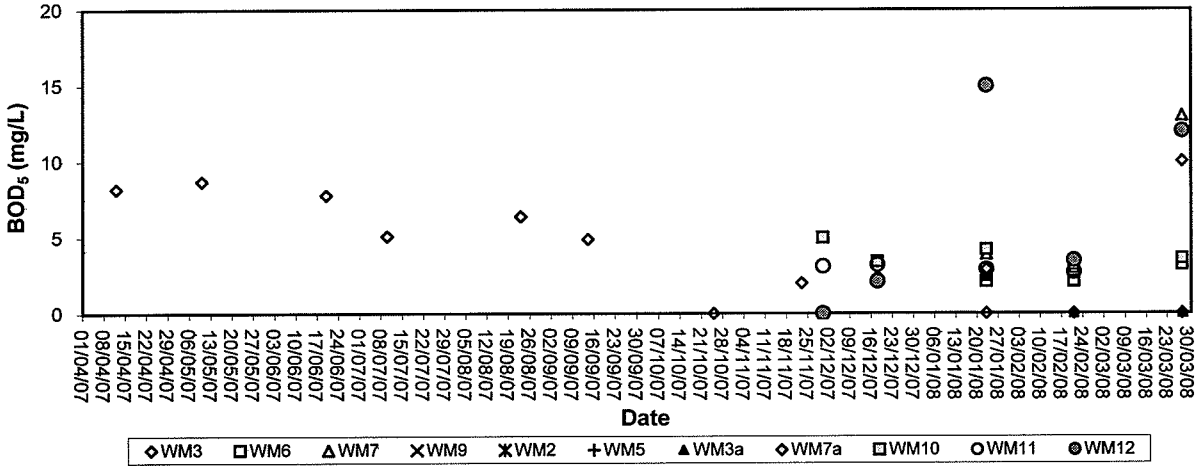
5-day Biochemical Oxygen Demand (BOD₅)

During this reporting year, groundwater monitoring was carried out at the designated manholes once per month. The groundwater quality measurement results during the monitoring period are detailed in Appendix B. Graphical presentation of the monitoring parameters for this reporting month is shown in Appendix C.

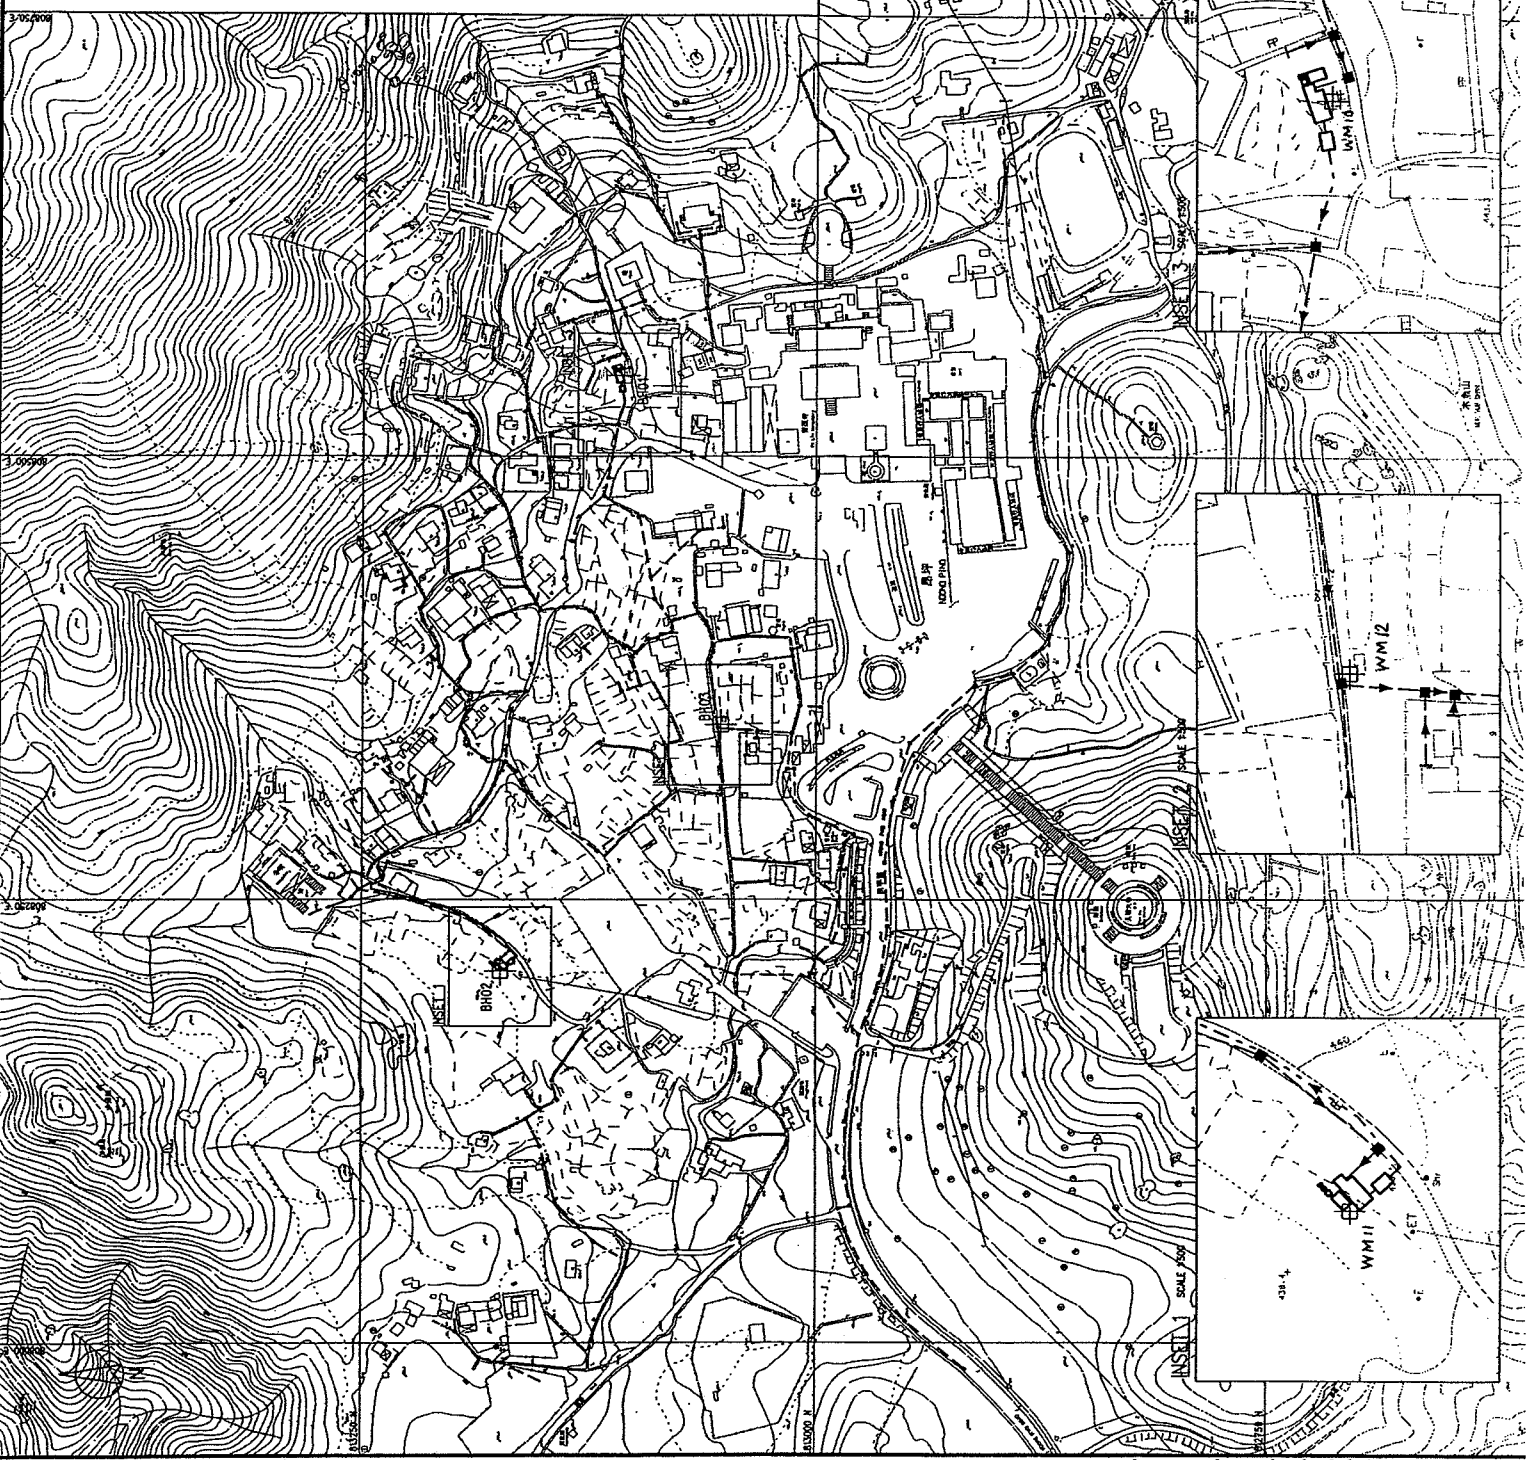
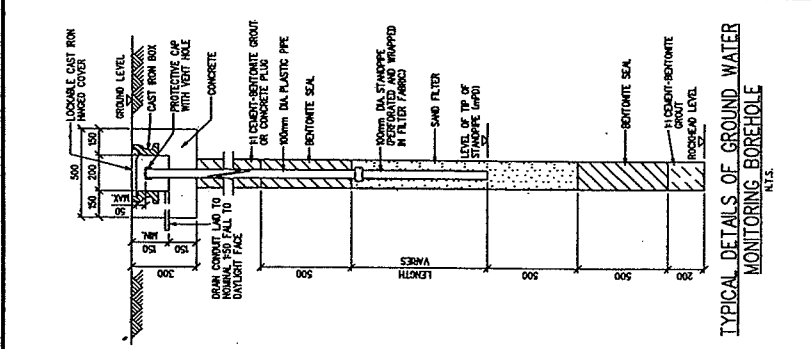
Drawing Title
LOCATION & TYPICAL DETAILS OF
GROUND WATER MONITORING BOREHOLE

NOTE:
EXACT LOCATIONS OF GROUND WATER MONITORING BOREHOLES ARE
SUBJECT TO CONFIRMATION ON SITE.

The general layout plan of the project is shown in Appendix D. The groundwater monitoring locations are also shown in the Drawing No. 23400/T/202, 23400/T/074, 23400/T/075 and 23400/T/076.

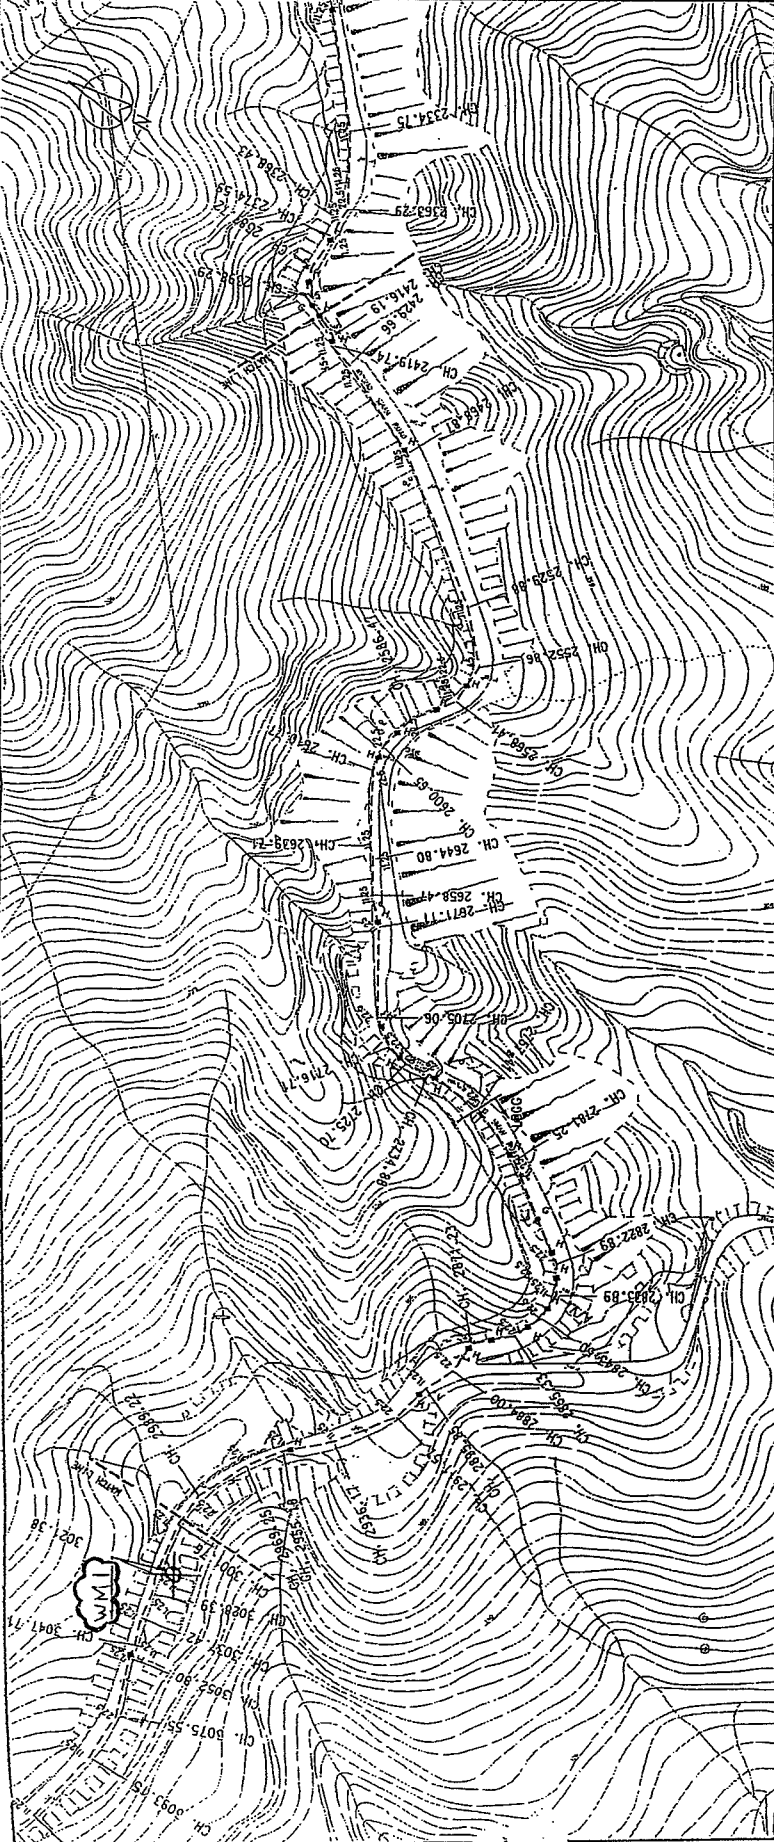
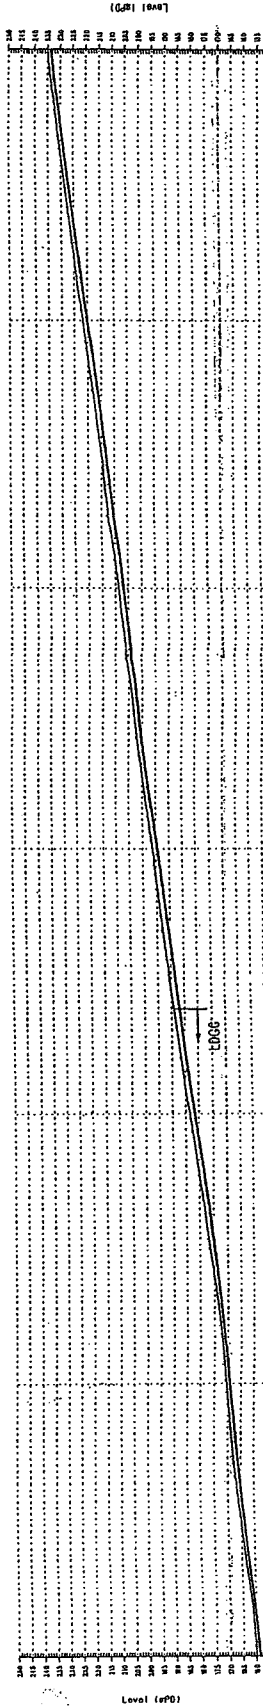
Drawing No. 23400/07074
Drawing Title
EFFLUENT EXPORT PIPELINE ALIGNMENT AND PROFILE (SHEET 6 OF 10)

VERTICAL PROFILE

TWIN DN200
