**NGONG PING SEWAGE TREATMENT PLANT,  
TRUNK SEWERS AND EFFLUENT EXPORT  
PIPELINE  
OPERATION PHASE**

**MONTHLY EM&A REPORT  
FOR  
GROUND WATER MONITORING  
(APRIL 2007)**

Report No.: ENA70243

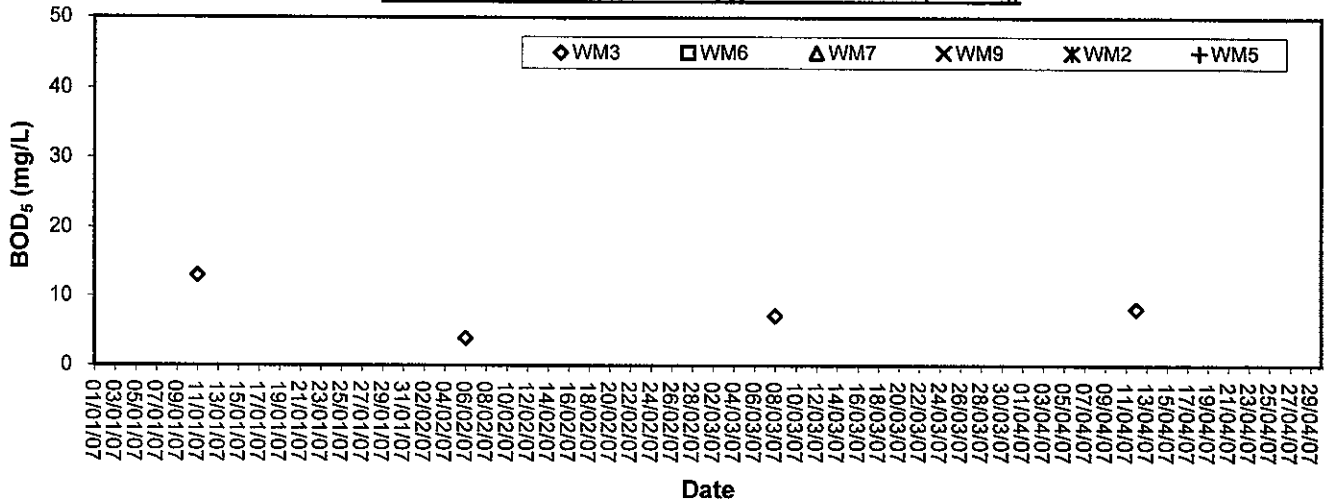
### 5-day Biochemical Oxygen Demand (BOD<sub>5</sub>)

In this reporting month, groundwater monitoring was carried out on 12 April 2007. During this monitoring, groundwater was found in Borehole No WM3 and the other boreholes were dry. The groundwater quality measurement results are detailed in Appendix B. Graphical presentation of the monitoring parameters for this reporting month is shown in Appendix C.
